# Analysis of the risks generated by the tailings ponds near the city of Borșa

**Abstract.** The paper presents the risks regarding the physical and chemical stability of the tailings ponds grouped under the name of Ds (D1, D2, D3, D4) located on the right bank of the river Cisla near the residential area of Baia Borșa and Colbu tailings pond upstream of the residential area of Borșa. The closure of these tailings ponds was done in a defective manner, without complying with the design and execution rules provided in the Technical Regulation on waste storage. There are two types of risks: first type, due to chemical instability that produces continuous acid drainage and the second type, regarding physical instability, due to erosion and extreme weather conditions which could lead to failure of the dams, with very serious consequences, causing material damages and loss of life. The risk of breaking the dams is even higher as it is located in the vicinity or upstream of residential areas located in a geographical structure of valley type containing the river Cisla with high debit.

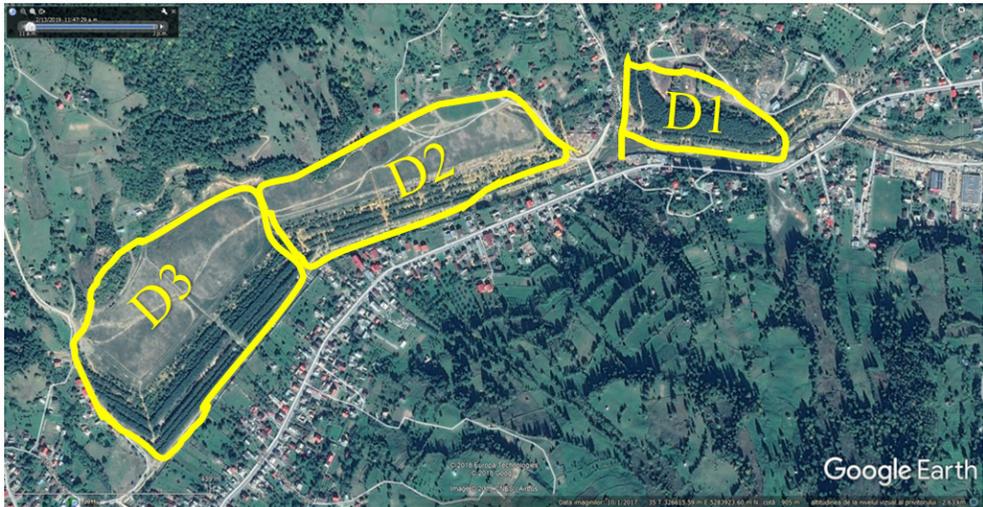
Ponds D1, D2 and D3 are located on the right bank of the river Cisla, in the vicinity of residential areas and present risks of physical and chemical stability (Figures 1 - 3). They have been rehabilitated, but with many deficiencies: without slope correction and without waterproofing, they have ravines through which material is entrained in the river, and geogrids are mostly revealed by entrainment of deposited material (consisting in many areas of sawdust and pieces of wood).

**Fig. 1.** Position of ponds D (1) relative to the Cisla River, Community (Borșa Bai) and road.
