Diagnosing the technical condition of modern diesel injectors using thermal infrared cameras

Marek Idzior¹ and Wojciech Karpiuk^{1*}

¹Poznan University of Technology, Institute of Combustion Engines and Powertrains, 61-138 Poznań, Piotrowo 3, Poland

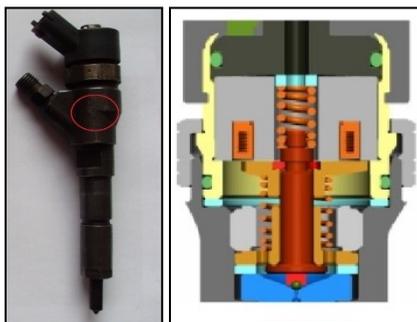
The main objective of this research work was to analyze the technical condition of the electromagnetic injector using a thermal imaging camera. On the basis of the measured value of the parameter - the temperature of the injector body in a specific point (Figure 1), the change of temperature gradient depending on the duration of its work was analyzed. The differences of the injector body temperatures between the injector with the damaged control valve unit and the fully working injector were determined during the analysis.

Fig.1. The location on the injector where the control valve is located (red border) and the design of the control valve [3].

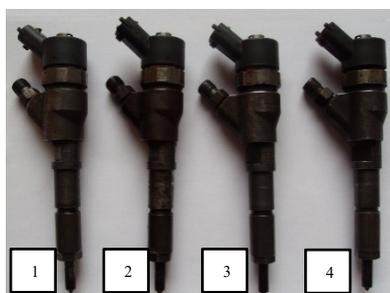
The first generation injectors manufactured by Bosch were used as test subjects (Figure 2). Before starting the tests, the types of defects of actuators and precision pairs, which occur in the above-mentioned injectors, were categorized (Table 1). Due to the common occurrence of mechanical damage of the control valve ball seat surface, it was decided to perform controlled damage of this element. An example photograph showing damage to the ball seat is shown in Figure 3.

Fig.2. The location on the injector where the control valve is located (red border) and the design of the control valve [3].
