Structural and material assessment of historic reinforced brick masonry elevator for grain – a study case

Abstract. The grain elevator was erected around 1940 and is situated at the Odra River embankment. It has a rectangular plan with the longer side perpendicular to the former port wharf. The structure of the building is mixed, made of reinforced concrete and brick masonry. The entire facility was founded on a reinforced concrete foundation slab. The ground floor columns, supporting the silos, the walls of the ground floor, the floor above the ground floor with silo drainage funnels, the inter-story ceilings of the technical route, the roof concrete frames and the attic ceiling are made of reinforced concrete. The main part of the structure consists of 74 interlocked grain silos, with a square cross-section. The walls of the silo chambers are brick, reinforced with steel bars in each joint. The article presents the results of diagnostics of the technical condition of the assessed object, including material analyses (concrete, brick, steel), as well as the results of static and strength calculations of the main load-bearing elements of the object conducted in order to verify the

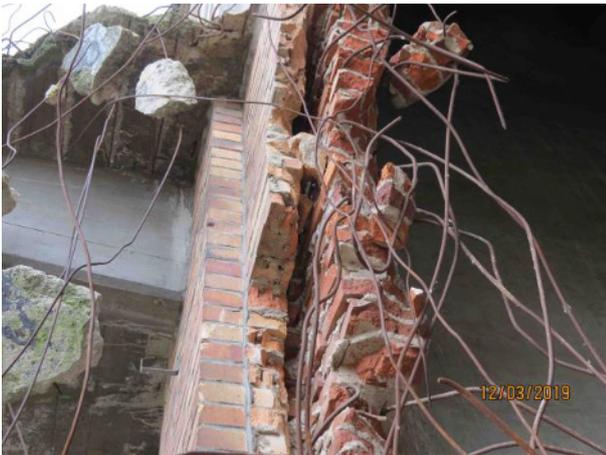
Based on the analysis of the archival documentation and the visual inspection, it was found that the structure of the building is mixed, made of reinforced concrete and brick masonry. The outer walls of the building are two-layered, with a load-bearing part with the thickness of 25 cm (also constituting the walls of the silos), an air gap and a veneer thickness 12 cm, fastened to internal walls with reinforcing bars (Fig. 5). From the side of the west,

Fig. 5. Two-layered walls of the building and silo chambers.

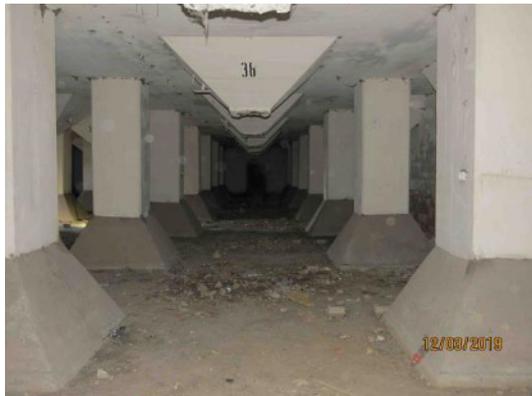
Fig. 7. View of the foundation structure of the elevator.

At the ground floor level, on the foundation slab, there are reinforced concrete pillars (Fig. 7) supporting the silo chambers, their discharge hoppers and, at the northern gable wall, the route of technical floors. Most columns measured 75 x 75 cm. At the foundation slab, the columns extend symmetrically to the dimensions of 155 x 155 cm, forming with the foundation slab a kind of inverted mushroom ceiling. The outcrop confirmed compliance of the reinforcement with the archival documentation.

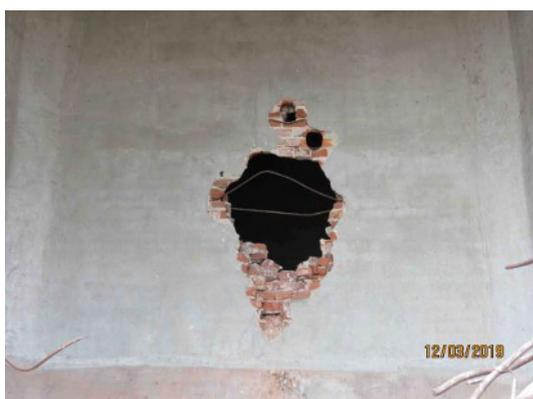
The greater part of the building consists of grain silo chambers with internal dimensions 3.90 x 3.90 m. The walls of the chambers are made of 25 cm full brick, reinforced with two Ø12 mm smooth rods every second joint (Fig. 14). The walls of the chambers are interconnected creating a rigid structure. Based on the destructive and sclerometric tests it was found that the chambers were made of a very high quality bricks. The technical condition of the chambers was assessed as good. No damage was found, although most of them were not fully available for direct observation and inside the chambers they may be damage on their surface. The static calculations showed that these walls can be used as load-bearing for the ceilings of residential stories, but with a significant reduction of the designed openings.

Fig. 14. The reinforced brick wall of the silo chamber.
