Impressed current cathodic protection of reinforced concrete in ATEX-zones – Case study: concrete slab in an industrial building

Bjorn Van Belleghem^{1,*}, Ben Smits², Hans van den Hondel³, Mathias Maes¹, Tim Soetens¹

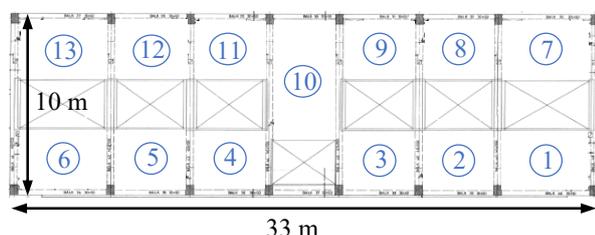
Fig. 1. Plan view of the floor slab.

The subject of this case study is a reinforced concrete floor slab with an area of about 230 m² in a 50-year old two-storey building on an industrial site in Belgium. The building is a production hall with numerous reactor installations used for the fabrication of raw materials for the production of photographic films. The floor slab, at the first level of the building, is supported by a framework of concrete beams, subdividing it into 13 smaller parts. The middle area of the floor contains openings for the reactors. Therefore, each floor part is supported by beams on 3 sides, leaving the side at the border of the openings unsupported. A plan view of the floor slab, indicating the 13 parts is given in Fig. 1. The areas indicated with a cross in Fig. 1 are the openings in the floor slab.

The concrete slab has a thickness of 15 cm in the outer parts (i.e. parts 1, 6, 7 and 13) and 13 cm in the other parts. On top of the slab there is a layer of screed and a tile floor finishing. The bottom of the slab is coated with a white paint.

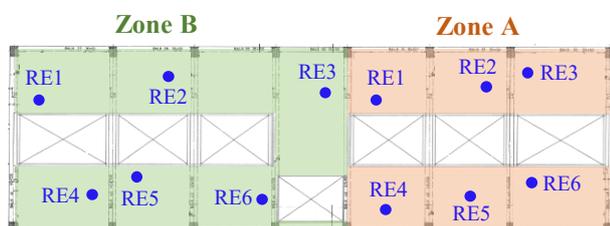
Fig. 10. Location of reference electrodes.

For the monitoring of the ICCP system, a total of 12 manganese dioxide (MnO₂) reference electrodes were installed (6 in each zone). The locations of the reference electrodes (RE's) are shown in Fig. 10. For both zones, the RE's are numbered from 1 to 6.

The reference electrodes were installed at a varying depth in the concrete slab to provide information regarding the protection of all steel reinforcement in the slab: in each zone, 3 RE's were installed near the bottom reinforcement, 1 RE near the top reinforcement and 2 RE's in the middle of the thickness of the slab.
