Analysis of causes of damage to masonry walls in the historic barrack No. B-115 in the former KL Auschwitz II – Birkenau camp

*Krzysztof Gromysz*¹, *Łukasz Szoblik*^{2*}, *Zofia Drabczyk*² and *Agnieszka Tanistra-Różanowska*²

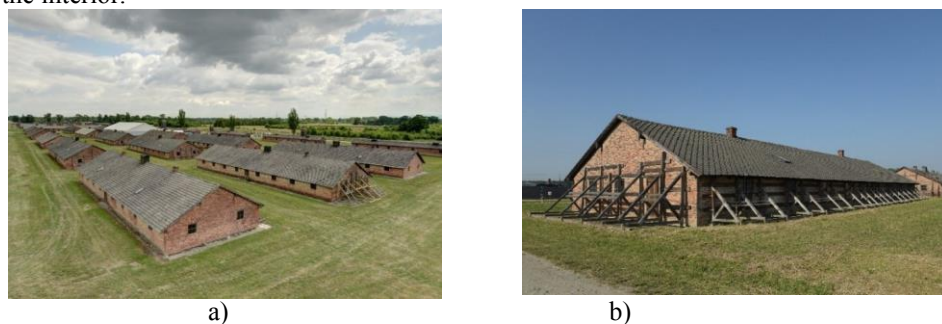
Fig. 2. Barracks on the grounds of Auschwitz-Birkenau camp: a) the sector B1, b) the barrack B-115.

The most serious damage was found in the front walls, which were deformed and detached from the lateral walls. An example of such damage (damage "A", Fig. 6a) occurred at the connection between the walls in axes 10 and B. The connection between these walls is extended by the pilaster, which supports the column that acts as the outer support for the timber purlin in the roof structure. This column transmits the load to the pilaster through the horizontal beam (bottom chord) at the level of +2.29 m. Debonding was found between the pilaster and the wall in axis B. The widest debonding is approximately 80 mm at the level of +2.29 m, which is 2/5 the height of the wall from the support on the masonry foundation. The gable wall in axis 10 is deformed. This wall is bowed in the shape of an arch segment. The net deflection of the bowing is 79 mm and is at the level of the bottom chord. Debonding is observed along the entire height of the gable wall. The gradual deformation of the wall poses a risk to its structural instability. To prevent further degradation, the wall was protected with a timber retaining structure (Fig. 2b) built on the outside.
