# Structural analysis and damage assessment of a fortified church – A case study: The Evangelical Church of Apos, Sibiu County

Porumb Ana-Maria<sup>1\*</sup> and Petruse Diana Eva Larisa<sup>1</sup>

<sup>1</sup>Polytechnic University of Timișoara, Piata Victoriei 2, Timișoara 300006, Romania

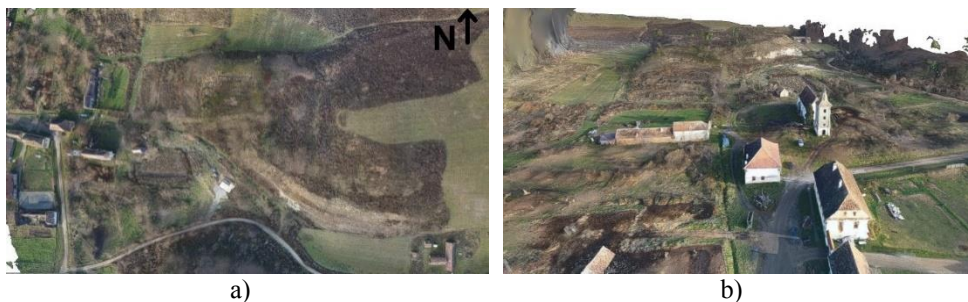
**Fig. 2.** (a) Aerial perspective - 3D Drone Survey, (b) Aerial perspective of the church, bell tower and clergy house - 3D Drone Survey

Based on the visual inspection, drone survey, illustrated in Fig. 2, as well as the damage assessment survey, the following conclusions have been drawn:
