Recent methods of visualization used in the diagnosis and consolidation of historic structures

Olariu Gigi^{1*} and *Nemet Florin Marius*¹

¹Polytechnic University of Timișoara, Piata Victoriei 2, Timișoara 300006, Romania

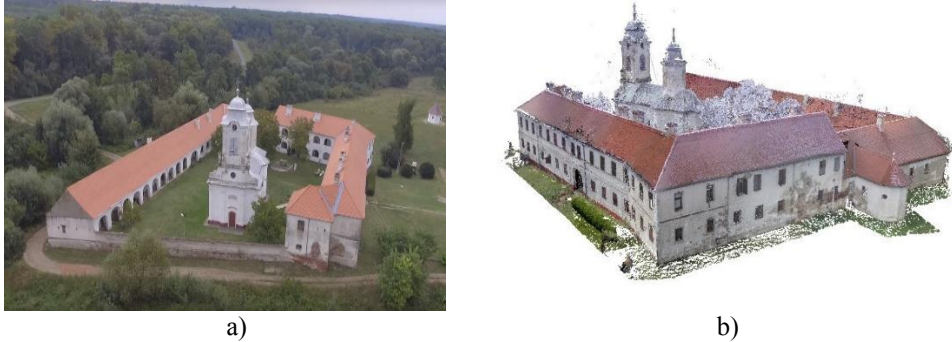
Fig. 1. (a) Aerial perspective, (b) Aerial perspective - 3D Drone Survey.

The investigation of the Bezdin Monastery Church was carried out using traditional methods of measurement and degradation identification, as well as recent visualization techniques, such as 3D laser and drone scanning. The scanning allowed for the collection of relevant information, such as degradation, dimensions, heights and details of inaccessible areas. The analysis included placing the entire building in a parallelepiped and conducting internal and external measurements to determine deviations, rotations, cracks and conservation status. The analysis also identified degradation caused by differential settlements, as well as architectural defects caused by water damage. To summarize, the investigation used a combination of traditional and modern techniques to collect detailed and accurate information about the current condition of the church.

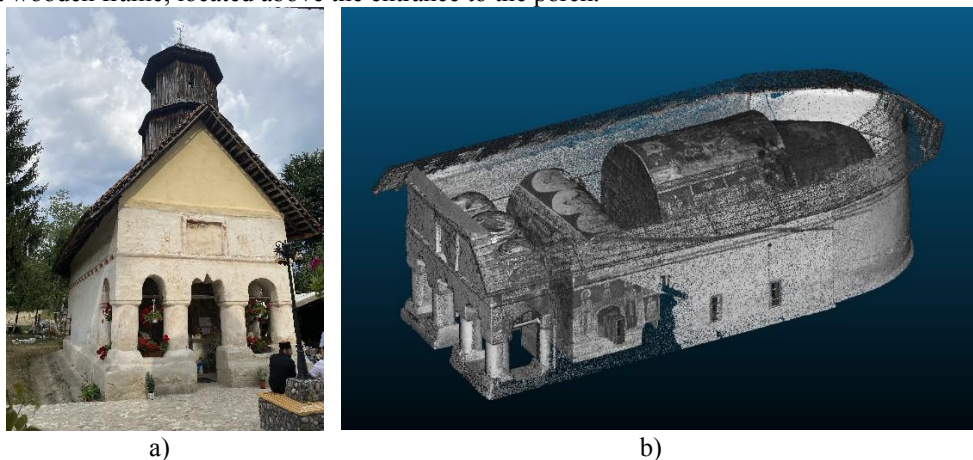
Fig. 5. (a) The "Saint Martyr Filimon" Monastery, (b) 3D Laser Survey.

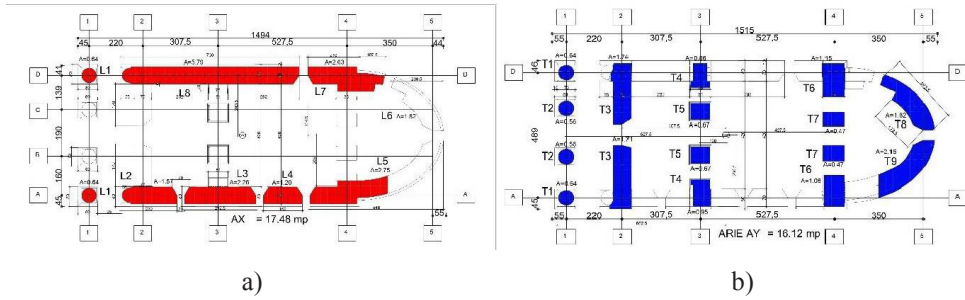
Following observations made on-site, it was revealed that a structural analysis was needed in order to consolidate the building, which showed multiple deteriorations caused by differential settlements, as well as the existing loads. The distribution and configuration of the load-bearing walls in the plan are shown in Fig. 6 (a) and (b). Thus, it can be observed that the area occupied by them on the OX axis is 17.48 square meters, and on the OY axis it is 16.12 square meters.

Fig. 6. (a) The distribution of the load-bearing walls in plan along the Ox axis, (b) The distribution of the load-bearing walls in plan along the Oy axis.

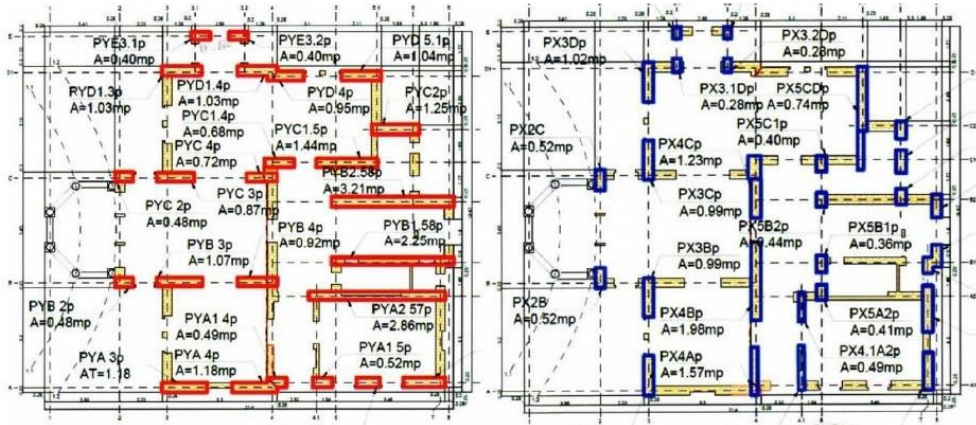
Structurally, the building has continuous foundations made of brick masonry, load-bearing walls made of brick and mortar based on lime, clay, and sand, with thicknesses of 50 cm on the exterior and variable thicknesses ranging from 30-50 cm on the interior. The floors are made of brick vaults in the basement, ground floor, and upper floor, with wooden beams arranged at a distance of 75 cm, with metal ties mounted at their level. The roof structure was made in a traditional manner using specific technologies of the time. The distribution of the walls in the plan is presented in Fig. 8. In the longitudinal direction, the walls occupy 21.65% of the built area, and in the transverse direction, 19.97% [4].

Fig. 8. Wall placement – ground floor plan and first floor plan.
