# Conservation, consolidation and restoration of the Holy Annunciation Church, Vatasesti village, region of Oltenia, Romania - Architectural and structural particularities

**Abstract.** The present article discusses the process of architectural and structural diagnosis of a late 18th century, brick masonry built, Christian church located in Vătășești village, Vâlcea county, Romania, presenting the particularities discovered. The church is dedicated to Saint John the Baptist and The Holy Annunciation and it is listed under the LMI code (List of historical monuments of Romania) VL-II-m-B-09968. Its registration in the list of historical monuments inscribed in the National Cultural Heritage of Romania was realized especially thanks to its original byzantine style mural paintings (frescoes) still left almost intact on the interior walls, the only serious damage made to it being found on the paintings once found on the outside walls. In order to properly conserve, consolidate and restore the vernacular monument, the process of diagnosis had to include research and investigations of various and complementary areas such as 3D scanning using laser scan technology, the archaeological repor

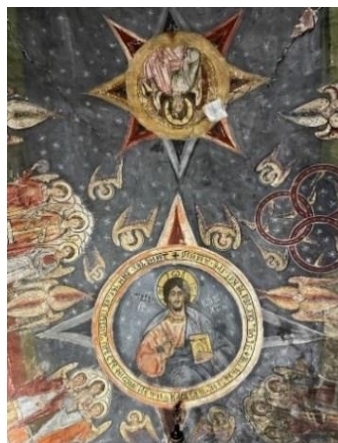
The naos is a 4 by 5 meters' room. Its ceiling is a vault oriented from east to west. Fig. 10 shows the mural paintings on the vault above the naos room.

**Fig. 10.** Detail of the vault above the naos.

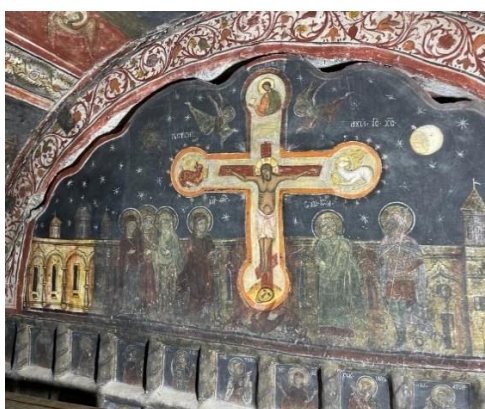
The altarpiece of the Holy Annunciation church in Vătăşeşti is unique. It is built of brick masonry, with three arched doors connecting the rooms, and at the top of the altarpiece it is not connected with the naos vault like usual, it actually ends with an offset decoration profile. (Fig. 11).

**Fig. 11.** Zoom in on the altar piece after the cleaning of the paintings try-out.

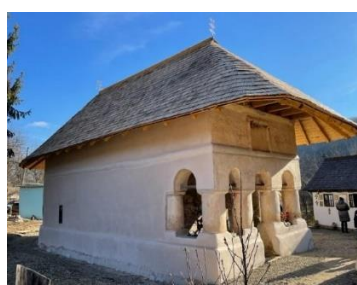
**Fig. 23.** The Holy Annunciation church at the end of the structural major interventions.

The architectural and engineering projects put together for the consolidation and restoration of the Holy Annunciation church seek to respect and apply all contemporary principles of interventions on historic buildings and cultural heritage theory (Fig. 21-23).
