Scarf Repair of Composite Laminates

Abstract. The use of composite materials, such as carbon-fiber reinforced plastic (CFRP) composites, aero-structures has led to an increased need of advanced assembly joining and repair technologies. Adhesive bonded repairs as an alternative to recover full or part of initial strength were investigated. Tests were conducted with the objective of evaluating the effectiveness of techniques used for repairing damage fiber reinforced laminated composites. Failure loads and failure modes were generated and compared with the following parameters: scarf angles, roughness of grind tool and number of external plies. Results showed that scarf angle was the critical parameter and the largest tensile strength was observed with the smallest scarf angle. Besides, the use of external plies at the outer surface could not increase the repairs efficiency for large scarf angle. Preparing the repair surfaces by sanding them with a sander ranging from 60 to 100 grit number had significant effect on the failure load. These results allowed the proposal of design principles for repairing CFRP structures.

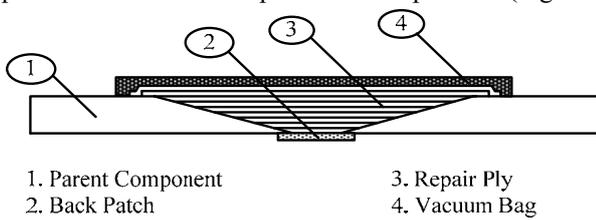
1. Parent Component
 2. Back Patch
 3. Repair Ply
 4. Vacuum Bag

Figure 1. Schematic of the vacuum patch repair process.

Two separate plates were joined together by the scarf techniques. Figure 1 shows the procedure sequence in the repair process of a damaged laminate. Initially a back plate was bonded at the back of the laminate in order to position the two parts. Then prepreg plies with tailored dimensions are placed on top of the plate. The patch materials are bonded to the laminate using adhesive film. One external ply was placed on the top and its boundaries are sealed with some adhesive. The electrically heated blanket is maintained until the reinforcement(patch) adherends to the parent component, awaiting solidification.

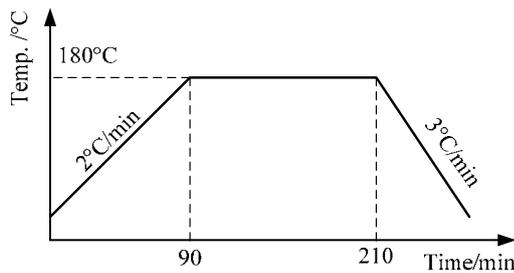
Figure 2. The temperature cycle used in making the repair.

The manufacture process consisted of hand lay-up followed by curing in a hot-plates with 0.8 bar pressure. The heat cycle initiated warming up the plate at 2°C/min, followed by two hours curing at 180°C. Cooling was performed at 3°C/min up to room temperature (Figure 2).

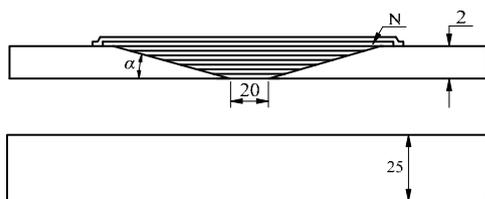
Figure 3. Dimensions of the scarf repairs coupon.

The coupons are prepared by cutting the panel into the standard coupon sizes (ASTM D3039). The coupon dimensions were shown in Figure 3. Three different scarf angles were conducted, and $\alpha=2^\circ, 4^\circ$ and 6° . In order to investigate the external plies effect on the repair efficiency, two different laminates were designed with $N=0$ and 1. Besides, undamaged specimens, noted as scarf angle $\alpha=0^\circ$, were tested to verify the repairs recovery efficiency. A total of five specimens were tested in tension for each case described above. The complete test matrix was shown in Table 2.

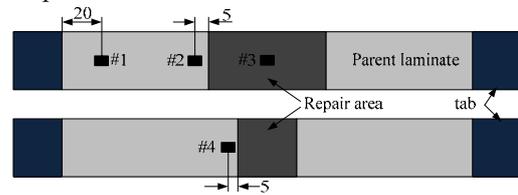
Figure 4. Strain gauge positions of the scarf joint coupon

Strain gages were placed at several locations on the specimen as shown in Figure 4. The strain gage readings were used to analyze the damage initiation and damage growth path.

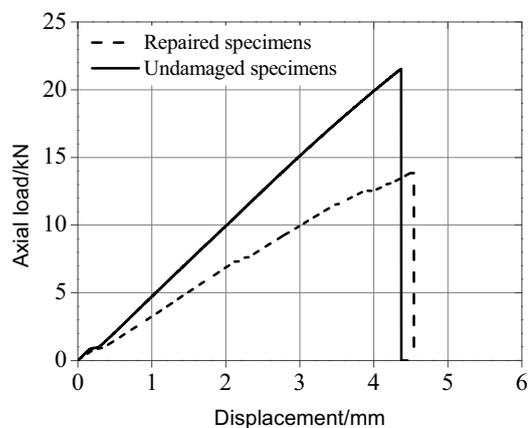
Figure 5. Typical load-displacement curves of the specimens.

The load-displacement curves for the repaired specimens and undamaged specimens are shown in Figure 5. The repair specimens' stiffness reduces as the adhesive modulus is much lower than the parent laminate. Besides, stiffness reduction experienced by the repairs prior to failure was caused by the softening of the adhesive layer at the bond edges.

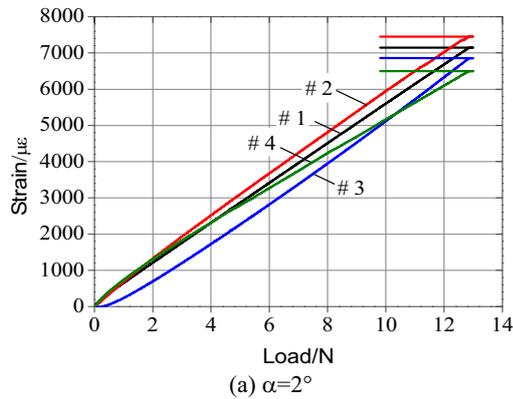
Figure 6. Strains measured at critical locations.

The strains measured at critical locations were shown in Figure 6. For the 6° repair structure, the strain increase rate at location #4 decreases with the load whilst it increases at location #3 which indicates that the damage initiates from the bottom of the adhesive and grows along the bondline(see in Figure 7).

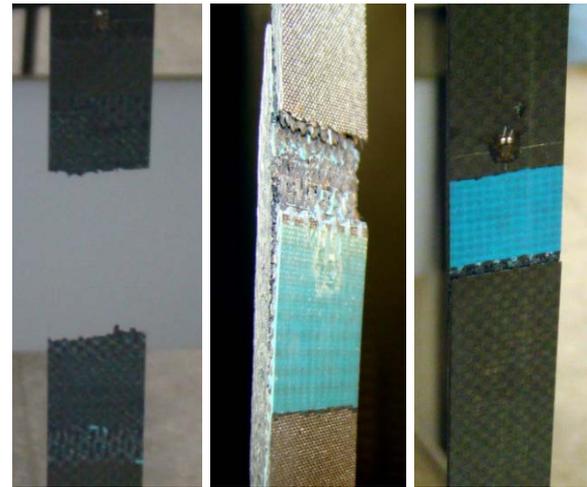
(a) $\alpha=2^\circ$ (b) $\alpha=4^\circ$ (c) $\alpha=6^\circ$

Figure 8. Failure modes in repaired specimens.

Figure 8 shows the typical damage modes observed in the tests conducted. For the case of $4^\circ\sim 6^\circ$ repair structure, it was seen that the primary damage mode is

adhesive debond. However, for the case of 2° repair structure, intra-laminar failure mode was also found.

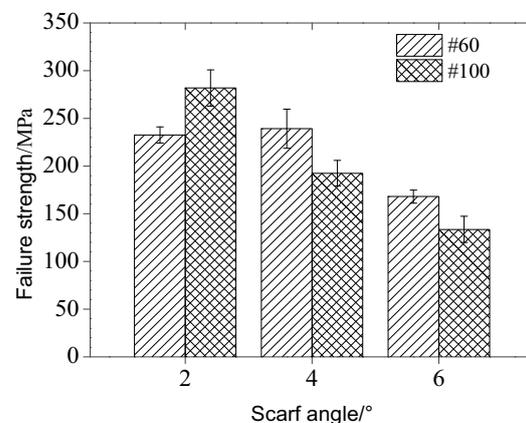
Figure 9. The failure strength of the specimens with different scarf angles and grit number of sanders.

Figure 9 and Table 2 show the failure strength obtained from the scarf repair approach with different repair parameters. The failure strength of the parent material was approximately 455MPa.

Testing of the scarf joints/repair recovered 29%~62% of the parent laminate strength. The failure strength increases as the scarf angle decreases. A slight decreasing trend on failure strength was observed increasing the scarf angle, even though with some variations.

Customarily, prior to repair the repair surface of the base laminate is sanded. To evaluate the influence of sanding on the failure load of repaired specimens, the repair surfaces were sanded with different grit diamond sanders. The failure loads of specimens repaired using different grit sanders are shown in Figure 9. The data indicate that the grit number of the sander have a significant effect on the failure load. For the material and type of repair used in this study, a sander with greater grit number could increase the failure strength for larger scarf angle and inverse trend was observed for small scarf angle.

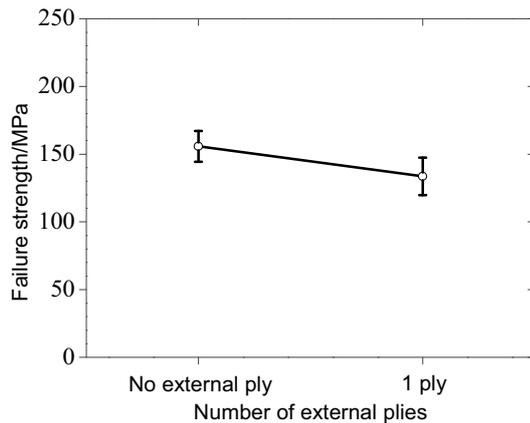
Figure 10. The effect of the number of external plies on the failure strength in scarf repairs.

The addition of external plies on the surface of the specimen resulted in decreased loads. The repair patch applied on one side contributes to out-of-plane bending by affecting the symmetry which resulted in secondary bending effects that begin to add the adhesive peel stress. However, reverse effect was observed in Sung's work [9]. This was because that in Sung's work, a smaller scarf angle was used. For the smaller values of α , normal stresses, σ_n , diminish in relative magnitude to τ_{avg} . Under these conditions, shear stresses, τ_m , govern the repairs behavior [10].
