# Analysis of partial discharge Ultrasonic wave characteristic on typical Defects in GIS

**Abstract.** For analyzing partial discharge ultrasonic wave characteristic on typical defects in SF<sub>6</sub> gas insulation switchgear (GIS), a 110 kV GIS was taken as an object to design and simulate the typical partial discharge models in GIS. There are point electrode model on bus and cavity of GIS, floating electrode model, air interstice model in insulator, metal particle and iron core electromagnetic shock models. PD signals on different defects were thus detected with the ultrasonic method. The experimental results indicated that the ultrasonic signals of different defects showed different characteristics in waveform, amplitude and phase resolved partial discharge chart, which is helpful in PD pattern recognition for GIS.

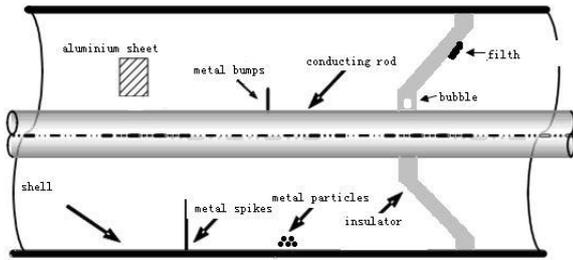
GIS internal reason of the failure of tend to be various, in the manufacturing and assembly process, GIS will inevitably leave some minor defects. According to the relevant literature and the experience of field test, Produced high-voltage bus for a metal spike, wall bulging metal spikes, structure as shown in figure 1.

**Figure 1.** GIS common defects schematic

Five kinds of common defects of GIS model designed, including a high-voltage bus metal spike, GIS wall metal spike, floating potential, insulator within the air gap and free metal particles etc. The metal spike model is a steel needle which is 53 mm length, the equivalent radius of curvature of the cutting edge is  $100 \mu\text{m}$ ; Metal suspended potential defects by polyethylene insulation screw to fix the metal aluminium on the high voltage bus bar, the two are separated by a distance (test respectively use 1 mm, 1.5 mm, 2 mm and 4 mm gap distance), insulating screw can be used to adjust the clearance between guide rod and suspended aluminum distance.

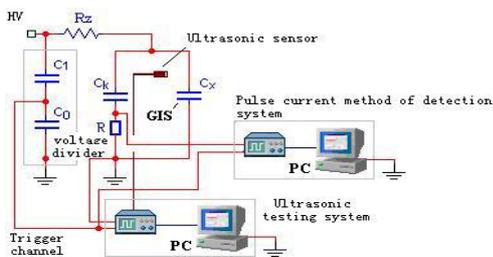
Typical defects of GIS experiment and testing system of ultrasonic signal main structure schematic is shown in figure 2. The system is mainly composed of the maximum output voltage is 250 kV AC testing transformer which without partial discharge, protection resistance  $R_z$  (water resistance), coupling capacitance  $C_k$  (85 pF), detection impedance ( $50 \Omega$ ),  $C_1$  and  $C_0$  divider, 110 kV gis test section which built-in defect can be replaced ( $C_x$ ), AIA ultrasonic signal detector and pulse current method of detection system. Pulse current method as an auxiliary means, is used to compare and confirm collection for discharge signals.

**Figure 2.** Test system structure diagram

Install the defects in GIS cavity in the body and the SF6 gas charging 0.45 MPa when test.

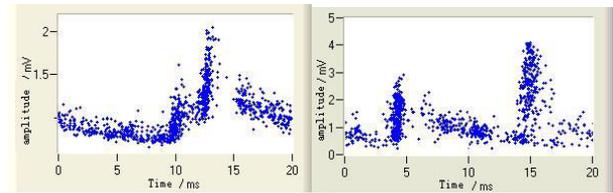
When test, the voltage from low to high, until stable the measured ultrasonic signal, record its initial discharge and strong discharge PRPD (phase - resolved partial discharge, partial discharge signals phase map) spectra, as shown in figure 3.

(a) starting discharge stage (b) strong discharge stage

**Figure 3.** Initial discharge and strong discharge PRPD spectra

From PRPD spectra can be found in this type of discharge in two stages: only negative half cycle appear a small amount of discharge pulse and the positive half cycle basic not discharge during low voltage, the cause of this phenomenon is that the positive polarity, tip quality of positive ions ionized to larger then moving slowly, but electrons to cutting-edge mobile quickly. At high voltage, gas ionization is very intense when the positive half cycle power frequency, a lot of positive ions to be near plate equivalent reduced the plate spacing, Continue to ionization and form electron avalanche discharge and lingers, which may arise in the positive half cycle breakdown produces large amplitude of discharge pulses. Partial discharge level increased, the positive half cycle also appeared a lot of discharge pulse, and the positive and negative half cycle of discharge pulse in power frequency phase peak near the positive and negative.

1) metal spike defects : When the metal spikes in different places, its cause partial discharge PRPD spectra will present different characteristics due to the polarity effect, in the low voltage, phase spectra show unimodal pattern, the high voltage, phase spectrum of two kinds of discharge the graph is bimodal pattern, but the signal amplitude and the signal density distribution difference;

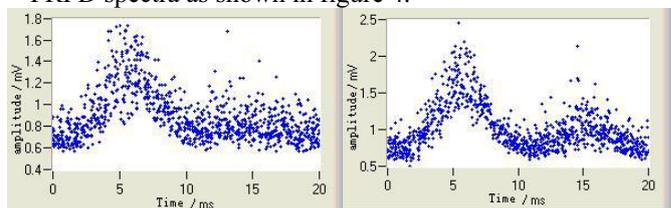
GIS shell wall connected to the earth, but due to the presence of metal spikes and make the electric field distortion, the spikes in the electric field makes the SF6 gas ionization occurred around, causing partial discharge. When the experiment, the applied voltage from low to high, recording the initial discharge and strong discharge PRPD spectra as shown in figure 4.

(a) starting discharge stage (b) strong discharge stage

**Figure 4.** Initial discharge and discharge strong PRPD spectra

It can be see that signal mainly concentrated in the positive half exemption value nearby when the initial discharge, as voltage continues to rise, discharge and discharge frequency continues to increase, and the negative half cycle also appeared some discharge pulse, phase concentration near the  $270^\circ$ .

When the metal spikes, therefore, the location is not at the same time, the cause of the partial discharge PRPD spectra will present different characteristics due to the

polarity effect, in the low voltage, phase spectra show unimodal pattern, when the voltage is higher, two phase spectrum of discharge of the graph is bimodal pattern, but the amplitude and density of the signal distribution difference.

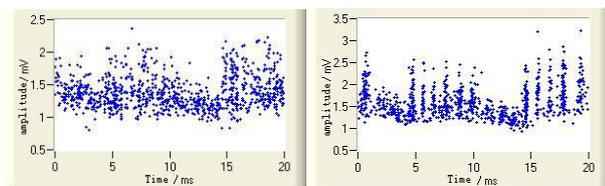
Suspended potential defects caused by partial discharge is in the nature of the local breakdown. Because floating potential and high voltage bus form a capacitor, when both ends of the equivalent capacitance voltage exceeds the withstand voltage, high voltage busbar and gaps between floating electrode was breakdown, partial discharge. When the applied voltage is higher, defects in a power frequency cycle may occur many times charge discharge process, appear many times breakdown phenomenon. Records of initial discharge and strong discharge PRPD spectrum diagram as shown in figure 5 .

(a) starting discharge stage (b) strong discharge stage

**Figure 5.** Initial discharge and discharge strong PRPD spectra

2) suspension potential defects: partial discharge is mainly focused on the falling edge of the power supply

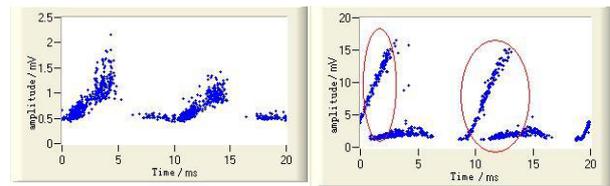
Considering the dispersivity of the discharge and the discharge mode of time accumulated, experiments on samples can step up to voltage until the first discharge signals collected, then the stability of this voltage applied of 10 minutes, and then gradually increase the voltage, each level voltages remain for 10 minutes or so on the discharge phenomenon. Record the starting discharge and strong discharge PRPD spectrum diagram as shown in figure 6.

(a) starting discharge stage (b) strong discharge stage

**Figure 6.** Initial discharge and discharge strong PRPD spectra

PRPD spectra showed obvious phenomenon of "rabbit ear" (in part). Due to near zero air gap applied electric field in applied voltage polarity reversal, and the air gap within the dual pole field intensity in the same direction, the superposition of two field intensity in the air gap within the field strength increase, and discharge, so the "rabbit ear" signal spectra.

With the increase of applied voltage, "rabbit ear" part becomes more obvious, the spectra of the air gap discharge mode change is not big, generally considered as the partial discharge, air gap of defects are happening gas molecules within the discharge decomposition, produce the electronegativity molecules, such as CO<sub>2</sub>, H<sub>2</sub>O, on the one hand these molecules influence the gases in the air gap discharge effect, on the other hand, with medium produces chemical reaction, generate crystalline objects attached in the surface of the medium, change the conductivity on the surface of the medium. Constant bombardment due to discharge of molecular and electronic media surface, the medium surface roughness increases, the influence on the discharge space charge accumulation, lead to the change of discharge spectra. Comparing the spectra of different voltages can also be found that with the increase of applied voltage and the phase of "rabbit ear" followed wide.

3) Insulator internal air bubble defect: the biggest feature of the air bubble defect is in positive and negative half cycle rise along their "rabbit ear" shape distribution, and with the increase of voltage "rabbit ear" amplitude increases, the trend of "rabbit ear" starting phase decreases;

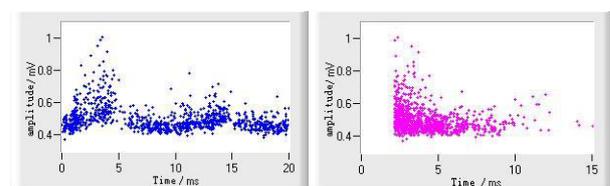
Recorded the initial discharge PRPD spectra and flight figure as shown in figure 7.

(a) PRPD spectra (b) flight figure

**Figure 7.** start discharging the PRPD spectra, flight figure

Initial discharge, the signal is concentrated in the power supply voltage is near the peak, the signal amplitude is smaller, particle flight jitter is not active, discharge and discharge time interval between the statistics are not relevant, no obvious characteristics on the drawing in the flight. This is because when the voltage is not high, the metal particles are not violent beating, a model is equivalent to a wall in metal bumps defect model, at this point the first discharge signals appeared in the positive peak of the power supply.

4) Free metal particles defect: particles without movement, the equivalent of the spikes defect on the grounding body, partial discharge signals show its discharge characteristics of thorns; Discharge occurs When the particle movement, defect discharge occurs in the whole power frequency cycle, power frequency ultrasonic signal amplitude, time of flight but showed strong cyclical changes;

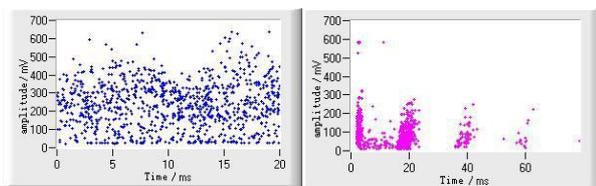
With the applied voltage rise gradually, the particles gradually occur beating, discharge more and more intense, recorded the PRPD spectra and flight diagram of the starting discharge, as shown in figure 8.

(a) PRPD spectra (b) flight figure

**Figure 8.** metal particle movement PRPD spectra, flight figure
