Analysis of roof membranes damaged by mechanical and climatic loads – pilot research

Abstract. Realization of roof construction has many hidden risks, especially in buildings with diverse architecture. There is a problem about cooperation of individual works (vertical and horizontal constructions) on roof in this type of architecture, during the process of realization. Purpose of this research is to reveal risks in form of the group of major source of defects by mechanical damages. The most often types of mechanical damages were chosen in this research, which then were applied on individual types of roof membranes. Response of this damage was found out during the test procedure of water pressure by special laboratory machines. Furthermore, samples of roof membranes were subjected to the Impact test, which was actually focused on damage by hailstone impact from the atmosphere. The final outcomes of the measurements show that the material composition of each roof membrane can influence their whole waterproofing after application of certain type of mechanical damage. In the Impact test, samples were suffered from impact of the hails. This test signified that the choice of base materi

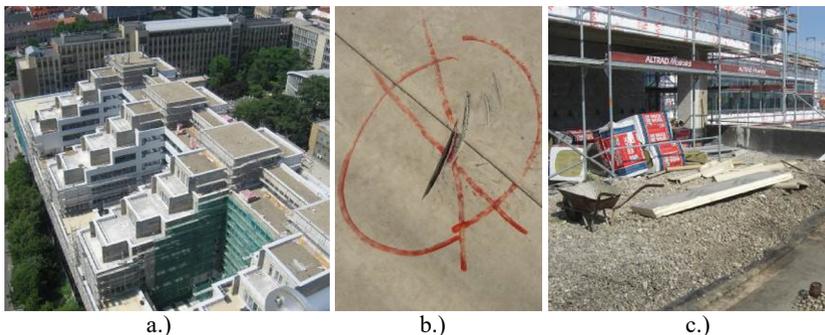
Fig. 1. The scene of roof restoration: a.) Faculty building of STU in Bratislava, b.) Mechanical damage PVC-P waterproof membrane, c.) Realization of horizontal and vertical construction of STU.

Especially, it is requisite to give better attention during the realization of architecturally shaped objects where generally flat roofs prevail. This type of architecture with gradually changed floors generates a lot of problems with cooperation each step of work on the vertical and horizontal parts of building construction (roof/facade). In many cases, flat roof could provide good place for storing building material, site equipment or scaffold, Fig. 1c. General example of this type of building could provide recent restoration of roof on the building of Slovak University of Technology in Bratislava, Fig. 1a. Many damages of waterproof membranes have been done due to unprofessional and irrational working operations, Fig. 1b. These recent circumstances in practise make up the main reason why this pilot research has been done.

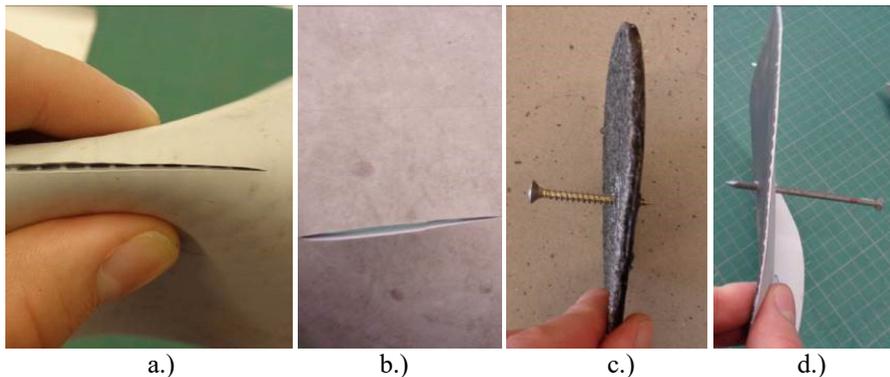
Fig. 2. Types of mechanical damage: a.) Half-cut knife, b.) Full-cut knife, c.) Nail perforation, d.) Screw perforation.

Waterproof properties of roof membranes are determined mainly by each component part used in the whole material structure. The main goal of this research is investigation of dependency between material compositions of the foremost using membranes and mechanical and climatic damage. Analysis of this dependency function was found out by experimental measurements realized in the special laboratories. Two types of analysis have been done in this research: analysis of mechanical damage on membranes caused by human factor and its influence on membrane waterproofing, analysis of hailstorm impact on membranes subjected under laboratory temperature 20 °C placed on different base material. Novel types of samples without any initial damages were used in the experimental measurements as well as samples taken from a site. Consequently, types of mechanical damage were chosen and implicated on membrane samples: 50 mm long knife cut (full and half of thick sample), nail perforation, screw perforation, Fig. 2.

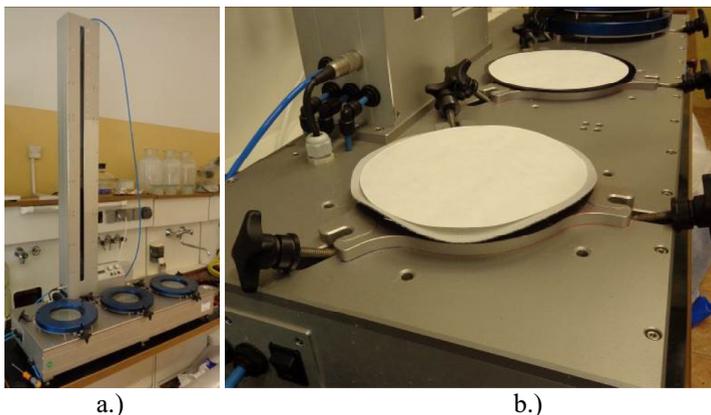
Fig. 3. Laboratory equipment for low-pressure water testing procedure: a.) Watertightness Tester WSP 3600, b.) Putting samples into the chamber.

Tests were carried out by using EN 1928 method A to determinate watertight properties of investigated samples [2]. Procedure triple tester, Fig. 3a, provides measuring three samples at the same time under maximum water pressure 12 kPa during 24 hour test period. Each sample was cut out for circle shape (ϕ 200 mm) and then place upper side downwards into chamber, covered by filtrated paper and glass plate with a flange ring, Fig. 3b. Tightness of chamber is ensured by three wing screws situated around the ring. Filtration paper could provide instantaneously identification of water penetration through membrane. After checking the whole corrections of apparatus, opening of inlet valve provided flowing of coloured water into chamber and subsequently started to press on the samples until water column reached maximum value 1200 mm. Samples were observed under the lower pressure during water pumping. If certain sample withstood process of filling up the water column then sample was leaved for observation during 24 hour.

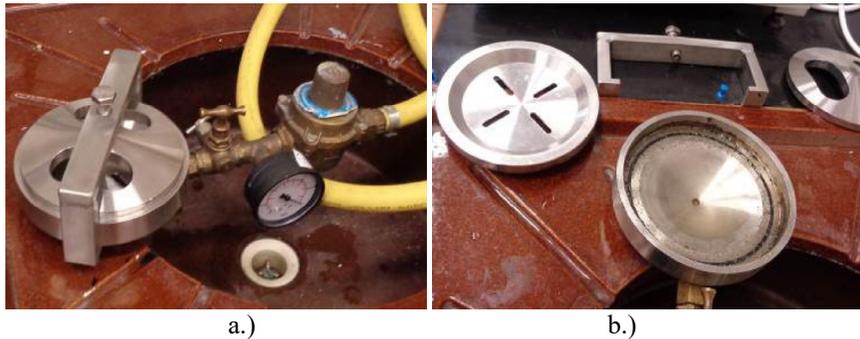
Fig. 4. Laboratory equipment for high-pressure water testing procedure: a.) Apparatus in process, b.) Each parts of apparatus.

This procedure could provide testing only one sample by one-time period in compliance with EN 1928 method B [2]. Samples were cut out circle shape (ϕ 130 mm) and then place upper side downwards into apparatus and covered by a circular steel disk containing four

slots, Fig. 4b. Cone-shaped covering was put on the disk and tightened by a clamp. Thereafter, opened inlet valve provided water flowing into the apparatus that immediately caused water pressure on the sample, Fig. 4a. Value of water pressure could be adjusted by throttle valve to maximum value 60 kPa.

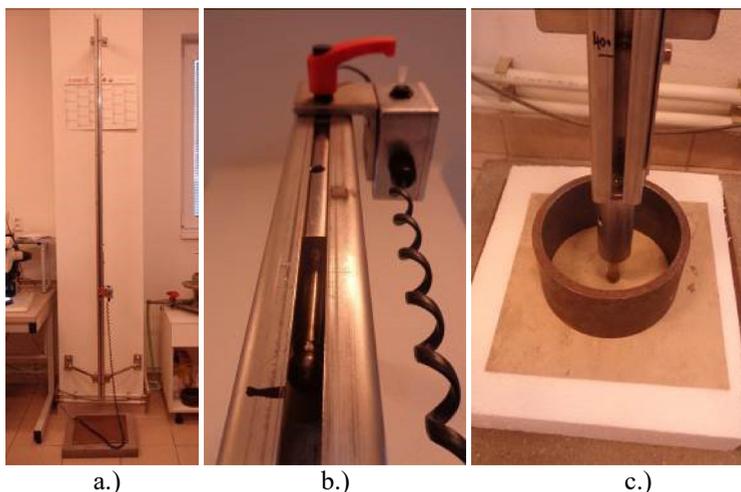
Fig. 5. Impact test equipment: a.) Whole apparatus, b.) Trigger with a setting device for variable drop, c.) Ballast ring on the sample.

The principle of this test is about simulated impact of a certain weight on the membranes [3] with different underlay material: expanded polystyrene (EPS), mineral wool (MW), polyisocyanurate foam (PIR) and steel plate with 3 mm of thickness. This weight is represented by cylindrical steel drop mass (500 g) with a fixed puncturing spherical-shaped tool (ϕ 12.7 mm), whole weight is attached on a release mechanism, Fig. 5b. The drop height was set up 2 m from the bottom of the puncturing tool to the upwards surface of the membrane. Each sample was burdened by ballast steel ring (2 kg) with inner diameter of 100 mm, Fig. 5c. Investigation was not only focused on the membrane damage but also underlay material damage by weight impact. If it could not be possible visually to determinate character of damage, then sample was subsequently subjected under water pressure testing procedure.
