# Application possibilities of the low-temperature repairs on creep-resistance turbine components from material GX23CrMoV12-1

**Abstract.** Papers deals with the problems of repairs at new and also already loaded components of steam and gas turbines. Generally, it is about welding repairs at valve and turbine chambers, transmitters, vane carriers, tripping valve body and so on. There are both technological defects caused by casting (e.g. shrinkage cavities, misruns, porosity and cracks) and defects caused by operation (thermal-stress fatigue, incorrect method of operation, etc.). Many of the mentioned defects take effect not until the final technological method - mostly at machining. However, in this production phase it is not possible to get form the supplier new production elements due to economical and also delivery time reasons. All of that results in delay of production and penalty. As the major aim of this paper, there was to find such repairs techniques which can ensure serviceability of mentioned devices under the standard regime. In these cases is needed to use much lower tempering temperature than under the standard production, mainly because of necessity to eliminate de

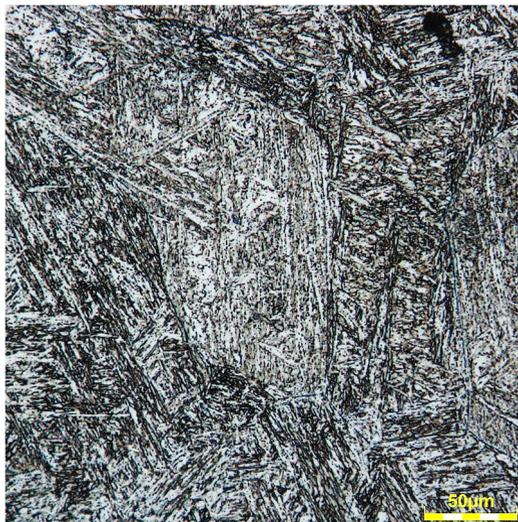
In Fig. 1 is shown the structure of delivered material GX23CrMoV12-1. It is tempered martensitic material with the initial hardness 259 HV for loading that corresponds to method HV10 acc. to ČSN EN ISO 6507-1. In Tab. 1 is shown the chemical composition of GX23CrMoV12-1 steel that was determined by spectrometer Q4 Tasman. In Tab. 2 are summarized mechanical properties of this tested material.

**Fig. 1.** Structure of tested steel GX23CrMoV12-1

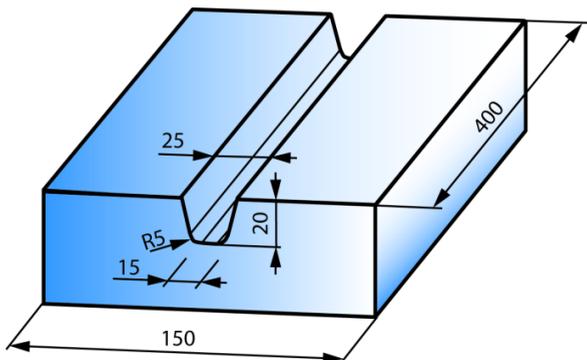
Before the classification of welding procedures and creation WPS, there was necessary to create the preliminary repairing welding procedure pWPS that is needed to be verified in light of both welding and subsequent thermal treatment of welds. Experimental verification is done by samples, which match to repairs on real part. In this case was as sample used multi-layer weld made into groove machined into workpiece having shape of plate with dimensions as following: 400 x 150 x 50 mm. Groove created along the whole length of plate had depth 20 mm, lower width of groove 15 mm, transient radii R5 and upper width of groove 25 mm. Groove is schematically shown in Fig. 2.

**Fig. 2.** Geometry of groove used for the multiple weld

Groove was fulfilled totally by 21 runs in 7 layers over each other, whereas each layer contained 3 runs side by side. Welding was done by method 111 acc. to ISO 4063 by electrodes BÖHLER FOX 20 MVW (E CrMoV12 B 4 2 H5). Root layer was welded by electrodes with diameter 2.4 mm, filling layers by electrodes with diameter 3.2 mm and also 4.0 mm and top layer by electrodes with diameter 5.0 mm. Repairing by welding was performed by pre-heating of part on minimal temperature 420°C and interpass temperature 480°C. During the whole time of repairing was temperature hold slightly over the temperature M<sub>s</sub>. Pre-heating was carried out by means of resistance heating elements (muffs) connected

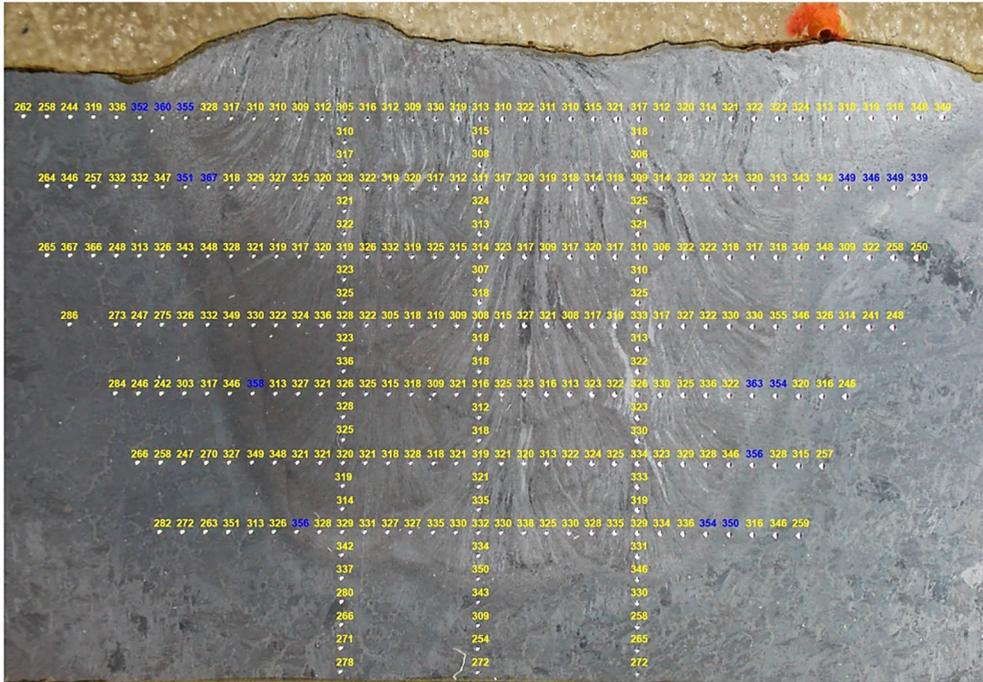
**Fig. 5.** Hardness values for multiple weld after welding and heat treatment at 580°C with holding time 45 Hrs

From the results is clear that tempering at temperature 550°C for 6 Hrs is completely insufficient. Hardnesses in weld metal and HAZ significantly exceeded the maximal allowed magnitude of 350 HV. That is why there was decided to extend the holding time at tempering temperature 550°C up to 10 Hrs. However, measured results revealed that also in this case is applied thermal treatment insufficient in light of weld metal and HAZ hardness values. There was certain decrease of hardness values indeed, but it was not enough. Thus holding time was extended on 45 Hrs because of that. Results measured under this condition are shown in Fig. 4. It flows from them that after this thermal treatment there was sufficient decrease of hardness values in weld metal, but hardness values in HAZ still exceed the maximal allowed hardness 350 HV. Due to fact that another extension of tempering time seemed to be useless, there was decided to increase tempering temperature on 580°C and keep the same tempering time – so 45 Hrs. In this case, measured results proved a strong decrease of hardness values in weld metal (i.e. under 350 HV).

Nevertheless, hardness values in certain areas of HAZ still exceeded the required magnitude. So it means that also this approach is not fully suitable for considered repairing. So finally there was decided to increase tempering temperature once more – now up to 595°C. In this case (see fig. 6) were for weld metal and the complete HAZ measured hardness values lower than 350 HV. In the weld metal they varied within 300 HV and 337 HV and in HAZ within 327 HV up to 348 HV.

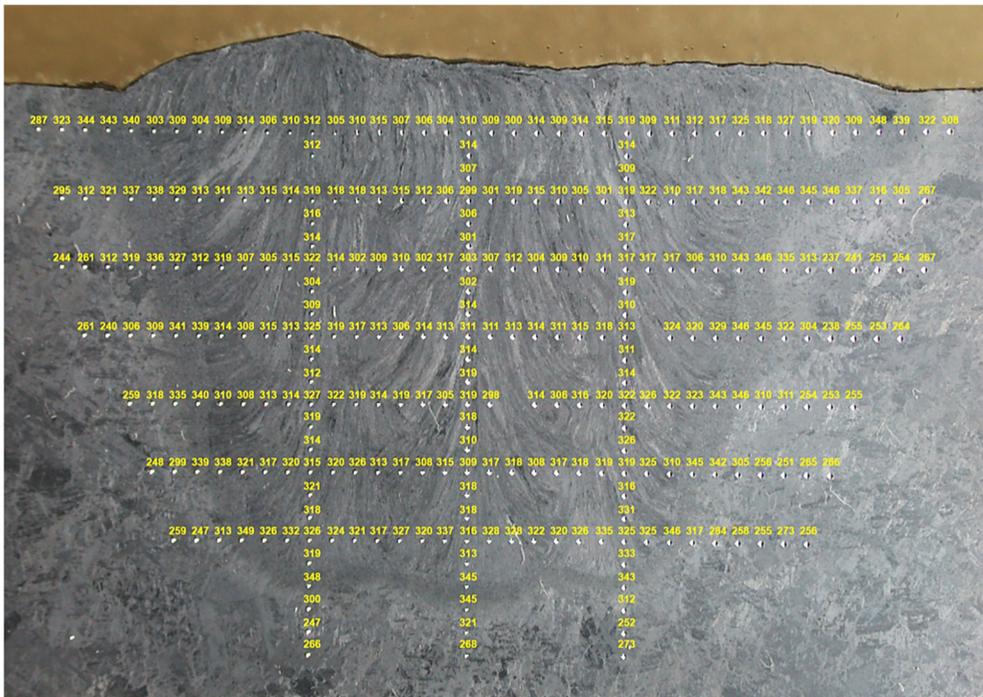
**Fig. 6.** Hardness values for multiple weld after welding and heat treatment at 595°C with holding time 45 Hrs
