# 3D characterization of the fracture mechanisms of a Fe-rich Al-Si-Cu alloy

**Abstract:** The effect of the defect size and morphology on the fatigue damage evolution was analysed in a recycled Al-Si-Cu alloy by micro-computed tomography and scanning electron microscopy. Fatigue tests were performed and the different crack initiation scenarios were characterized and classified. The interaction between shrinkage and gas pores was the key crack initiation mechanism and the  $\beta$ -Al<sub>5</sub>FeSi particles did not play any role in the crack initiation phase. However, crack path analysis indicated that there is a certain amount of crack advance by brittle fracture of the  $\beta$ -phase particles. This is in accordance with the findings of tensile tests in which the ductility depended strongly on the iron content.

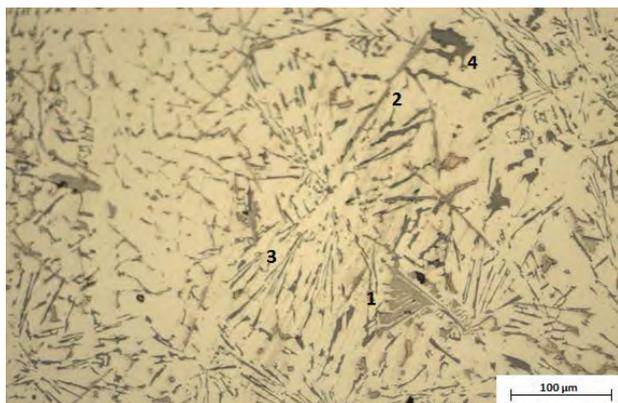
**Fig. 1** Main inclusions of recycled Al-Si-Cu alloy: 1-  $\alpha$ - $\text{Al}_{15}(\text{FeMn})_3\text{Si}_2$ , 2-  $\beta$ - $\text{Al}_3\text{FeSi}$ , 3- Eutectic silicon, 4-  $\text{CuAl}_2$

The studied alloy is characterized by the eutectic silicon particles, Fe-rich inclusions and Cu-rich compounds, which can be observed in Fig. 1. The Chinese-script-like  $\alpha$ -phase and the platelet-like  $\beta$ -phase are the main iron rich inclusions present in the alloy. The brittleness of  $\beta$ -

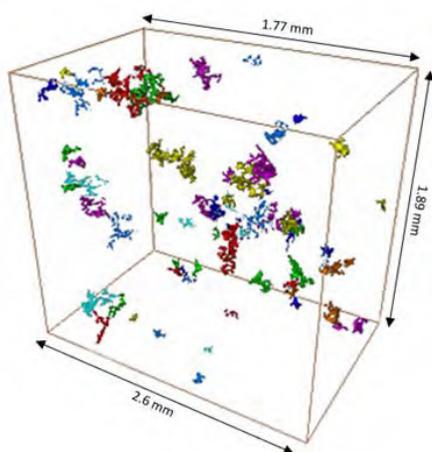
**Fig. 2** 3D reconstruction of the typical shrinkage pores in the studied alloy.

Interaction between defects was the most common scenario, what led to the premature failure of the specimens. This phenomenon can be explained by the fact that gas pores tend to agglomerate around shrinkage pores in the interdendritic structures (see Fig. 6 and Fig. 7). Furthermore, multiple crack initiation is likely to happen as a result of the intricate spatial pattern of bifurcations and branches of typical shrinkage pores (see e.g. Fig. 2).

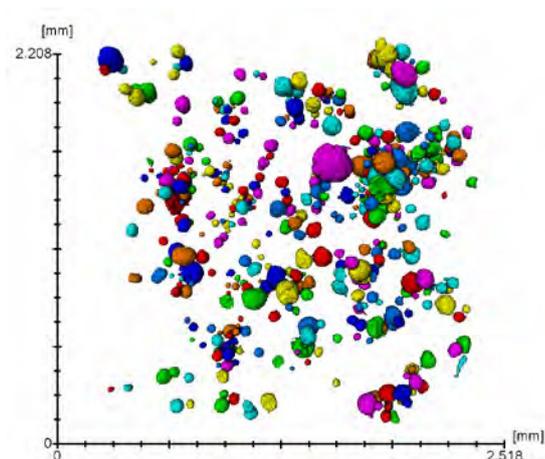
**Fig. 3** 3D reconstruction of the typical gas pores in the studied alloy.

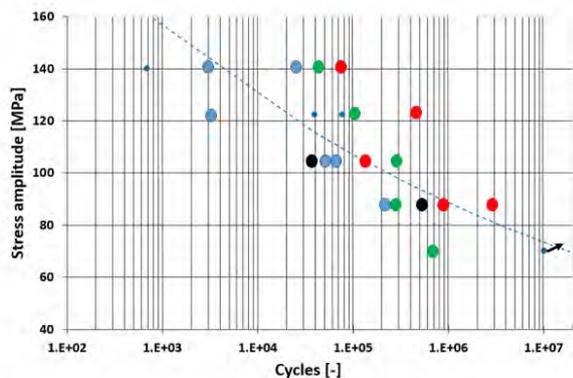
**Fig. 4** Fatigue curve of die cast specimens; classification according to fracture origin; red circles: gas pores, green circles: interior and subsurface shrinkage pores, blue circles: interaction between gas pores and shrinkage pores, black circles: crack initiation from MgO inclusions on surface; small symbols: surface damage or non-identified fracture origin.

Fig. 4 shows the results of the fatigue tests performed with the previously described specimens. The large scatter in the fatigue life at each stress amplitude level indicates the strong influence of the casting defects on the fatigue as well as the high variability of the morphology of defects associated with this casting process. An exhaustive analysis of the fracture surfaces both by scanning electron microscopy and micro-computed tomography revealed that there are distinct failure behaviors related to different fatal defects.

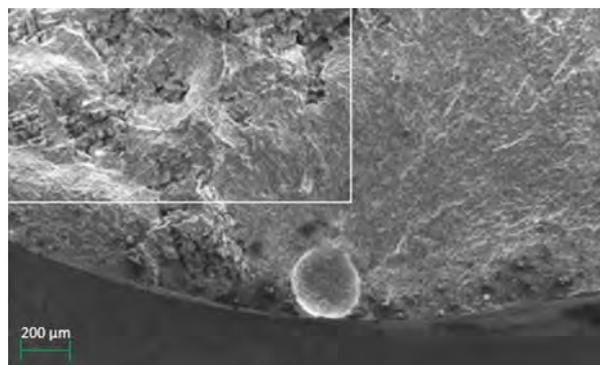
**Fig. 5** Fracture surface of specimen failed at 140 MPa, 74,283 load cycles.

Cracks tend to initiate from gas pores located close to the surface in the cases in which large shrinkage pores are absent and the gas pores are located close to the surface (see Fig. 5). The variability of the cooling rate during the casting process increased the dispersion of the size of shrinkage pores. Under unfavorable conditions, specimens were cast with giant shrinkage pores of around 1 mm (see Fig. 7).

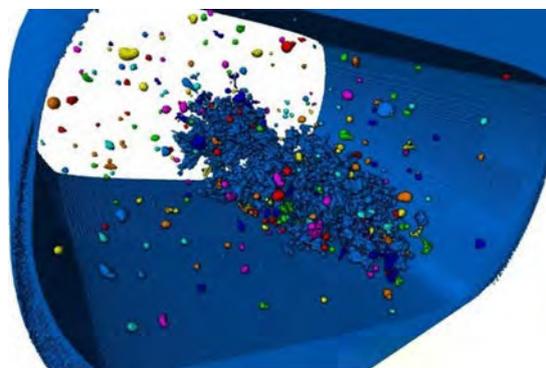
**Fig. 6** Sample containing typical gas and shrinkage pores.

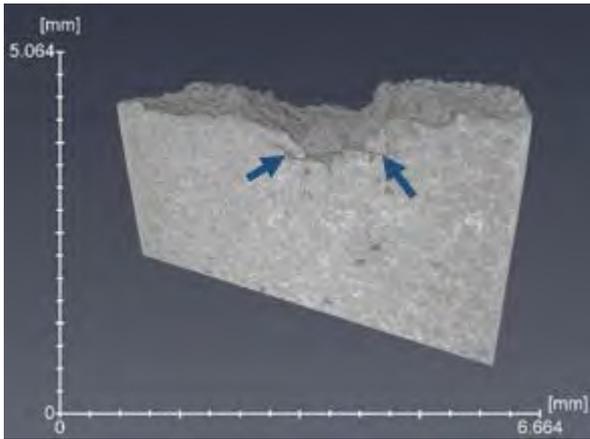
**Fig. 7** Fracture surface of specimen failed at 140 MPa, 45,065 load cycles; large shrinkage pore with rough fracture surface and secondary cracks (blue arrows).

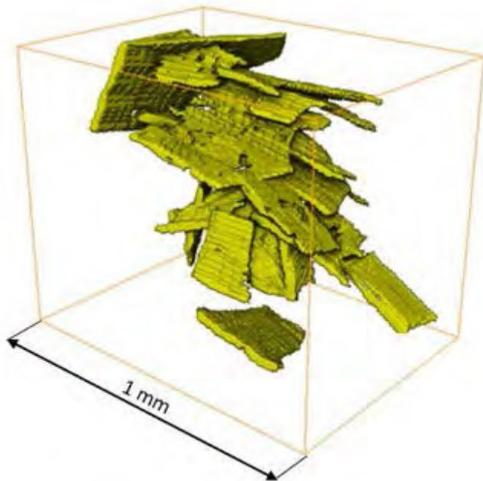
**Fig. 8** 3D reconstruction of a  $\beta\text{-Al}_5\text{FeSi}$  inclusion cluster.

The  $\beta\text{-Al}_5\text{FeSi}$  particles form large three-dimensional clusters (see Fig. 8), but they did not had a significant influence on crack initiation. These clusters are embedded flaws, as there are no iron inclusion in the surface or subsurface regions (see. Fig. 9). No direct influence of the  $\beta\text{-Al}_5\text{FeSi}$  particles was observed in the SEM analysis of the fracture surfaces. This is in agreement with the fact that a higher concentration of these particles was observed in the inner part of the specimen; and therefore they have a limited effect on the crack initiation.

Agglomeration of complex clusters of inclusions distributed along the specimens can be observed in the 3D reconstructions of the  $\beta\text{-Al}_5\text{FeSi}$  particles. Therefore, the inclusions that are depicted as individual needle-like particles in the 2D metallographic images may actually belong to a larger composite inclusion consisting of an agglomerate of plate-like particles.

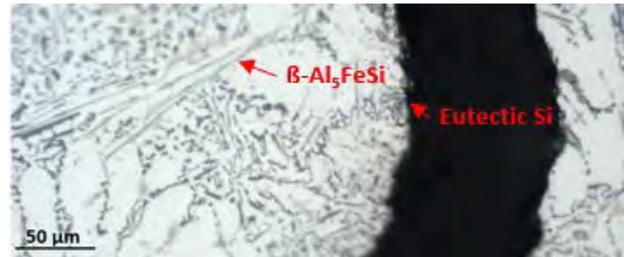
**Fig. 9** Fracture surface cross section of a fatigue specimen at 122 MPa and 39,122 cycles.

Fig. 9 shows an example of the cross sectional fracture surface of fatigue specimen. It can be observed that a large cluster of  $\beta\text{-Al}_5\text{FeSi}$  inclusions is located close to the crack path, and that the crack path follows the eutectic Si particles without breaking the cluster of the  $\beta$ -phase inclusions. This is related to the fact that the preferred orientation of these inclusions is perpendicular to the crack path in this particular case. However, cleavage fracture of a  $\beta\text{-Al}_5\text{FeSi}$  particle can be observed in another area of the cross sectional fracture surface in the same fatigue specimen (see Fig. 10). Here, the plate-like morphology of the  $\beta\text{-Al}_5\text{FeSi}$  inclusion causes the kinking of the crack path at the edges of the particle.

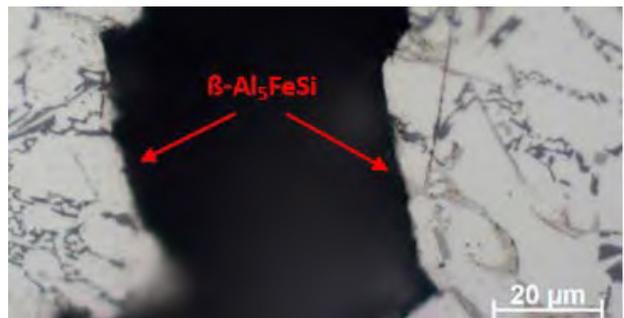
**Fig. 10** Cleavage fracture of a  $\beta\text{-Al}_5\text{FeSi}$  plate in the cross section of a fatigue specimen.

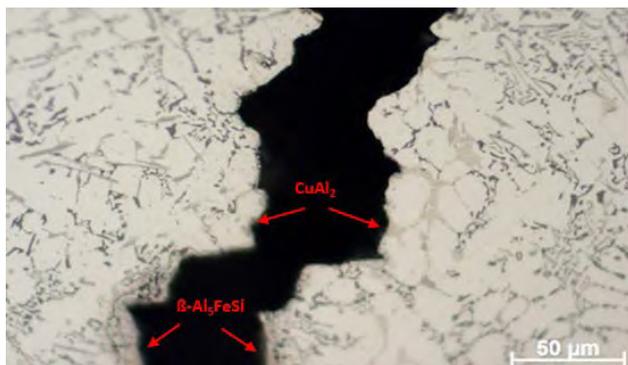
**Fig. 11** Crack path in the cross sectional fracture surface of a fatigue specimen.

Fig.11 shows the kinking of the crack path as a result of cleavage fracture of hard intermetallic particles. It can be observed that the  $\beta\text{-Al}_5\text{FeSi}$  platelets split right through the middle and drive the local direction of crack. The crack grows to the end of the  $\beta\text{-Al}_5\text{FeSi}$  platelets, until it reaches the aluminum matrix that allows the relaxation at the crack tip by local plastic flow due to its ductility. It can also be observed Cu-rich particles located parallel have a similar effect on the crack path.

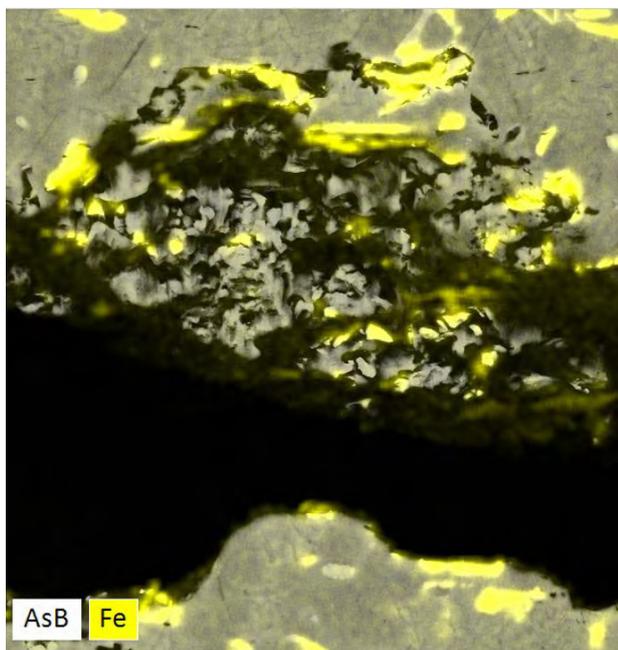
**Fig. 12** SEM cross sectional fractograph of a fatigue specimen with a broken  $\beta\text{-Al}_5\text{FeSi}$  cluster.

Fig. 12 shows the cross sectional fracture surface of a fatigue specimen in which the rupture of an entire  $\beta\text{-Al}_5\text{FeSi}$  occurred. It can be observed that the crack propagated breaking various Fe-rich particles belonging to the same cluster. In this case the particles also broke through the middle at different levels of the cluster (see Fig. 8). The connection of the  $\beta\text{-Al}_5\text{FeSi}$  plates in different plains leads to the kinking of the crack path. Besides the plate-like  $\beta\text{-Al}_5\text{FeSi}$  particles, broken Chinese-script  $\alpha\text{-Al}_{15}(\text{Fe,Mn})_3\text{Si}_2$  inclusions were also observed in the crack path at the cross sectional fracture surface of the fatigue specimen (see Fig. 13).

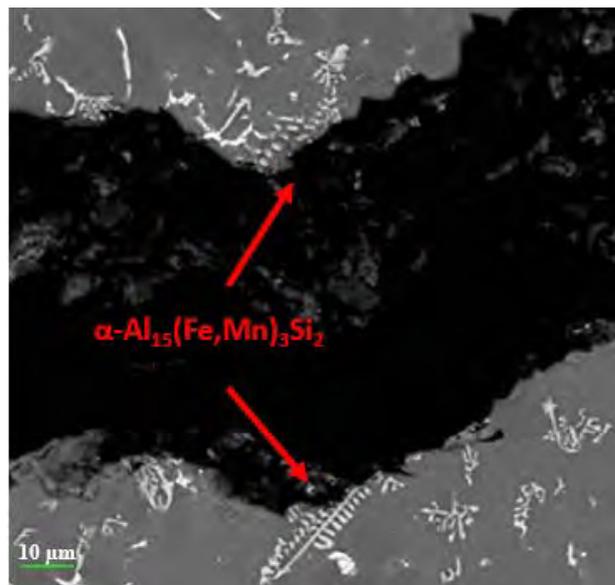
**Fig. 13** Cleavage fracture of a Chinese-script like  $\alpha\text{-Al}_{15}(\text{Fe,Mn})_3\text{Si}_2$ .

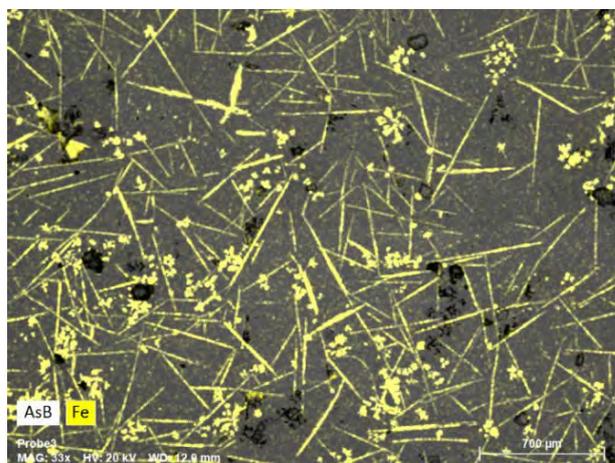
**Fig. 13** Massive brittle  $\beta\text{-Al}_5\text{FeSi}$  plates in the alloy with 2.3 Fe% (D)

The fracture surface analysis shows the cleavage fracture of massive  $\beta$ - $\text{Al}_3\text{FeSi}$  plates together with some fractured Cu-rich particles (see Fig. 13). The observation of the cross sectional fracture surfaces also reveals the dominating fracture mechanism. Fig. 14 shows two fractured  $\beta$ - $\text{Al}_3\text{FeSi}$  inclusions that have been split through the middle at the rupture of the specimen. The difference on the orientation of the broken plates causes the formation of sharp angles in the fracture surfaces.

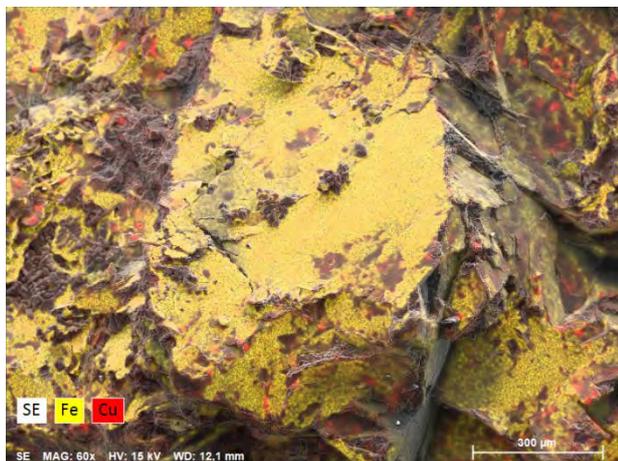
**Fig. 14** Cleavage fracture of a massive  $\beta$ - $\text{Al}_3\text{FeSi}$  inclusion in the alloy with 2.3% Fe content (D) together with some Cu-rich particles.

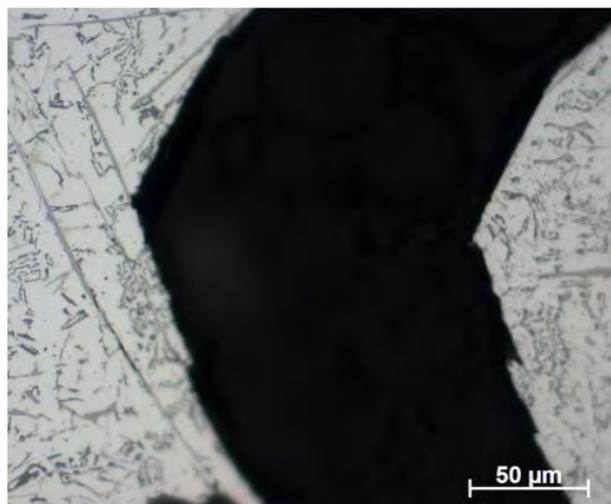
**Fig. 15** Cross section of the fractured specimen with 2.3% Fe content.

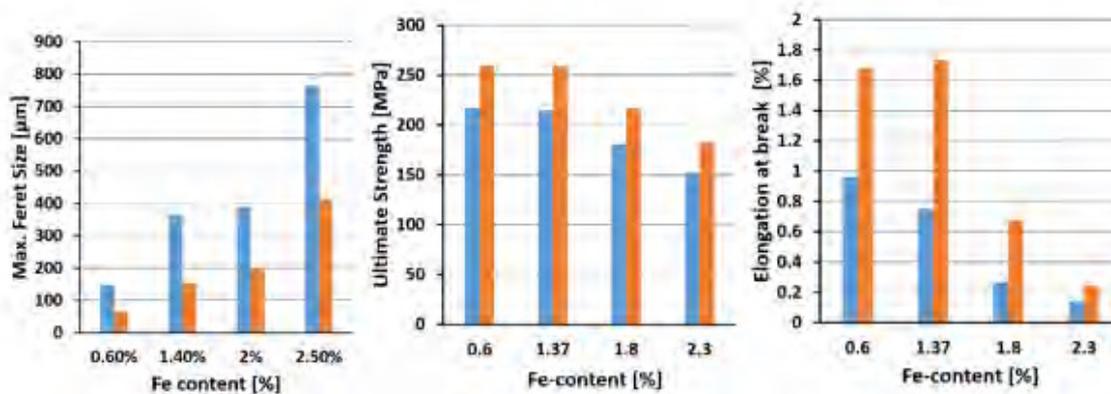
**Fig. 16** Influence of the Fe content before (blue) and after (orange) heat treatment on: a) max. Feret size of the Fe-rich inclusions; b) ultimate strength (MPa); c) elongation at break (%).

4) The size of the  $\beta$ -Al<sub>3</sub>FeSi inclusions increased exponentially with the Fe-content, what caused a deep reduction of the ultimate strength and the ductility of the alloy.

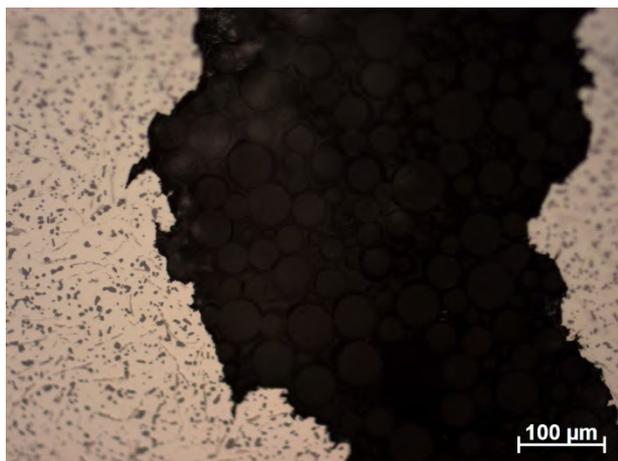
**Fig. 17** Fracture surface (cross section) of the heat-treated specimen with 2.3% Fe.

In the heat-treated specimen with high Fe-content the main fracture mechanism was the cleavage of  $\beta$ - $\text{Al}_3\text{FeSi}$  inclusions that were not able to fragment and dissolve during the heat treatment. Nevertheless, it can be observed that the fracture mechanism was not fully dominated by the rupture of the Fe-rich inclusions, but the fracture of the eutectic Si particles (see Fig. 16).

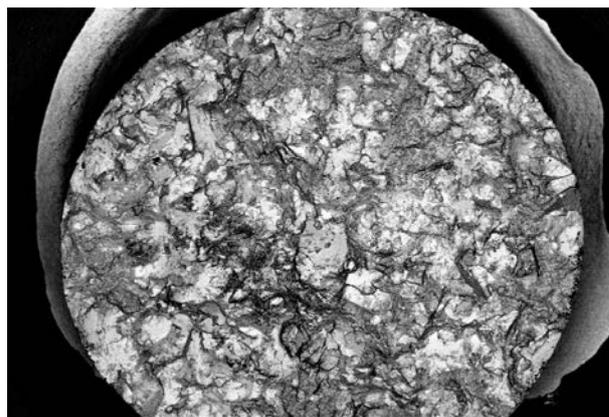
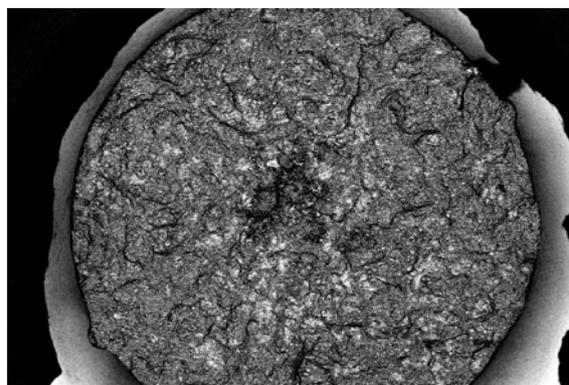
**Fig. 17** a) Fracture surfaces of the tensile specimens with 1.85% Fe content before and b) after heat treatment.
