Shear failure of AA2024 and AA7175 under high strain rate loading

Abstract. In the context of the design of aeronautical structures regarding accidental events, we are here investigating and comparing the shear failure of two aluminum alloys, namely AA2024 and AA7175, under high strain rate loading. With this aim in view, two experiments were carried out: (i) high strain rate shear compression of hat shaped structures, and (ii) impact test on the edge of double notched plates. The fractured surfaces of post-mortem specimens were observed using optical and scanning electron microscopes (SEM) in order to identify the failure mechanisms.

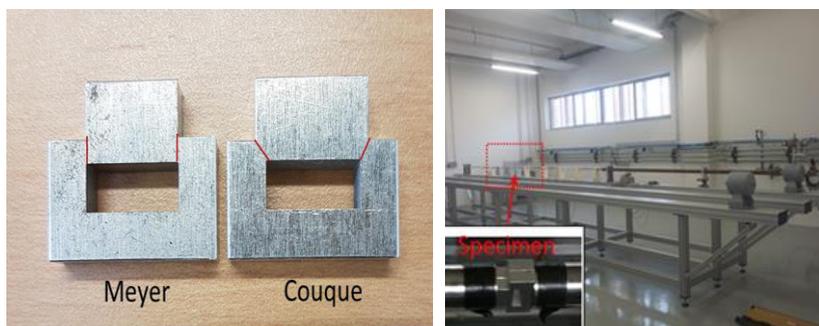
Fig. 1 High strain rate shear compression of hat shaped structures. Left: Geometries of the specimens. Right: Split Hopkinson pressure bar apparatus

The set-ups used for high strain rate shear compression of hat shaped structures and impact test on the edge of double notched plates are shown in Figs.1-2.

Shear compression tests were conducted at ambient temperature and at high strain rate using a split Hopkinson pressure bar (SHPB) apparatus, see Fig.1. This apparatus consists in three steel bars which are striker, input and output bars. Input and output bars are equipped with strain gauges. The specimen to test is inserted between the input and output bars. The impact of the striker bar onto the input bar generates a compression wave which propagates throughout the input bar and loads the specimen. The parts of the incident wave reflected into the input bar and transmitted into the output bar are used to estimate the strain and stress in the specimen. The lengths of the striker, input and output bars are 0.3m, 3m and 2m respectively with diameter of 20 mm. Two geometries of hat shaped specimens (HSS) were used, namely Meyer [6] and Couque [7], see Fig.1. Meyer- and Couque-type HSS are designed in order to involve in the shear zone of interest (marked in red in Fig.1) a stress triaxiality ratio close to zero and negative, respectively.

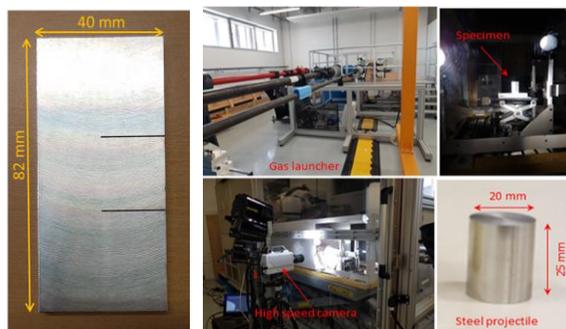
Fig. 2 Impact test on the edge of double notched plates. Left: Geometry of the plate. Right: Experimental set-up

Impact tests were carried out using a gas launcher, see Fig.2. The test consists in impacting

a Kalthoff and Winkler [8] (KW)-type double-notched plate which simulates pre-crack-containing structures, see Fig.2. Photron SA5 high-speed camera was used to record the projectile-plate interaction and crack advance during the impact loading at 10^5 frames per second (fps) and 320×192 pixel² spatial resolutions. Lighting was provided by Dedolight HMI floodlight of 400W.

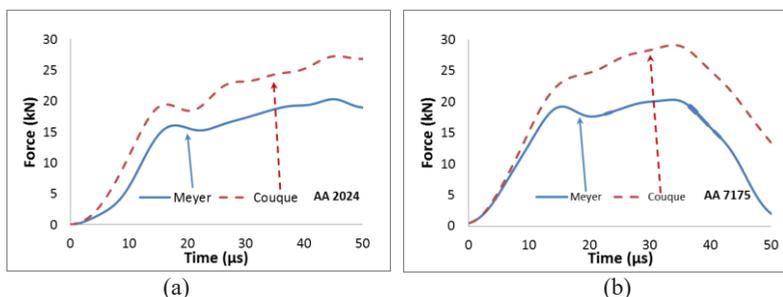
Fig. 2 Comparison of force history for AA2024 and AA7175 for different types of specimen geometry

The force history curves obtained from the high strain rate shear compression tests are plotted in Fig.2 for the two aluminum alloys under consideration, viz. AA2024 and AA7175. According to Fig.2, the force is larger for Couque-type specimen compared to Meyer-type specimen for both materials, as a consequence of the stress triaxiality ratio (higher for Couque and lower for Meyer). On the other hand, whatever the specimen geometry, the force is higher for AA7175 compared to AA2024, as a consequence of the material strength (higher for AA7175 and lower for AA2024). At last, it can be seen for AA7175 that there is a drop in force from $t=35\mu s$, whereas the force monotonically increases for AA2024.

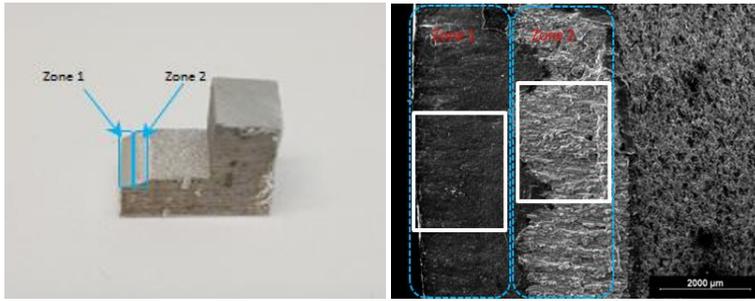
Fig. 3. Fractured surface of AA2024 for Couque type specimen

Fig.3. shows the fractured surface of Couque-type specimen for AA2024. Two different zones can be evidenced on the surface. Microstructural observations shows flat shear surface for zone 1 and dimple cluster for zone 2, see Fig.4 (a) and (b).

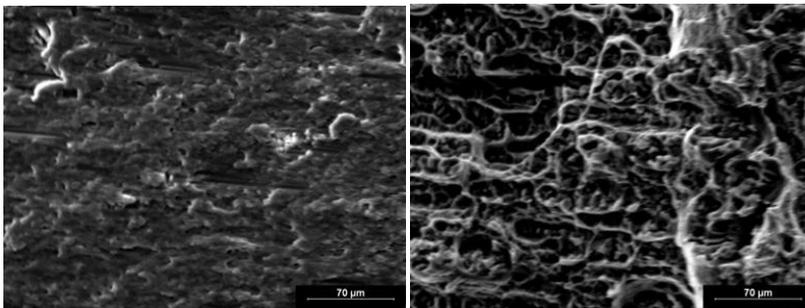
(a) Zone 1

(b) Zone 2

Fig. 4. Microstructure of AA2024 for Couque type specimen for zone 1 and zone 2

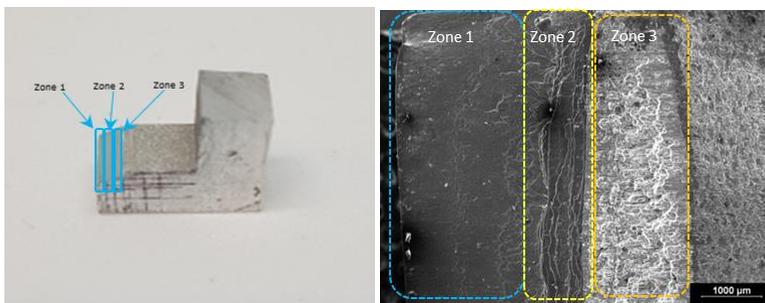
Fig. 5. Fractured surface of AA7175 for Couque type specimen

Fig. 5 shows the fractured surface of Couque-type specimen for AA7175. One can distinguish three different zones on the fractured surface. Microstructural observations show flat shear surface for zone 1 and zone 2, see Fig. 6 (a) and (b). Zone 3 exhibits dimple cluster as depicted in Fig.6 (c).

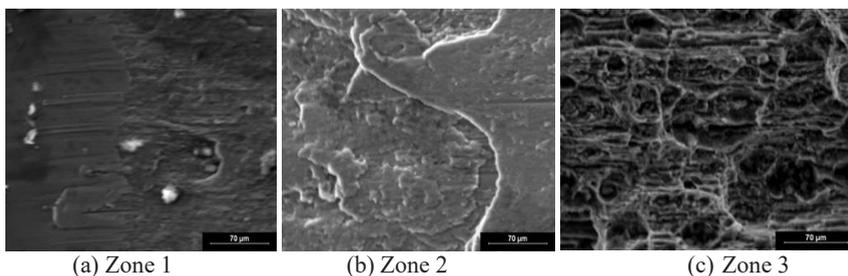
Fig. 6 Microstructure of AA7175 for Couque type specimen for zone 1, zone 2 and zone 3

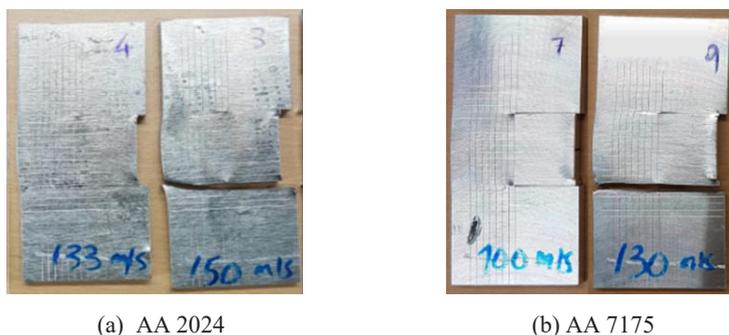
Fig. 7 . KW specimens after impacted at different velocities

Post-mortem double-notched plates made of AA2024 and AA7175 are shown in Fig.7 for different impact velocities of the projectile. It can be seen that the complete fracture occurs at different critical impact velocities depending on the alloy grade. The complete fracture results in crack propagation throughout the whole plate. The critical impact velocity for AA2024 is between 133 and 150 $\text{m}\cdot\text{s}^{-1}$ whereas for AA7175 it is between 100 and 130 $\text{m}\cdot\text{s}^{-1}$, i.e. less.

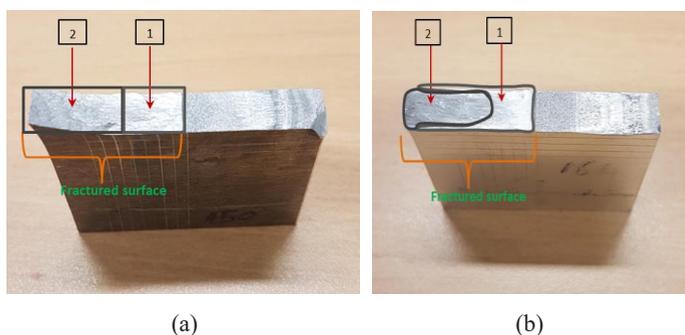
Fig. 8 . Analysis of fractured surface (a) AA2024 after impact at 150 m/s (b) AA7175 after impact at 164 m/s

Fig.8 (a) and (b) show the fractured surface of plates after impact at the velocities of 150 m.s^{-1} and 164 m.s^{-1} for AA2024 and AA7175 respectively. According to Fig. 8(a) two different fractured zones can be seen. Zone 1 shows the surface at crack initiation and zone 2 shows the surface at crack propagation which leads to fully fracture of the structure. Fig.8 (b) also shows two zones where zone 1 corresponds to crack initiation and zone 2 to crack propagation until ultimate fracture. According to Fig.8 (b) crack lip area exhibits similarities with the crack initiation zone 1.

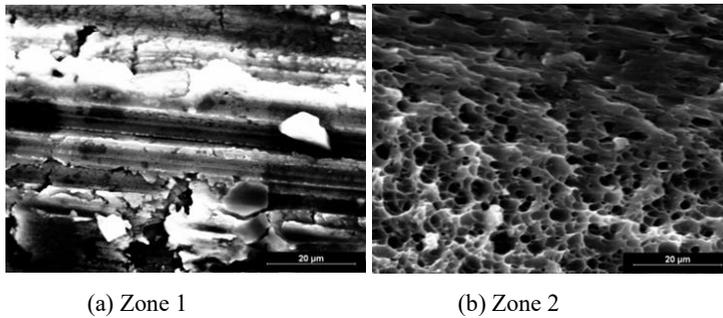
Fig. 9. Microstructure view of AA2024 ruptured surfaces (a) Flat shear (b) Dimple cluster

Fig.9 shows the microstructure of AA2024 for both fracture zones after impact at 150 m.s^{-1} . Microstructural view for AA2024 shows that zone 1 is featured by flat shear surface (Mode II), see Fig. 9(a) and zone 2 is opening mode where microstructural view shows a dimple cluster (Mode I), see Fig. 9(b).

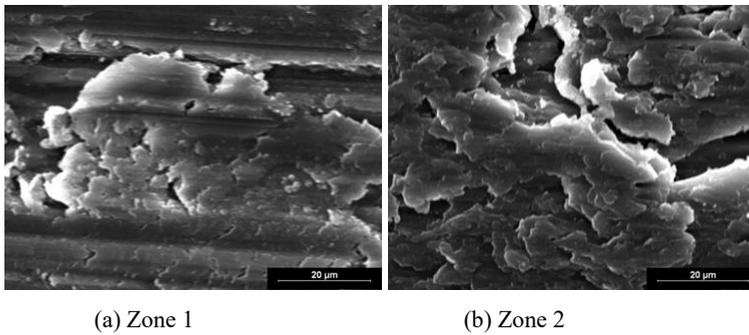
Fig. 10.Microstructure view of AA7175 ruptured surfaces (a) Flat shear (b) Flat shear

Fig. 10(a) and (b) shows the microstructure of AA7175 after impact at $164 \text{ m}\cdot\text{s}^{-1}$ for zone 1 and zone 2 respectively. Microstructural view of AA7175 shows that both region are flat shear surface, hence the failure is mainly due to shear (Mode II). On the other hand, the observation of the crack lips reveals the presence of adiabatic shear bands, see Fig.11.

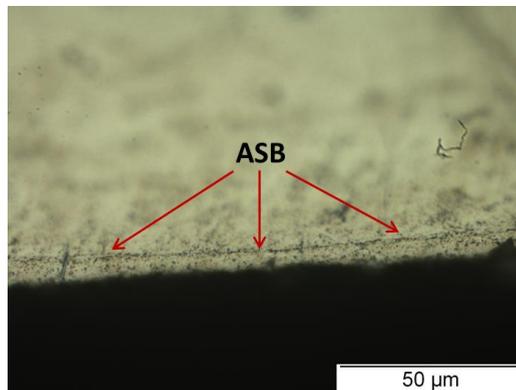
Fig. 11. Adiabatic shear band near crack lip of fractured surface for AA7175
