Tensile and bend behaviour of nanostructured HVOF and flame sprayed stellite coatings

Abstract. Stellite 6 powder (CoCrSiW) was deposited using flame spray (FS) and high velocity oxygen fuel (HVOF) techniques on steel substrates. The microstructure of stellite coatings produced with these deposition techniques displayed a rather similar morphology consisting of cobalt-rich dendrites surrounded by hard (Cr_3C_7) carbide particles. The stellite (both FS and HVOF) coating was found to reduce the tensile strength of the steel. The failure of the coated steel specimens initiated by cracking on the coating surface, transverse propagation of the cracks towards the coating - substrate interface and diversion along the interface leading to local delamination and breakage. During the bend tests cracks developed along the coating and the main failure in the coating occurred due to the tensile-shear deformation, particularly in the coating-substrate material interface. The coating thickness does not appear to affect the bending strength. During bending the number of surface cracks per unit length decreased with increasing coating thickness. Stereoscopic analysis showed that the thicker the co

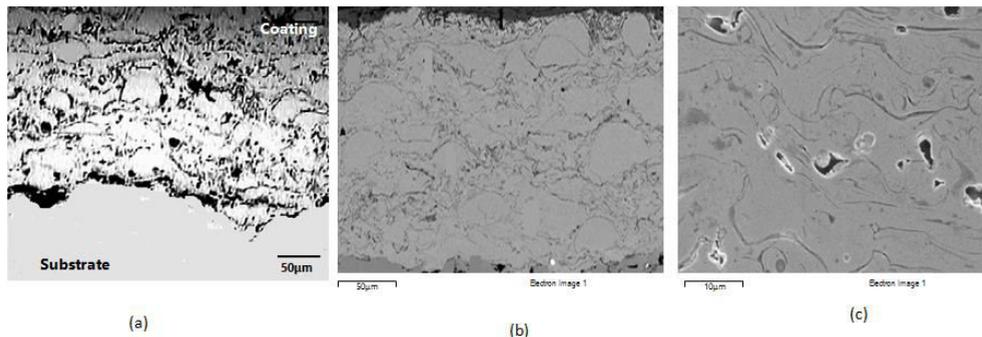
Fig 1. Cross sections of the stellite coatings (a) optical micrograph of FS coating (b) SEM micrograph of HVOF coating (c) SEM micrograph of FS coating.

Micrographs in Figure 1 illustrate the cross-sectional microstructure of the stellite FS and HVOF sprayed coatings. The coatings exhibit lamellar structure (typical for sprayed deposits). The coating is built-up by a deposit of lenticular splats, one over the other, in a uniform manner, throughout the coating. The microstructure of Stellite 6 coatings produced with different deposition techniques displays a rather similar microstructure consisting of cobalt-rich dendrites surrounded by hard carbide particles [2, 12]. It can be clearly observed that coatings possess porosity, oxidised, unmelted and semi-melted particles as well as inclusions. Unmelted particles are identified in the coating by their size and near-spherical morphology. Oxide stringers can be observed in the microstructures in the form of intersplat lamellae or globules oriented parallel to the substrate surface. Pores appear black in the micrographs. The percentage of porosity, as measured by image analysis, was 3±0.5 %. No cracks were observed on the sectioned surfaces of the coating. Coating-substrate interface exhibited occasional inclusions.

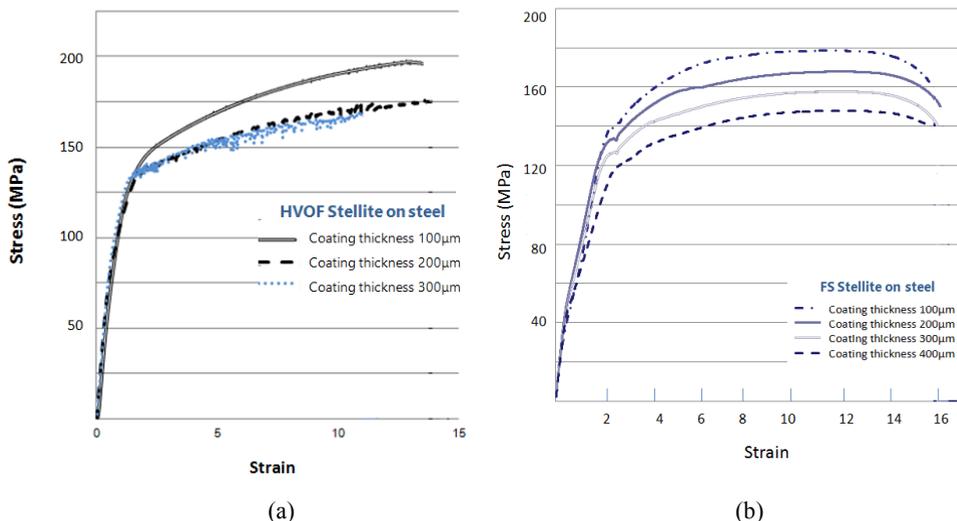
Fig 2. Stress strain curves of CoCrSiW coated steel with various thicknesses (a) HVOF coated and (b) Flame spray coated.

Figure 2 shows the engineering stress-strain curves for the deposited CoCrSiW coating on the steel substrate with various coating thicknesses. The presence of the stellite coating results in a lower tensile strength of the coated steel in comparison with the tensile strength of the uncoated steel. It is evident that with the increase of the coating thickness, independently of the deposition method (HVOF or FS) the tensile strength of the coated system is decreasing. The reduction of the tensile properties can be attributed to the brittle characteristics of the coating, while fracture analysis revealed that brittle cracks, formed in the coating, are the primary cause of the tensile failure of the coated specimens.

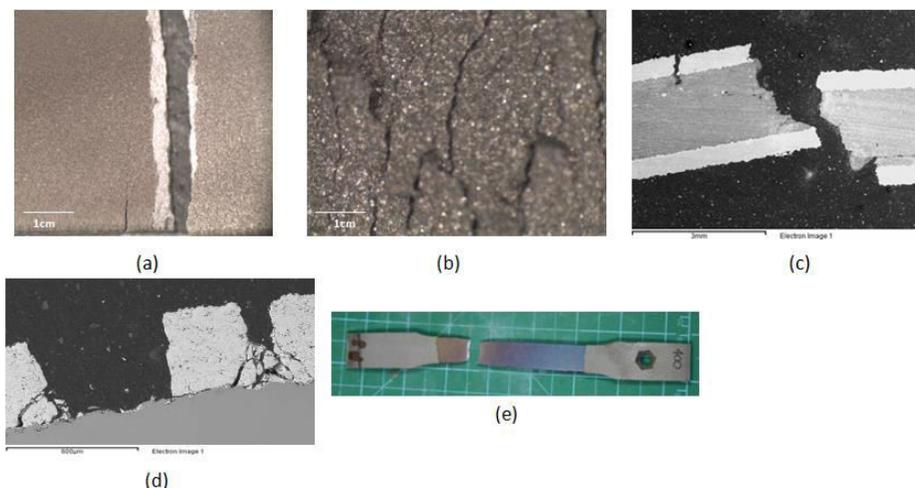
Fig 3. (a) Plan view of the HVOF stellite coating in the fracture area (b) plan view of the FS stellite coating in the vicinity of fracture (c) SEM cross section of the HVOF stellite on steel after fracture (d) SEM cross section of FS stellite on steel near the fracture area (e) plan view of a fractured and peeled FS stellite coated steel

During tensile tests both HVOF and FS coatings exhibited cracking in the transverse direction of the tensile load due to their brittle nature (figs 3a and 3b). A cross section of a HVOF sprayed Stellite-steel composite after fracture is illustrated in Fig. 3c. The number of cracks for the HVOF coating was considerably less compared to the FS coating ones presumably due to a less number of pores and internal defaults. The initiation of these cracks was observed at the free surface of the coatings prior to entering the plastic region and can be attributed to the coating brittle nature. By increasing the tensile strain these cracks increased in number and some of them propagated within the coating, in a tree like manner and were either relieved within the coating or stopped at coating-substrate interface

causing local peeling (fig. 3d). The HVOF stellite coating, though, lasted the tensile loads and was negligibly delaminated while the FS coatings were heavily peeled (fig. 3e). Note also, that the interfacial delamination cracks in coated systems have been already studied; they are attributed to the linkage of previously formed cracks and are both relative to the residual stresses and associated with the fracture toughness of the coating [13-15].

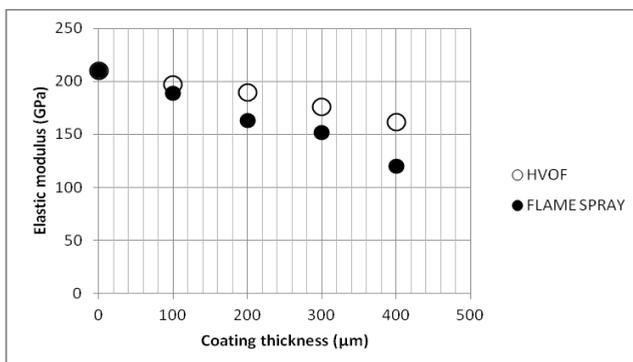
Fig 4. Elastic modulus of the stellite coated steel in relation to coating thickness.

The coated steel substrate bearing equal CoCrSiW coating thickness on both sides behaves as a laminated composite system stressed parallel to the lamellas with the coating and the substrate being the constituents, which determine the elastic and elastic-plastic behaviour. Figure 4 shows that the elastic modulus of the coated system is decreasing in proportion with the coating thickness (for both types of coatings i.e., FS and HVOF) which could also be explained by the rule of mixtures for layered composites in the elastic region.

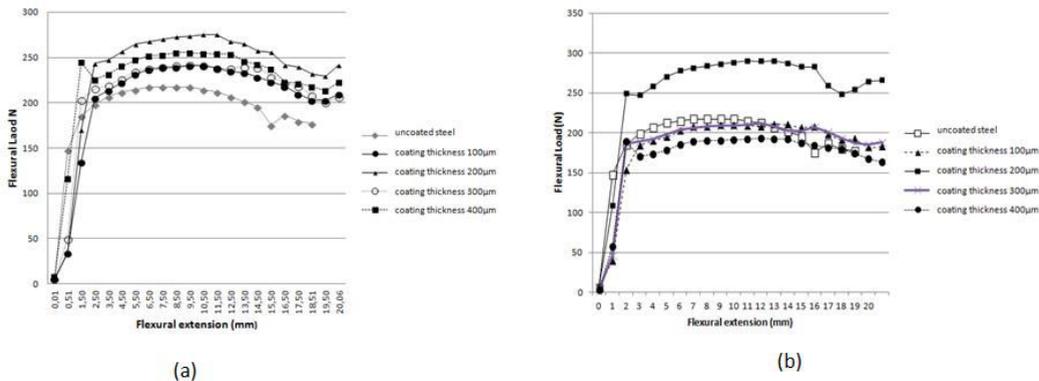
Fig 5. Load and displacement characteristics after three-point bend tests (a) HVOF coated (b) Flame spray coated.

Fig. 5 shows the load-displacement curves for the as received steel and the stellite coated steel both by HVOF (fig. 5a) and flame spray (fig. 5b). It can be seen that the plastic region for the coated specimens initiates at lower load levels for the same flexural

development which means that the presence of the stellite coating decreases the ductility of the steel substrate especially for the HVOF coatings. Abnormal behaviour in some curves indicates that the gradual deformation of interface of the substrate material probably cannot relieve the stress levels at the interface. The coated steel specimens exhibit similar behaviour regardless of the coating thickness.

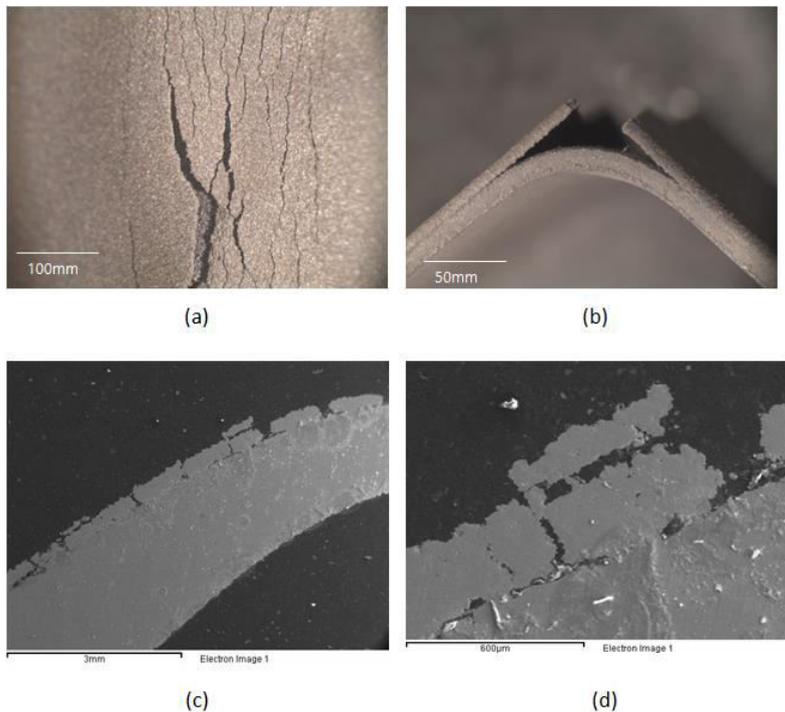
Fig 6. HVOF stellite coated specimen with thickness 395µm (a) cross section after bending (b) plan view after bending showing local exfoliation (c) cohesive failure area (d) coating exfoliation area.

During bend tests surface cracks were observed; micrographs showing crack formation are presented in Figs 6a-6d. Since the coated surface is placed in the bottom (opposite) site where the three-point bend load is applied, the coating section of the workpiece is subjected to tensile-shear force only. Consequently, the main failure in the coating occurs because of the tensile-shear deformation, particularly coating-substrate material interface; see Fig. 6b [16].

The crack in the coating is formed due to the tensile load and initiated at the free surface of the coating as shown in Fig. 6a. It was observed that during bending the number of surface cracks per unit length decreased with increasing coating thickness. Further on, it was also observed that the thicker the coating the deeper the surface cracks. This phenomenon might be attributed to internal stresses, which are primarily developed due to the mismatch between the thermal coefficients of the stellite coating and the steel substrate. In addition, internal stresses can be developed due to tensile-shearing force which creates local stress concentrations at defect sites in the region of coating-substrate interface (such defects might be oxides, unmelted particles etc). It should be noted that stress concentrations at defect sites are, in general, higher than the mean internal stresses. Under the tensile-shear loading delamination occurs above the plastically deformed region. When, therefore, the critical stress for crack propagation is reached in defect sites at the interface, the entire coating fails and peels off from the substrate material (figs 6c and 6d). When the crack propagation is limited to local region, the fracture of the coating is resulted. In this case, internal stress in the coating is relaxed around the crack sites. If the energy used to propagate the crack is dissipated, the crack cannot extend beyond the substrate material, i.e., it terminates at the free surface of the substrate material.
