Thermal and Mechanical Response of Partially Protected Steel I-Beam under Fire

Abstract. Offshore and onshore structures continuously experience hydrocarbon fire accidents almost every year. To secured structure against extreme fire conditions, passive fire protection (PFP) is applied. However, PFP is a costly material which is applied only on critical structural members. Any unprotected surface can cause major structural damages during fire incidence if the behaviour of an unprotected surface is unknown. Usually, PFP applied easily around the column, but for beams, the application varies with the beam locations. In this paper the behaviours of steel beam compared with three different common scenarios such as fully protected, unprotected and partially protected under hydrocarbon fire. Fully protected beam has tremendous fire resisting capability compared to partially protected beams or unprotected beams. The study revealed that temperature of the top flange in partially protected beam exceeds more 600°C in less than 10 minutes which caused rapid failure in less than 30 minutes. Under extreme fire conditions the strength and stiffness of a beam affected which cause instability of s

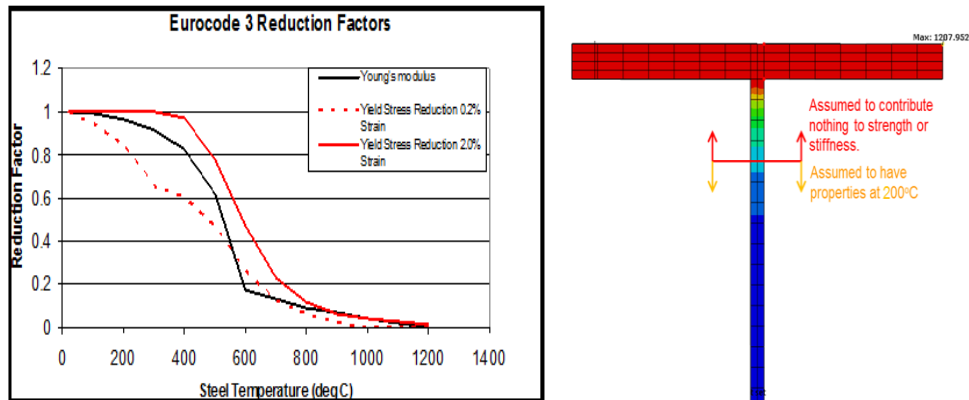
Fig.2. Mechanical properties of steel after 400 °C and Thermal Gradient [9]

The mechanical properties of start steel losing as the temperature exceed more than 400°C according to Eurocode 3. After 400 °C steel the mechanical properties are considered to contribute nothing and continue to deform shown in Fig. 2 [9]. However exposed vs protected surface to fire is a major factor that directly affects internal stability of a beam.

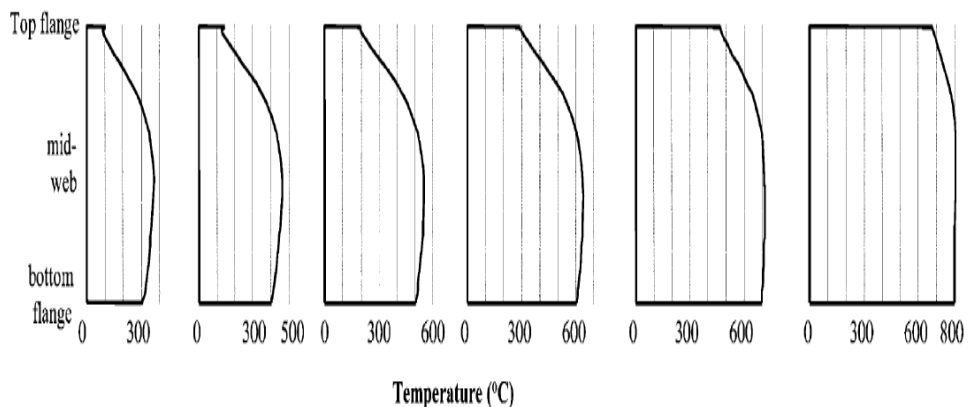
Fig. 3. Temperature distribution between web top and bottom flange [17]

Another behavior was reported by [17], when beam tested under ISO384 standard fire temperature. During the test top flange was protected by the PFP to prevent damage to load cell. The temperature gradient on the protected top flange rose slowly compared to unprotected the bottom flange and the web. Temperature initially rose much more slowly as shown in Fig. 3. When the burner switched off the heat conduction continued to top flange until difference reduced from 300°C to 100 °C as shown in Fig. 3.

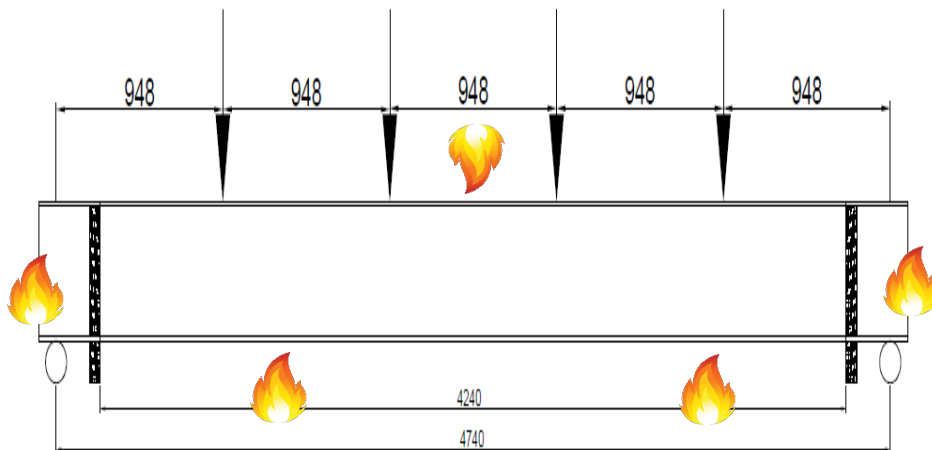
Fig. 4. Beam Model Details of Applied loading

To perform thermal analysis for the beams typical properties of Universal Beam Section UB 457x152x52 were used with the span of 4240 mm as shown in Fig. 4. Three steel loaded beams were modelled with total static load of 40 kN at L/4, (10 kN per node). Effects of fire & PFP was considered during thermal analysis using *Fire and Heat Transfers Simulation* (FAHTS) and static loading with FEM using *Ultimate Strength for Offshore Structure* (USFOS). The beams were modelled with following boundary conditions:

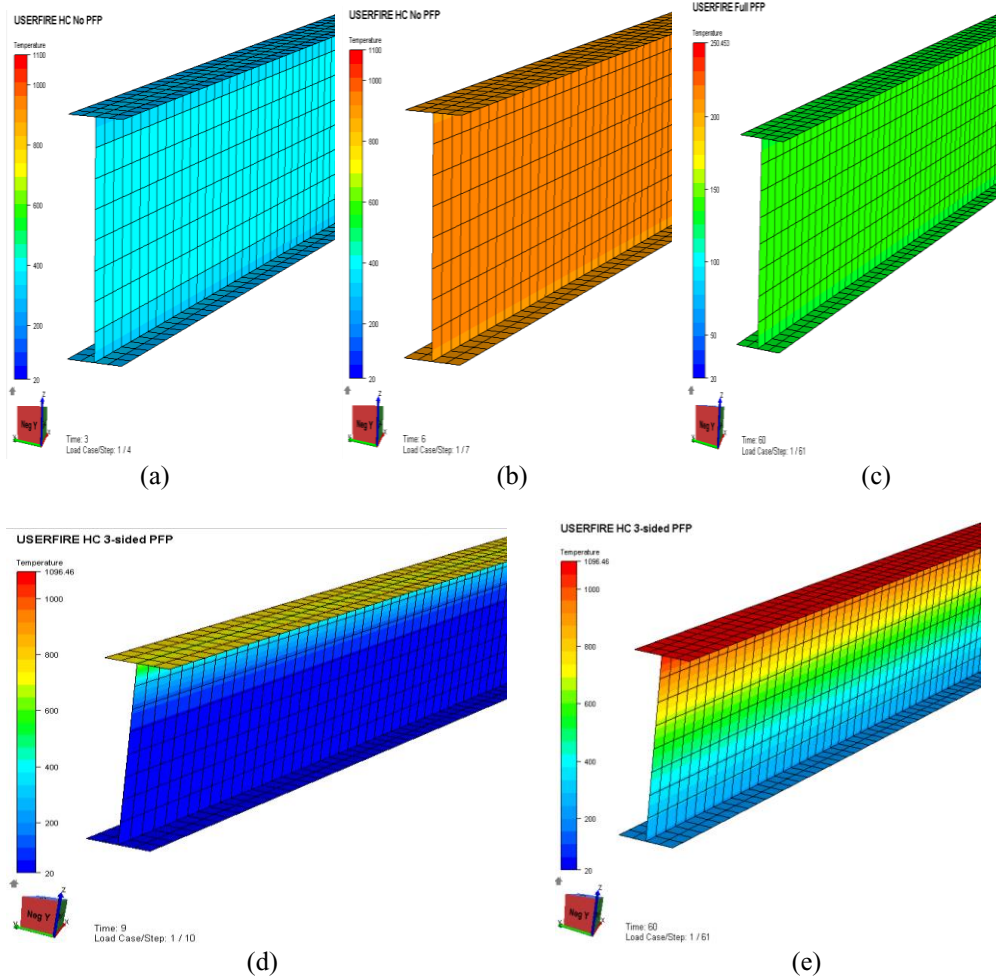
Fig. 5. (a) Temperature distribution on unprotected beam after 3 minutes (b) after 6 minutes (c) Temperature distribution on fully protected beam after 60 minutes (d) Temperature distribution on 3 sides protected beam after 9 minutes and (e) Temperature distribution on 3 sides protected beam after 60 minutes

in 3 minutes as shown in Fig 5 (a) and after 6 minutes exceeds 800°C as shown in Fig 5 (b). The top flange, web and bottom flange have more or less same temperature as shown in Fig 6. The smallest variation in delays was recorded due to heat conduction in section as shown in Fig. 6.

In contrast, fully protected beam resisted temperature to propagate and maintain temperature below 400 °C for 2 hours as shown in Fig 7. Due to fully protection the top & bottom flanges and the web exhibited was almost uniform temperature gradient though out section. Fully protected beam has tremendous fire resisting capability. After an hour beam temperature was below 200 °C as shown in as shown in Fig 5 (c) and Fig 7.

On the other hand, three sided protected beams exhibited different behaviour as shown in Fig 8. Top unprotected flange was exposed to high temperature from top face and heated rapidly compare to the web as shown in Fig 5 (d) and Fig 8. The temperature of the web reached 400 °C after 40 minutes and after an hour web temperature rose to 600 °C as shown in Fig 5 (e). The lowest temperature was recorded on the bottom flange which was heated up slowly through conduction from the top flange to the web.

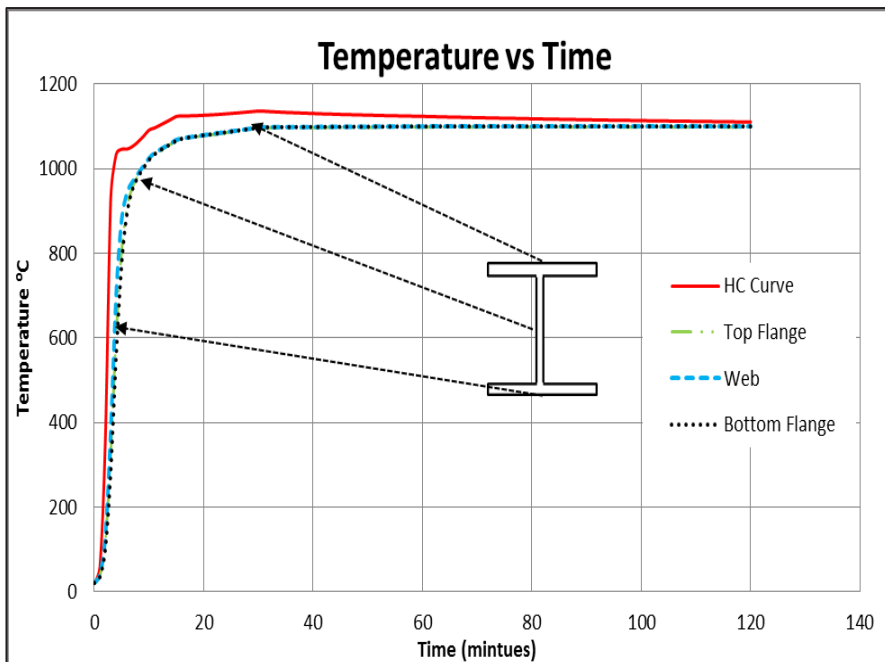
Fig. 6. Temperature vs time curve distribution of unprotected beam

The comparison of three different types of beams under hydrocarbon fire clear shown the variation in temperature. For unprotected beam, the web, top flange and bottom flange almost followed the hydrocarbon fire curve as radiation and conduction is high. Typically, beam having a ratio of a large surface area to volume cools down more quickly than a section having a small ratio. The web heat up faster than the top and the bottom flanges which caused steel section to deform more rapidly. In case of unprotected beam the web possessed high exposed surface area which heat up section quickly. The beam temperature increased 400°C

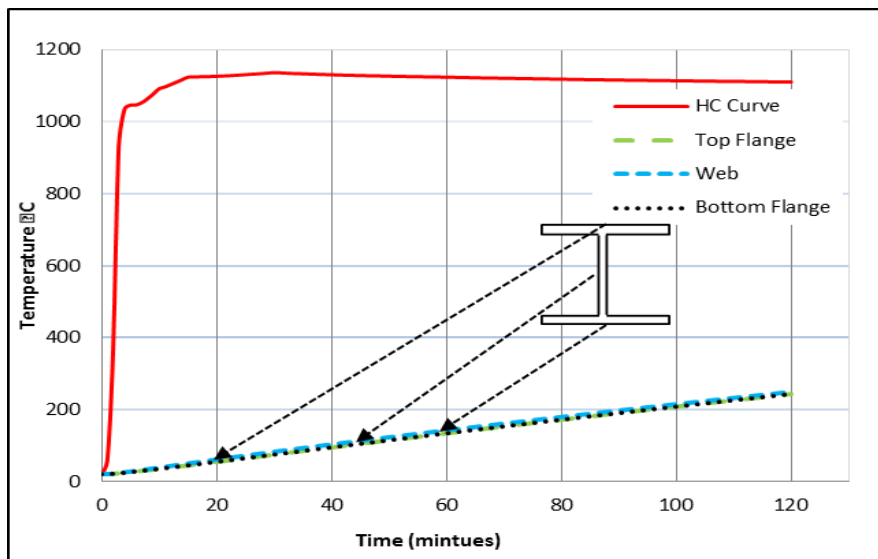
Fig. 7. Temperature vs time curve distribution of fully protected beam

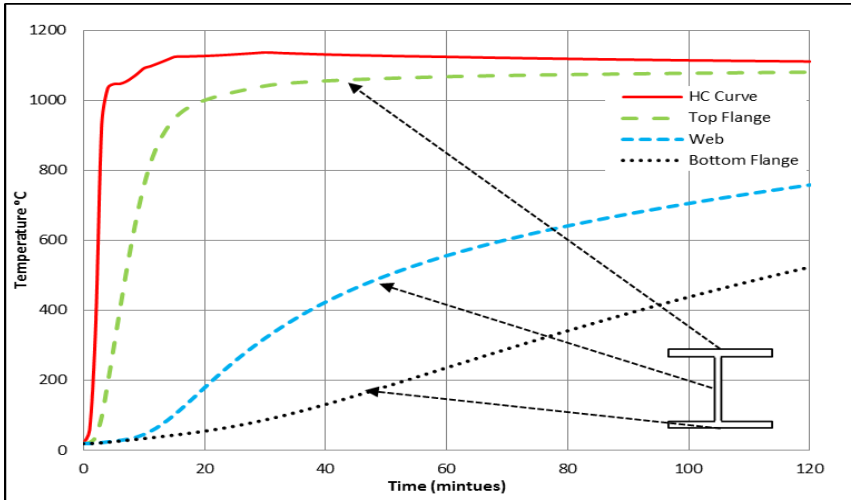
Fig. 8. Temperature vs time curve for three side protected beam

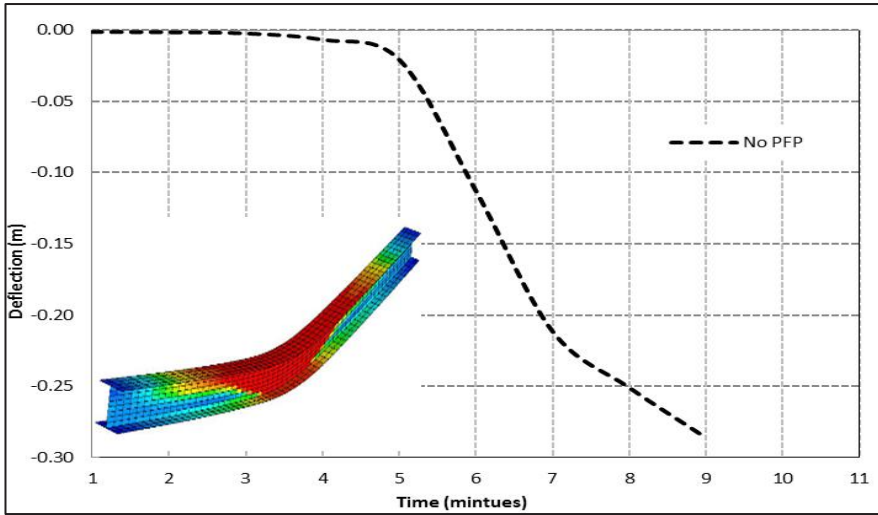
Fig.9. Deflection vs time curve for unprotected beam

The behaviour of an unprotected beam started with deformation as temperature increased to 400 °C and rapid deformation observed after 4 minutes as the temperature exceeded 600 °C as shown in Fig 9. As discussed in Section 2 where under normal fire experimental, beam failed just in an hour. But under hydrocarbon fire the temperature was so intensive that beam completely failed in less than 6 minutes. This shown the significance of PFM application and understand behaviours of PFM under extreme fire conditions for petrochemical industry.

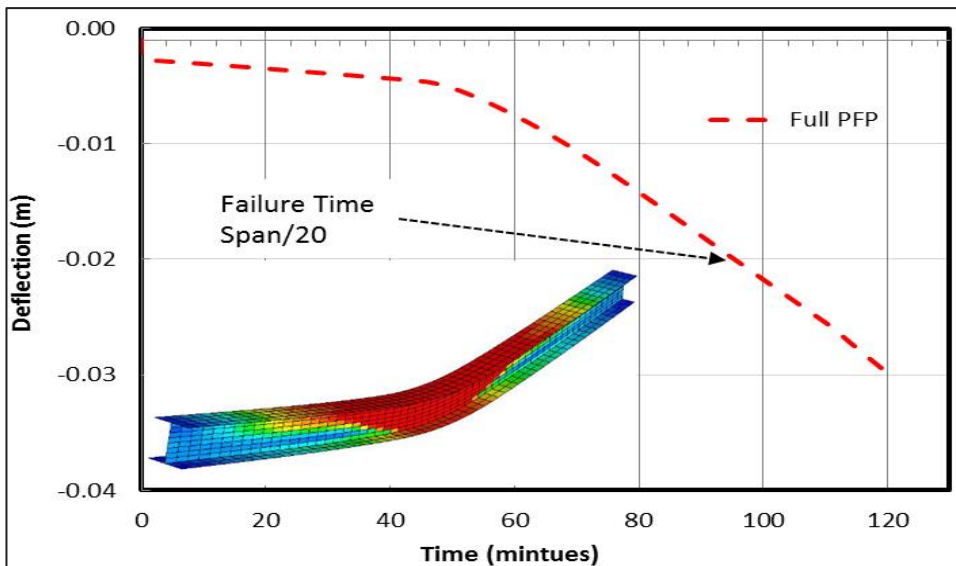
Fig. 10. Deflection vs time curve for fully protected beams

The comparison is therefore necessary between fully protected and partially or three sided protected beams. The behaviour deflection verse time for fully protected was uniform beam started deform after 50 minutes of fire exposure. Deformation accelerated after an hour till failure occurred as deflection exceeded span/20 after +/- 90 minutes of fire exposures shown in Fig 10.

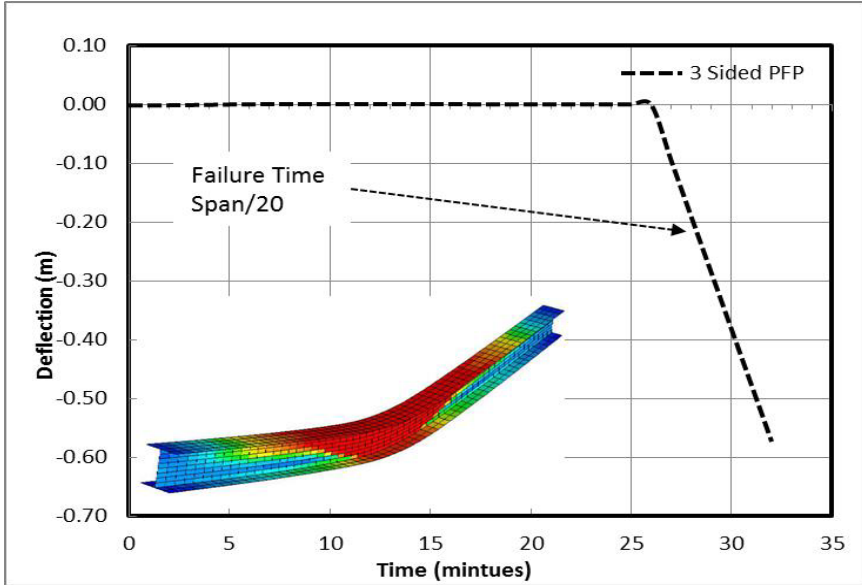
Fig.11. Deflection vs time curve for three side protected beams

The three sided protected beams on the other hand, deformed initially as behaviour changed from sagging to small amount of hogging after 25 minutes of fire exposure. Suddenly, tensile stresses were formed due to high temperature at top flange which caused minor hogging. As the temperature of top flange exceeded to 600 °C, the beam started bending again and rundown deflection was observed. This behaviour was due to rapid temperature increment at the top flange which caused sudden thermal expansion as shown in Fig 11 and suddenly rundown deflection observed.
