The FAC Experimental Research on Vapor-water Two-phase Flow Piping System of CAP1400 Secondary Loop

Abstract. CAP1400 power plant is one of the advanced Third-generation Pressurized Water Reactor power plant. To ensure the safety and stability of the power plant secondary loop during operation, the corrosion characteristic of CAP1400 secondary loop should be investigated. This paper set up a test facility to study the vapor-water two-phase flow corrosion status, which could be seen in the piping system after the control valve of heater drain line. The key parameters, such as pressure drop, temperature, and surface topography have been observed and measured, and the different corrosion characteristic in straight pipe, elbow, tee, and reducer also have been acquired in the tests. The test results and analysis could provide the basis for the corrosion resistance design of the drain pipelines in the CAP1400 nuclear power plant.

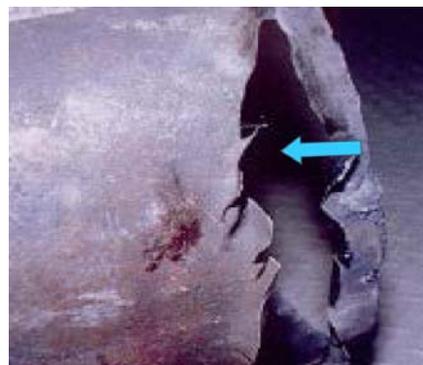
Figure 1. Cracked Welded Joint of Unit 2 of the Arkansas Nuclear One Nuclear Power Plant.

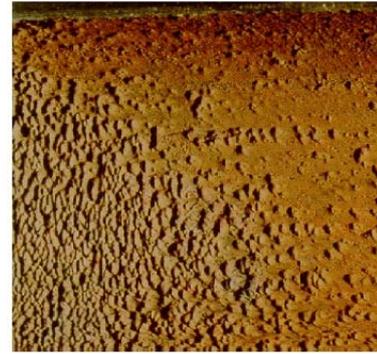
Under single-phase flow condition, FAC will cause horseshoe shaped pits on the metal surface, and the entire surface looks like an orange peel, as shown in Figure 2. In some areas where FAC rate is not very high, there are obvious dent features. If further investigation is conducted, it will be clear that these features have a certain direction and can be described as "serrated" or "horseshoe-shaped" pit "strings" whose tips point in the direction of flow [5]. As the corrosion becomes more severe, these serrated shapes gradually overlap. The most serious corrosion parts will create continuous rounded holes or orange-peel-shaped abrasions. Almost no oxide (Fe_3O_4) remains on the surfaces of these corrosion parts,

and it can be seen on the metal profile that the oxide layer is very thin (about a few microns). Using a microscope scan with a higher magnification ratio, the structure of a typical rounded dent caused by FAC can be observed.

Figure 2. Corroded Metal Surface Caused by Single-phase FAC.

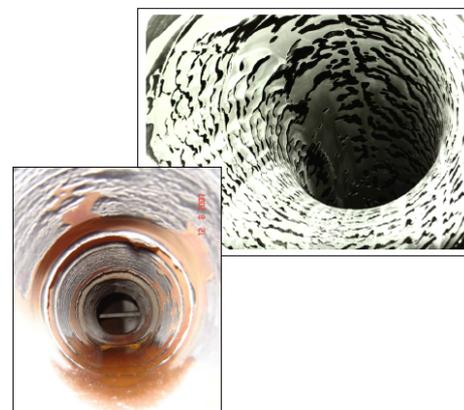
Under two-phase flow condition, FAC will cause tiger print shaped appearance on the metal surface, as shown in Figure 3. The black part of the figure is the area with relatively serious corrosion while the red part of the figure is the oxide layer on the metal surface. The two-phase FAC usually creates the wear marks on the metal surface which appear black and shiny, or even enamel-like. These marks usually have pit-like markings, which sometimes show serrated or horseshoe-like directional characteristics as the damage caused by single-phase flow.

Figure 3. Corroded Metal Surface Caused by Two-phase FAC.

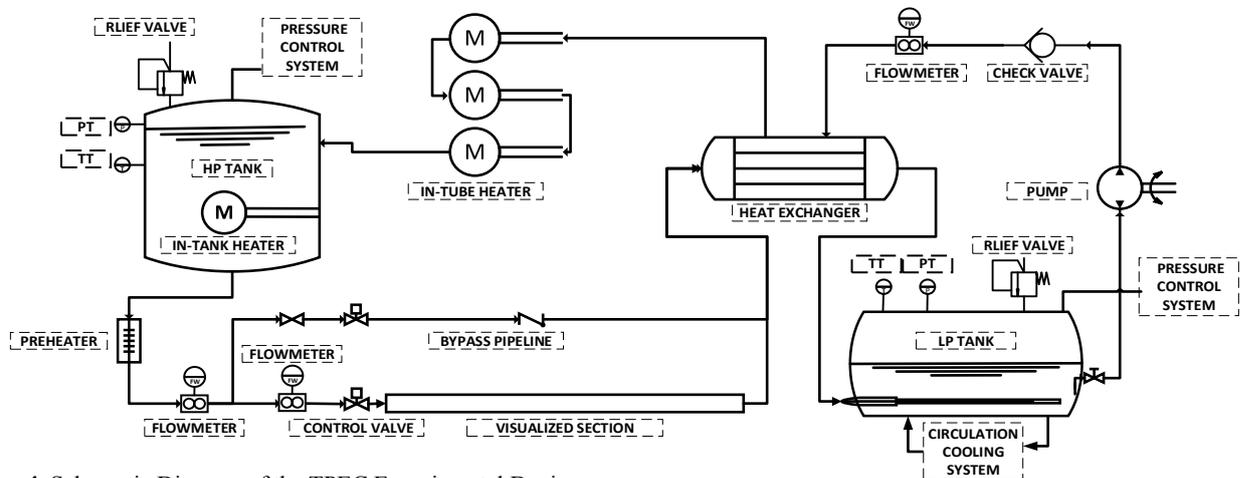
Figure 4. Schematic Diagram of the TPEC Experimental Device.

The specification of the pipe in the test is DN50. The material after the control valve is determined according to the test conditions, and the material of other parts of the test loop is 304 stainless steel.

The schematic diagram of TPEC test loop is shown in Figure 4.

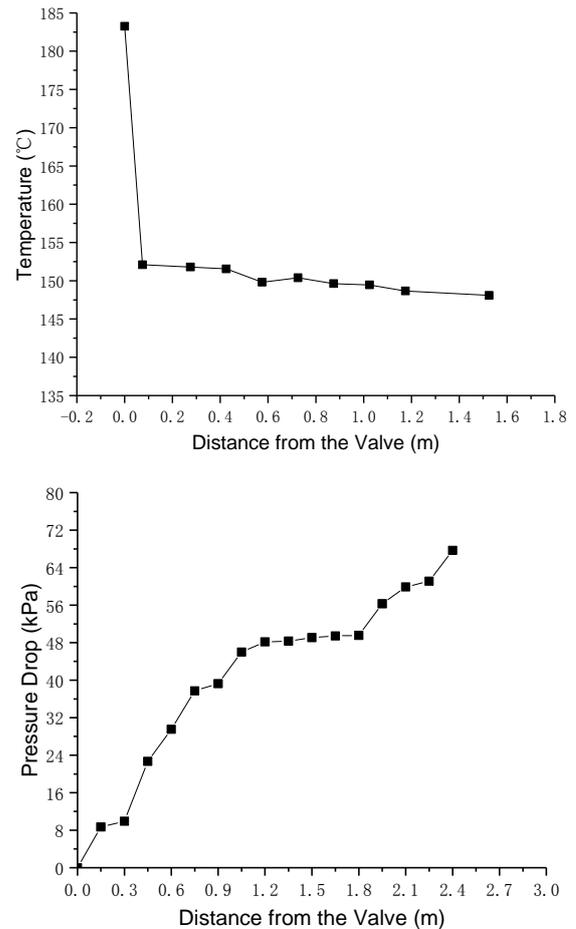
Figure 5. Curve of Temperature and Pressure Drop along Straight Pipe Section.

The curves of temperature and pressure drop along straight pipe section, elbow section, tee section and reducer section under the condition listed in Table 1 were measured, as shown in Figure 5~ 8. As can be seen from the figure, after passing through the valve, due to the pressure drop, there will be a stepped steep drop in the temperature after the valve which is related to the form of the piping components. The temperature of the straight pipe section after the control valve is the highest while the temperature of the reducer section after the control valve is the lowest. The reason is that the straight pipe has the least influence on the flow pattern. However, for the reducer section, before entering to the pipe with larger diameter, the flow of the fluid is driven by the pressure difference, which means the fluid moves under favorable pressure gradient. When the fluid enters the area with a larger diameter, based on the mass continuity, the velocity of the fluid will decrease due to the increase of the flow area. According to the Bernoulli equation of incompressible fluid, the decrease of velocity will lead to the increase of static pressure, which will result in appearance of adverse pressure gradient in the local area on upper and lower sides of the reducer. The combined effect of adverse pressure gradient and wall viscous resistance will cause the fluid in the local area to decelerate continuously. Eventually, the inertial force

cannot overcome the resistance and cause the flow to leave from the wall surface and generate vortex. Since the velocity of the viscous fluid does not change abruptly as the pipe shape, it changes gradually. This sudden change in the flow distribution results in severe turbulence in the local area, which will reduce the pressure in the local area and cause the temperature to drop rapidly. The temperature change of elbow and tee is between the straight pipe and reducer.

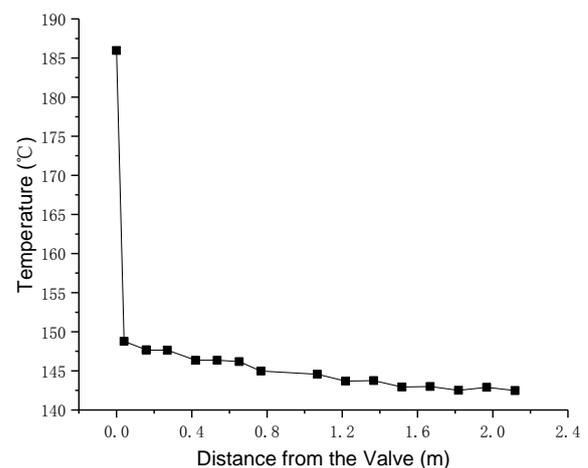
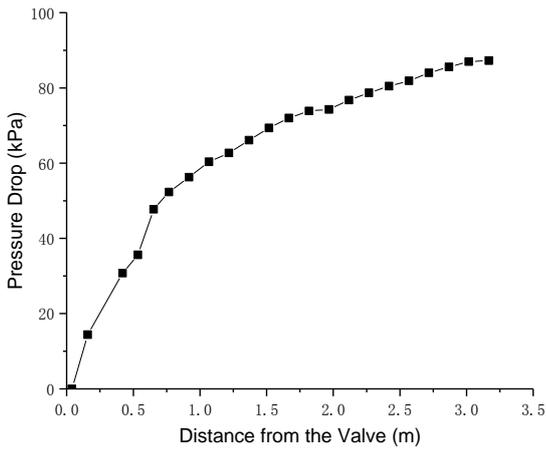
Figure 6. Curve of Temperature and Pressure Drop along Elbow Section.

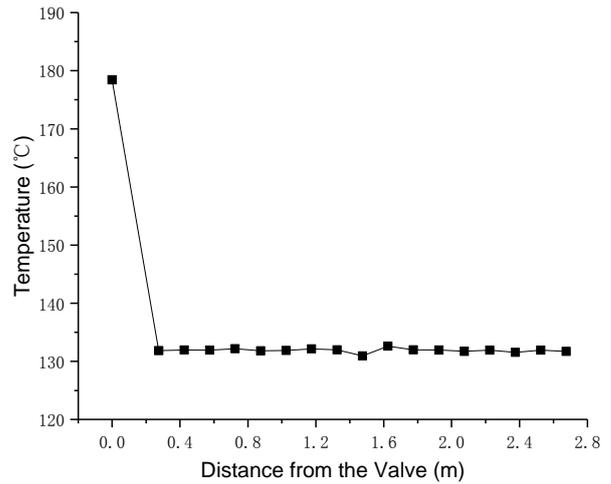
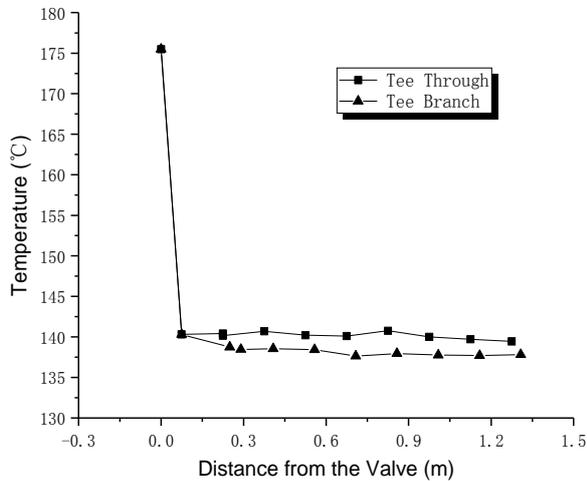
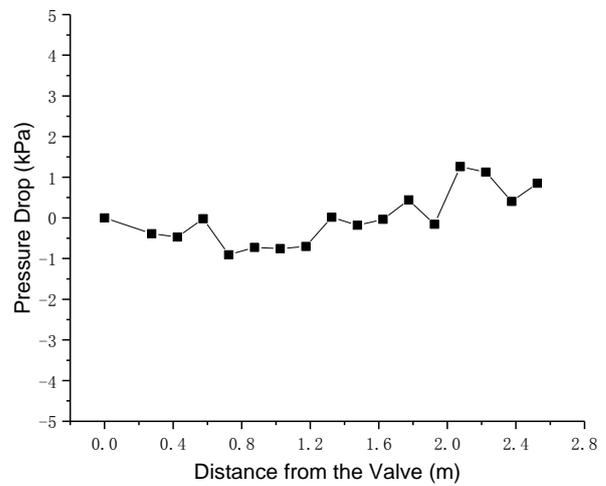
Figure 8. Curve of Temperature and Pressure Drop along Reducer Section.

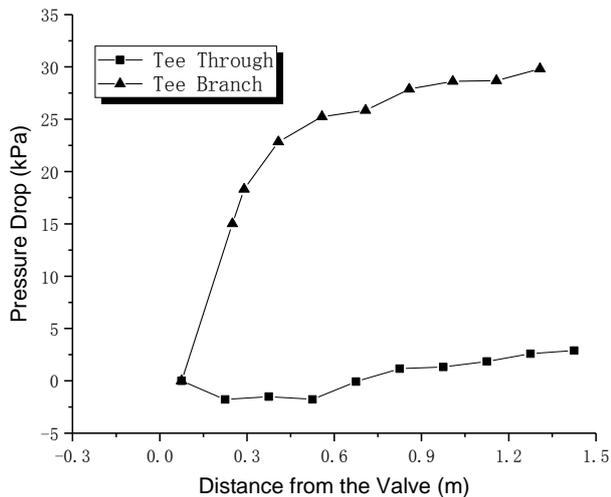
Figure 7. Curve of Temperature and Pressure Drop along Tee Section.

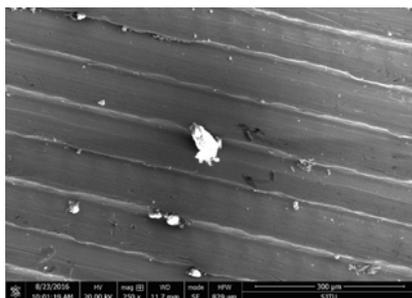
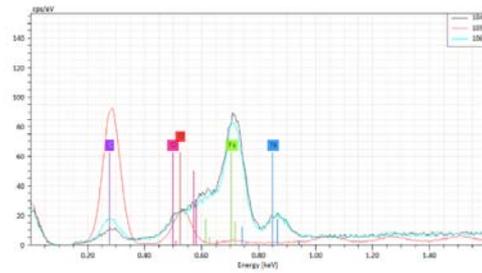
Figure 9. Surface Morphology and Element Distribution of Carbon Steel Sample in Straight Pipe Test Section.

Figure.9 ~ Figure.12 show the surface morphology and elemental analysis results of carbon steel samples tested in each experiment of straight pipe, elbow, tee, and reducer. As can be seen from Figure 9, after the carbon steel samples scoured by two-phase flow in straight pipe section, the oxide concentration area can be observed. The concentration area is basically round, the size of it is ranging from 0.5~1mm. According to the EDS observation, no oxygen can be found out of the oxide concentration area. In the oxide concentration area, the proportion of oxygen is different in different area, the thickness of oxide layer is thicker in the center of the oxide concentration area than at the edge. The experimental results show that there is a significant concentration of oxygen element and a significant increase of carbon element in the destroyed area of the sample which means high temperature oxidation occurs at the place that result in embrittlement of the structure.

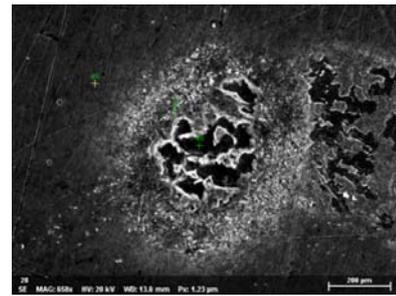
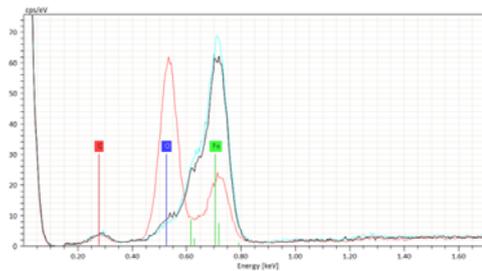
Figure 10. Surface Morphology and Element Distribution of Carbon Steel Sample in Elbow Test Section.

In Figure 10, it can be seen more clearly in the sample of elbow test that obvious round shape scour marks are showed on the surface of the No.20 steel sample, and a few dotted pits are generated inside these round shape scour marks. These pits are irregular in position, but mainly concentrated inside of the scour marks. The larger marks have more pits inside of them and the pit size is smaller in the smaller scour marks.

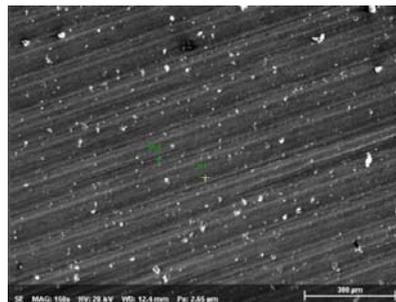
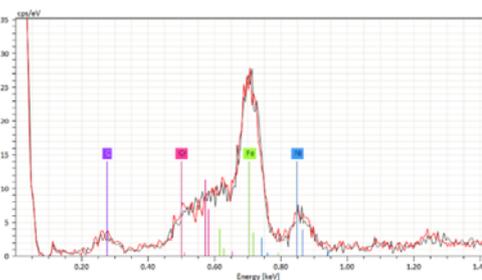
Figure 11. Surface Morphology and Element Distribution of Carbon Steel Sample in Tee Test Section.

From Figure 11, it can be seen that the samples of tee test section can also be scoured, and there are round scour marks appear on the surface which looks less obvious than the scour marks on the samples of the straight pipe test and the reducer test. Considering the position of the samples, it can be considered that the two-phase flow area in the tee is relatively large, and thermodynamic parameters change significantly at the position of the tee (which due to the flow diversion caused by the branch pipe). Therefore, the two-phase effect is weakened, causing less corrosion.

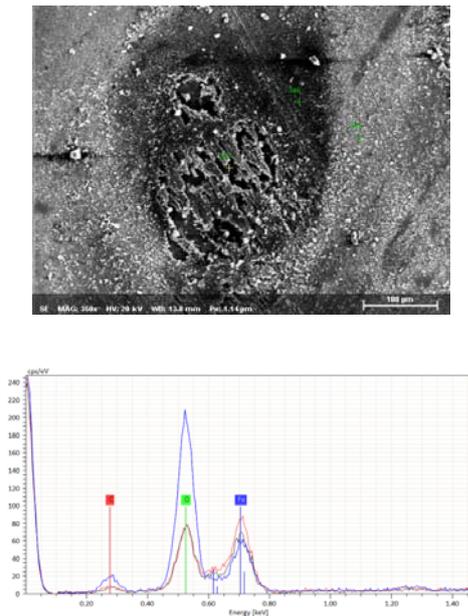
Figure 12. Surface Morphology and Element Distribution of Carbon Steel Sample in Reducer Test Section.

As shown is Figure 12, the scour marks of the size between 0.1~0.3mm are also found on the surface of the samples of reducer section. The structural failure points are showed in the internal area of the scour marks. The failure points appear to be typical FAC morphology, and the material is scales off the surface. According to the EDS results, oxygen element is found in the damage point which indicates that oxidation also occurs at the damage point. And the oxide layer inside the scour marks appears the trend of thinning. It means that the dotted pits produced by the two-phase flow are generally dotted pits, which usually appears inside the round shape scour marks. The scour marks are created by the high temperature generated by the bubbles impact, which leads to the property change or thinning of the oxide layer. And the oxide layer is delaminated due to the bubble scouring or the mechanical force produced by the bubble collapse.

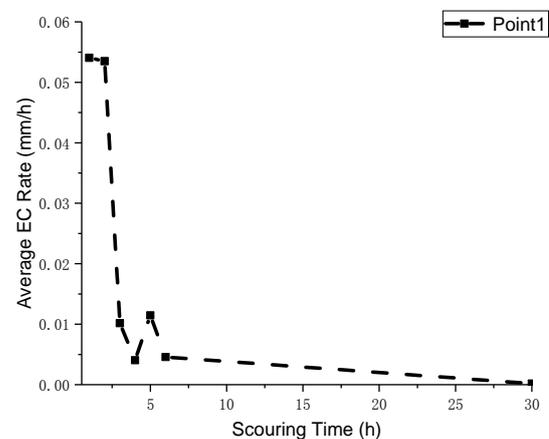
Figure 13. The Curve of the Average Piping Wall Thickness Reduction of the Samples at Point 1 of the Elbow Test Section with Time.

In order to observe the correlation between the thinning of the piping wall thickness and the time, the impact experiments of scouring time were conducted. Two sample points (point 1 is at the 0° of the elbow, point 2 is at the 30° of the elbow) were measured using a three-dimensional profilometer, and the test results are as follows.

It can be seen from Figure 13~14, the erosion rate was larger during the initial 1h~2h, which was related to that the initial piping wall was already oxidized. The average EC rates are significantly different for the two sample points is due to the different initial oxidation degree. After the initial oxidation layer was scoured away, the erosion rate dropped rapidly, but it increased at 5 h. This is related to the process of erosion development. During the initial period of two-phase scouring, the pipe wall oxidized and generated the oxide layer in the water

environment. Due to the low strength of the oxide layer, it was stripped away from the pipe surface by the two-phase flow bubbles and left several dotted pits. Since the peeling of the oxide layer exposed the underlying metal matrix which strength is relatively high and hard to be damaged by the two-phase flow bubbles, the erosion rate starts to decrease. With continuous oxidation of the metal matrix, the erosion rate increases slightly at later time.

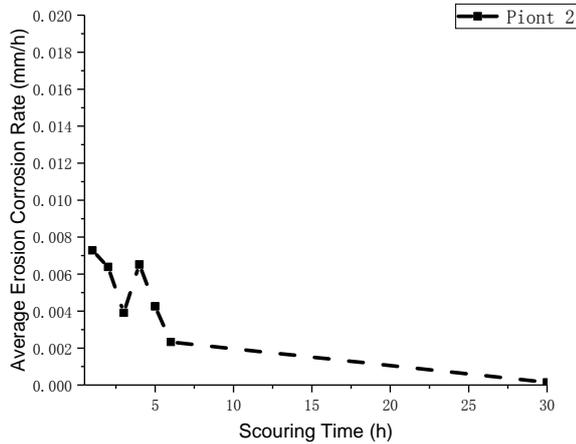
Figure 14. The Curve of the Average Piping Wall Thickness Reduction of the Samples at Point 2 of the Elbow Test Section with Time.

According to the experimental results, due to the reduction of the oxygen concentration of the fluid in the pipeline, the piping wall thickness reduction rate reached a relatively small steady value after a period of time, which was about $0.485\mu\text{m/h}$.
