Laser cleaning for rust removal on mild steel: An experimental study on surface characteristics

Vishnu Narayanan, Ramesh K Singh and Deepak Marla

Department of Mechanical Engineering, IIT Bombay, Maharashtra, India

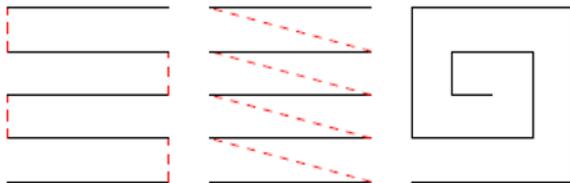
Figure 1. Paths followed by the laser beam

Experiments were conducted to study the effect of scan speed and number of passes on the surface of rusted and pure mild steel surfaces. When rust is removed by laser cleaning, the pure steel layer beneath the rust layer would also get subjected to laser irradiation as process nears completion. Therefore, it is important to know the adverse effects of process parameters that are optimal for effective rust layer removal. In order to understand the heating effects occurring underneath the rust layer and quantify the damage, experiments were also conducted on pure steel samples. Lines were scanned on the mild steel samples at different speeds keeping all other parameters same and the samples were analysed using Zeta optical profile analyser and the effects like depth of removal, and change in surface profile were studied. Galvo-scanner can be used to scan a particular area by following a predefined hatch pattern. This option was used to scan samples with multiple scan patterns as shown in figure 1 and investigate whether the path followed by laser during the cleaning process affected the material properties.

Three scan patterns (figure 1) were selected and used to study the effect of path followed by laser in material properties of surface after interaction with the laser. The surface was scanned once with each pattern. The study was repeated for three scans for every pattern. Each pass was timed 10 seconds apart. The roughness and hardness of this area was measured and compared with initial roughness before laser processing for rusted and pure samples.

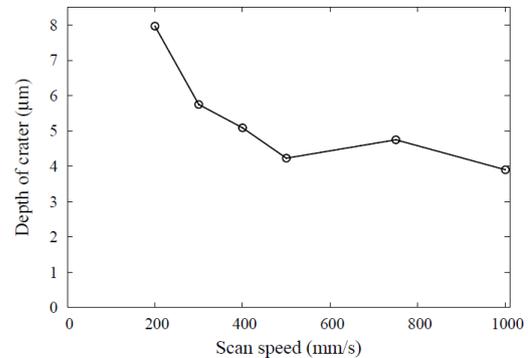
Figure 2. Depth of crater vs. scan speed

Figure 2 shows the change in depth of ablation with a change in scan speed. The experiments were conducted to study the change in surface profile when the sample is scanned with the laser at different speeds ranging from 2 mm/s to 1000 mm/s. The lines traced were studied with a Zeta profilometer. It was observed that at lower speeds (less than 100 mm/s), the surface was deformed and discoloured to dark brown by the laser beam. Whereas, at speeds above 200 m/s the surface did not show any

discolouration and relatively flat surface was transformed into a wavy profile with a depression at the centre and elevations on either side after laser irradiation. The wavyness and discolouration decreases with an increase in scan speed but so does the depth of removal. The depth of removal follows a steady decrease with an increase in scan speed initially till it reaches 500 mm/s, and is observed to remain almost constant thereafter.

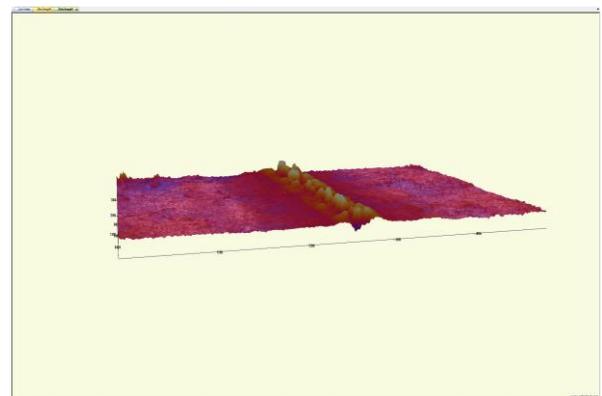
Figure 3. Surface after 15 scans for 100 mm/s

Figures 3 and 4 show the surface profiles after 15 scans at 100 mm/s and 500 mm/s, respectively. The study showed that for lower speeds, multiple scans deform the surface in a disordered way. At lower scan velocity with multiple scans, it was observed that the processed surface is irregular with peaks and valleys forming at random positions on the irradiated region (see figure 3).

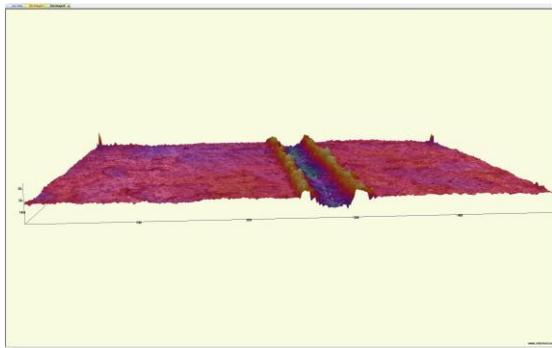
Figure 4. Surface after 15 scans for 500 mm/s

But for higher scan speeds, the surface gets deformed into a wavy pattern with a crater in the irradiated zone and humps formed on either ends of the crater (see figure 4).

As seen in figure 4, the processed surface for high speeds can be observed to be of wavy cross section. The general wavyness of the surface remains the same for any number of passes. Figures 5 and 6 show the relationship between number of passes with the average depth of depression and the average height of peak on the surface, respectively.

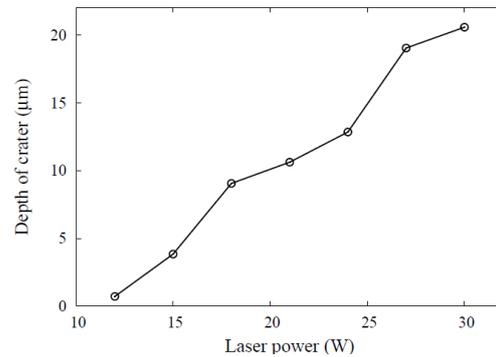
Figure 7. Depth of crater vs. Laser power.

Unlike the scan speed, depth of removal increased with an increase in laser power or fluence (figure 7).

The height of peak and depth of valley increased steadily with an increase in laser power. For lower powers the processed surface looked clean, but as power was increased the surface appeared darker after irradiation. The discolouration and change in surface topology is possibly due to a combined effect of corrosion and deformation initiated by the laser beam. Further studies can shed light on a deeper understanding of the phenomena observed during the experiments.
