Conservation Level Assessment - Application to a heritage building

Abstract. An evaluation methodology to estimate the envelope's degradation level (DL) was developed being after object of adjustment and improvement. The methodology is based on visual survey and in the application of the Failure Mode and Effects Analysis (FMEA) method allied to evaluation scales, aiming to achieve building condition assessment and prioritizing refurbishment interventions. In Portugal, the high buildings number needing refurbishment justified the evolution and improvement of the original methodology of state of conservation assessment of residential buildings at controlled costs. This methodology firstly developed and applied for residential buildings was based on an evaluation scale of eight levels, which was after adjusted to five levels. This simplification aims an easier application of this methodology and provides users with a clear understanding of his features. A summarised evolution of this methodology will be depicted in this paper and will be applied to a heritage building located in the city of Oporto, in Portugal. Beyond the evolution of this buildings conservation assessment methodolog

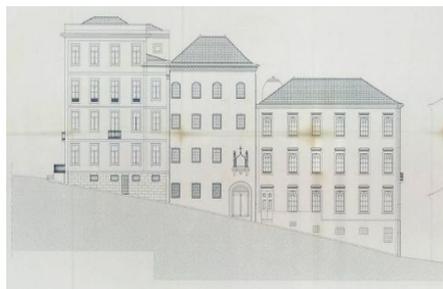
Fig. 1. West elevation

The building under study, Casa do Infante, is located in the historic centre of Oporto, in Portugal, at the riverside zone. The main facade is oriented towards a street with a sharp slope [24] as can be observed in the west elevation in Figure 1. The Oporto town council is the owner of the building. Is composed by 11 blocks, as shown in Figure 2, built in different periods, being the eldest one built between the XIV and the XVII century. According to each block localisation, the number of stories varies from 2 to 8. All over the years, several interventions in the buildings were conducted (Figure 3).

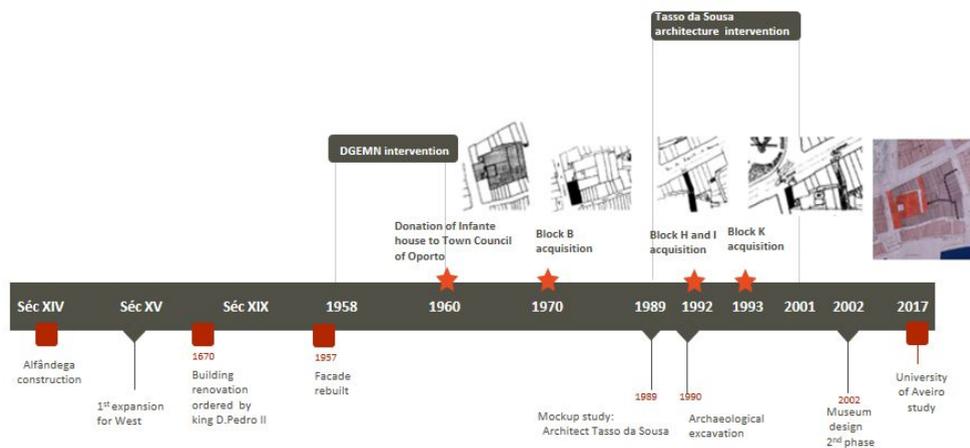
Fig. 3. Timeline of acquisitions and interventions in Casa do Infante
