# Pushover Analysis of Partially Strengthened Column Structures on an Existing Multi-story Building

**Abstract.** A pushover analysis was conducted to evaluate structural performance of an extended building structure subjected to simulated seismic loads. The Inna Garuda Hotel was selected as a building object of this research focusing on the extension building only. This 7-story reinforced concrete building has been functioned as a hotel building in the Yogyakarta City of Indonesia for over 30 years. Preliminary results of this analysis indicated that the performance level of this building was categorized as an immediate occupancy (IO), however, the plastic hinges on the slim column structure components occurred. Given this condition, the structure of the building does not fulfill the concept of a strong column-weak beam (SCWB). The research objective is to follow up on the potential of building collapse due to the column structure weakness by conducting a research on the strengthening of slim column elements. A pushover analysis was carried out using ETABS software. A strengthening technique was adopted by enlarging the dimensions of the slim column gradually. In this study, the

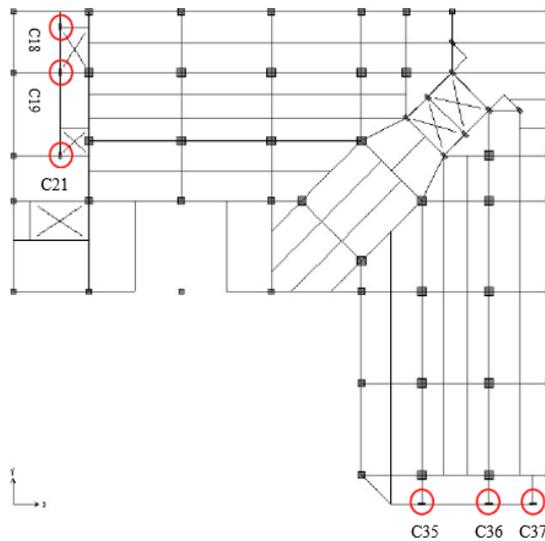
**Fig. 1** Indicate damage points on slim columns

The calculation steps begin with simulating the enlargement of the slim column dimensions that are conducted gradually. The simulation for achieving an expected dimension was performed five times of pushover analysis under the same seismic load, and the fifth simulation was the best slim column dimension used in this research to recheck the existing building performance. The slim columns layout of the extension building structure shown in Fig.1 consists of 4 levels having typical plans. Fig. 1 also presents the indicated damage points on the slim columns as circled with red marks. Table 3 shows the simulation sequence of slender column dimensions starting from the initial dimensions of 150/500 mm to 300/650 mm.

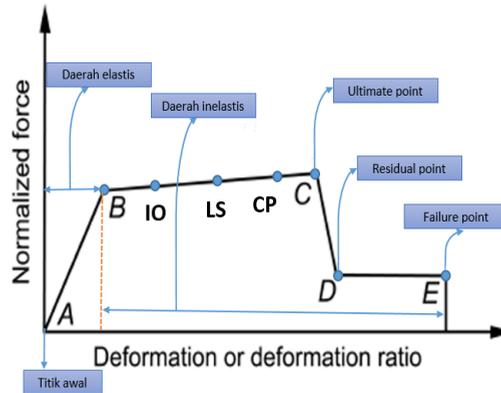
**Fig. 2.** Load-displacement relationship and damage level [7]

The location elements experiencing plastic hinge conditions at certain levels according to the performance level. Based of damage to structural elements is presented based on the results of pushover analysis by looking at structural on the graph of ATC-40 [7] referring to Fig. 2, the relationship between load-deformation and boundary level criteria in accepting deformation with the description of damage level is described.

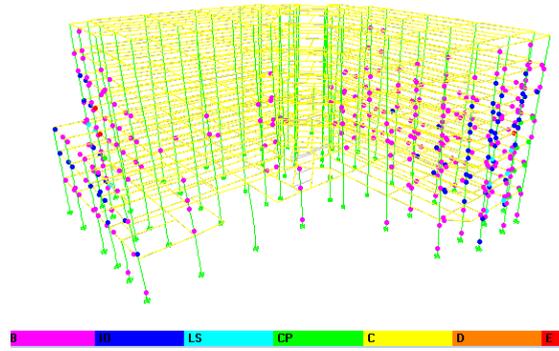
**Fig. 3** Plastic hinge location at step-14 of a pushover in the x-direction (N-S) of KJ-P5 model

More importantly, during the analysis process will start from the first step to the end and the program will gradually mark spherical points (small circle) as notification of the decrease in the strength of the structure. Referring to the pushover analysis of the KJ-P5 model having the slim column dimension of 300 x 650 mm, the plastic hinge results of the performance points in the four directions are presented in Fig. 3. The color level showing in Fig. 3 marks the strength degradation after reaching the step-14, whilst Fig. 4 displays the plastic hinges occurring on the 3rd frame in the x-direction.

Fig. 3 and Fig. 4 show that the points of damage to the structure elements experienced by columns and beams. In step-14, there are many plastic hinges that occur and have exceeded the limit of immediate occupancy conditions, even there are several points of the beam element being damaged until the final collapse is marked in red. The 3<sup>rd</sup> frame in the x-direction (north to south) shown in Fig. 4 has experienced the initial plastic hinge marked with purple color and there is 1 point of column structure element and the beam is in immediate occupancy condition.

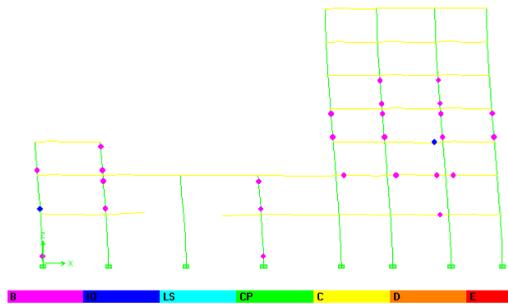
**Fig. 4** Plastic hinge location: step-14 of the 3<sup>rd</sup> frame in X-direction (N-S) of KJ-P5 model

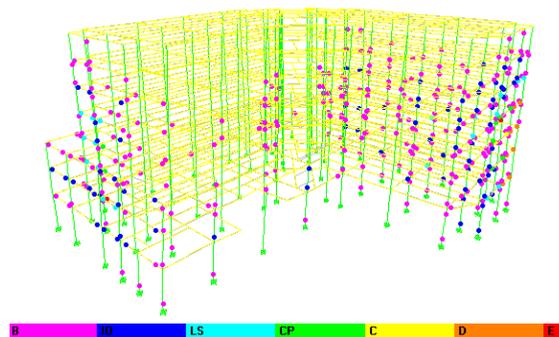
**Fig. 5** Plastic hinge location: step-19 of a pushover in X-direction (S-N) of KJ-P5 model

Similarly, the x-direction from the north to the south, in the opposite direction is the south to the north. In the 19<sup>th</sup> step, it is shown that many plastic hinges that occur are over the immediate occupancy condition, and even there are several points of the beam element being damaged until the final collapse is marked in red (Fig. 5). In Fig. 6 the D frame in the x-direction from the south to the north has experienced an initial plastic hinge marked with purple and there are 2 points of column structure elements already in immediate occupancy conditions.

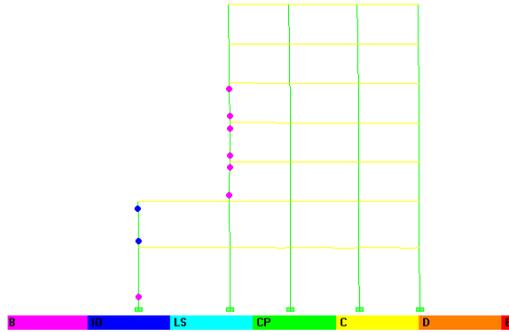
**Fig. 6** Plastic hinge location: step-19 of the D frame in X-direction (S-N) of KJ-P5 model

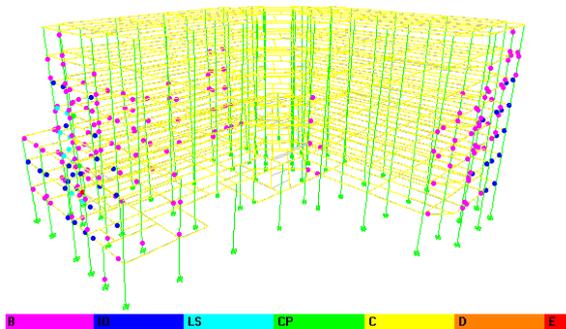
**Fig. 7** Plastic hinge location: step-4 of a pushover in Y-direction (W-E) of KJ-P5 model

In the step-4 denoted in Fig. 7 presents many plastic hinges on the beam and columns that occur already in the condition of immediate occupancy (IO), there are even some points of the beam element damaged in the condition of immediate occupancy. The 7-frame in the y-direction as shown in Fig. 8, many column structural elements undergo initial

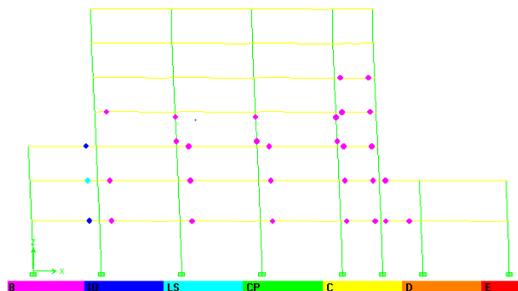
**Fig. 8** Plastic hinge location: step-4 of the 7-frame in Y-direction (W-E) of KJ-P5

plastic hinges as marked with a purple color and there are 2 beam element points have been already in the immediate occupancy (IO) condition and the column element point in life safety condition (LS).

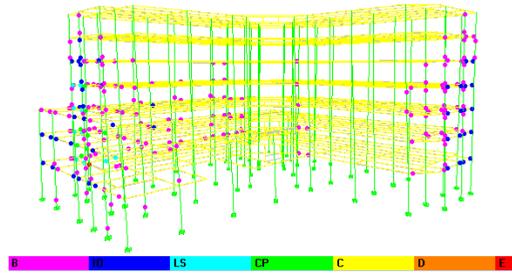
**Fig. 9** Plastic hinge location: step-4 of pushover in Y-direction (W-E) of KJ-P5 model

Similar to the step-4 in the y-direction from the west to the east or otherwise as presented in Fig. 9 and Fig. 10, it is resulted many plastic hinges on the beams and columns that have been already in immediate occupancy (IO) conditions, but several points of the beam elements have exceeded the immediate occupancy conditions.

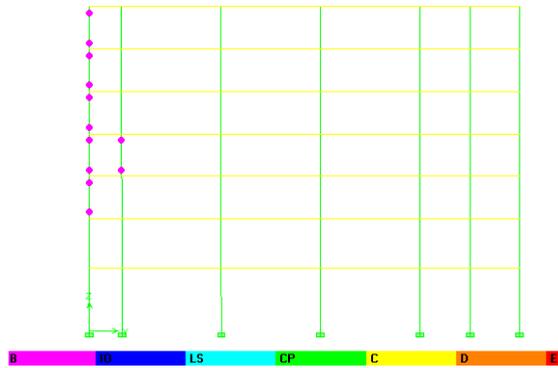
**Fig. 10** Plastic hinge location: step-4 of the H-frame in Y-direction (W-E) of KJ-P5 model

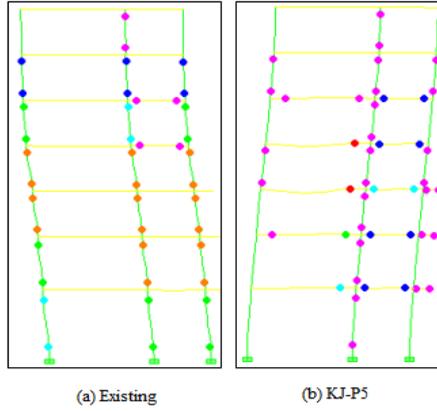
**Fig. 11** Plastic hinge location of slim columns: final step of the A-frame in X-direction (N-S)

Fig. 11 to Fig. 18 show that by strengthening the cross-section of indicated weak-column elements (slender columns) changing the level of damage and improve the performance level of the extended building of Inna Garuda Hotel. The result of pushover analysis of the building structure proves that the reinforced column elements that have been strengthened contribute significantly to the improvement of overall structural performance.

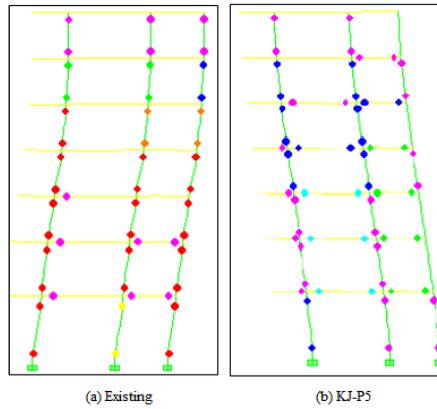
**Fig. 12** Plastic hinge location of slim columns: final step of the O-frame in X-direction (N-S)

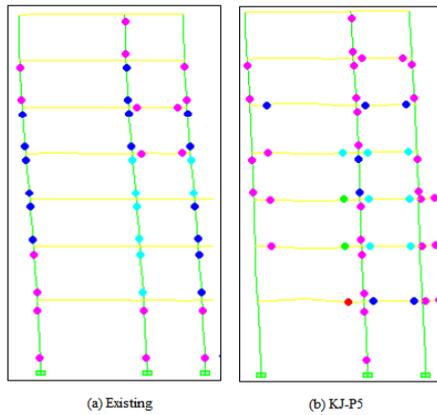
**Fig. 13** Plastic hinge location of slim columns: final step of the A-frame in X-direction (S-N)

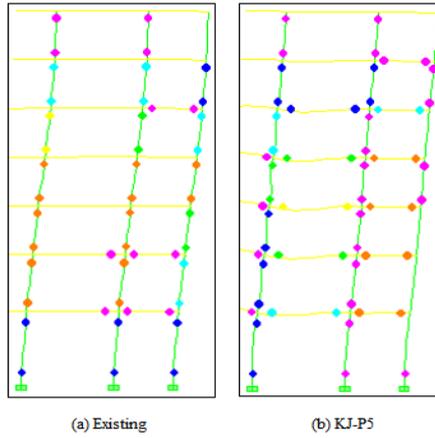
**Fig. 14** Plastic hinge location of slim columns: final step of the O-frame in X-direction (S-N)

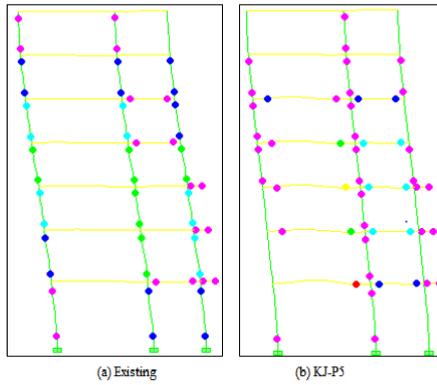
**Fig. 15** Plastic hinge location of slim columns: final step of the A-frame in X-direction (W-E)

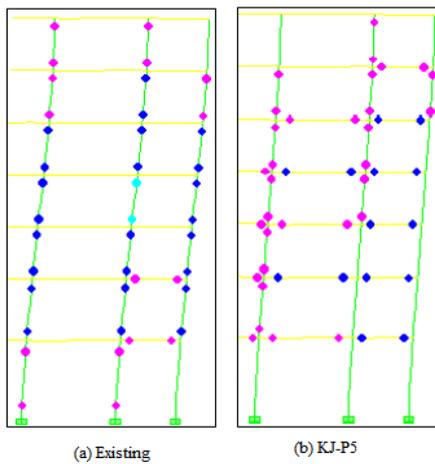
**Fig. 16** Plastic hinge location of slim columns: final step of the O-frame in X-direction (W-E)

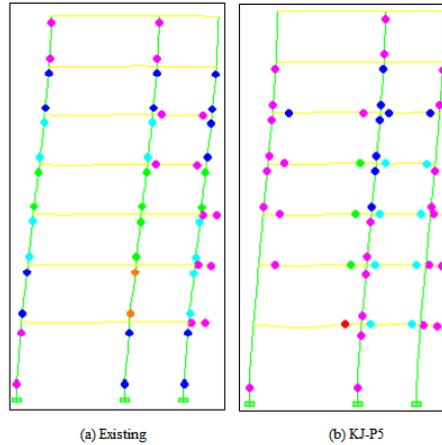
**Fig. 17** Plastic hinge location of slim columns: final step of the A-frame in Y-direction (E-W)

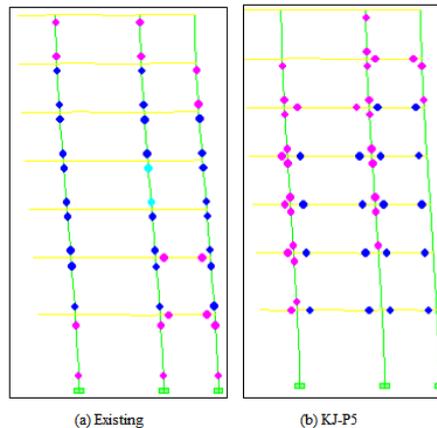
**Fig. 18** Plastic hinge location of slim columns: final step of the O-frame in Y-direction (E-W)
