# Analysis and evaluation of the effect of vibrations on historical buildings

**Abstract.** Continued exposure of human induced vibrations contributes to the degradation of materials and joints, causing the initiation of cracks or the growth of existing ones, such that they may endanger the structure. Loads, which an undamaged structure could safely resist, can be critical if repeated numerous times. This risk is present in various types of historical buildings, and is influenced by changes in vibration magnitude, by the distance from their source, and by the quality of the building's maintenance. Good maintenance, which includes regular inspections, allows early detection of any emerging damage and its subsequent repair. This article describes the methods and results of the measurement of dynamic response to road traffic and other types of technical seismicity in four historic buildings. The goal of this paper is to present some examples of analysis and evaluation of the effects of such human activity.

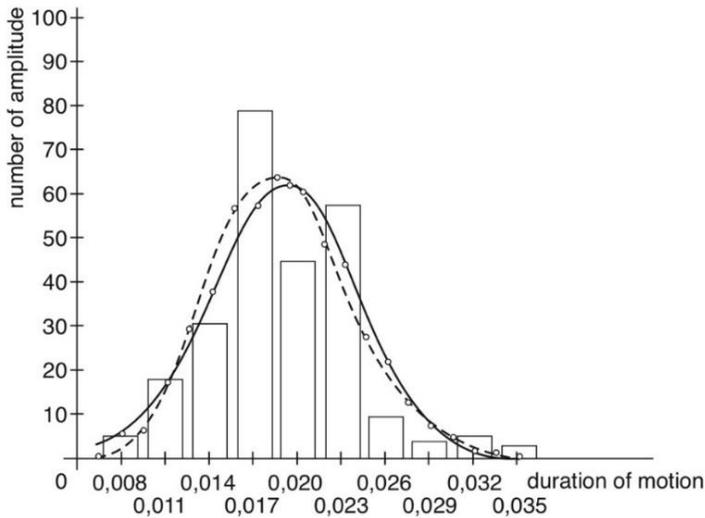
**Fig. 1.** A bar graph of horizontal vibrations spreading from the site as old tram cars pass by. The theoretical normal distribution curve and the Pearson type III distribution curve.

In the 1971s Baťa processed measurement results statistically [2]. Here is an overview of the results of certain processed measurement records. Forced oscillations were investigated from various vehicles at St. Tomas in the Lesser Town of Prague. Graphical representation

of a group distribution of frequencies in a histogram and a distribution function. The best match was obtained using the Pearson type III distribution see Fig. 1.

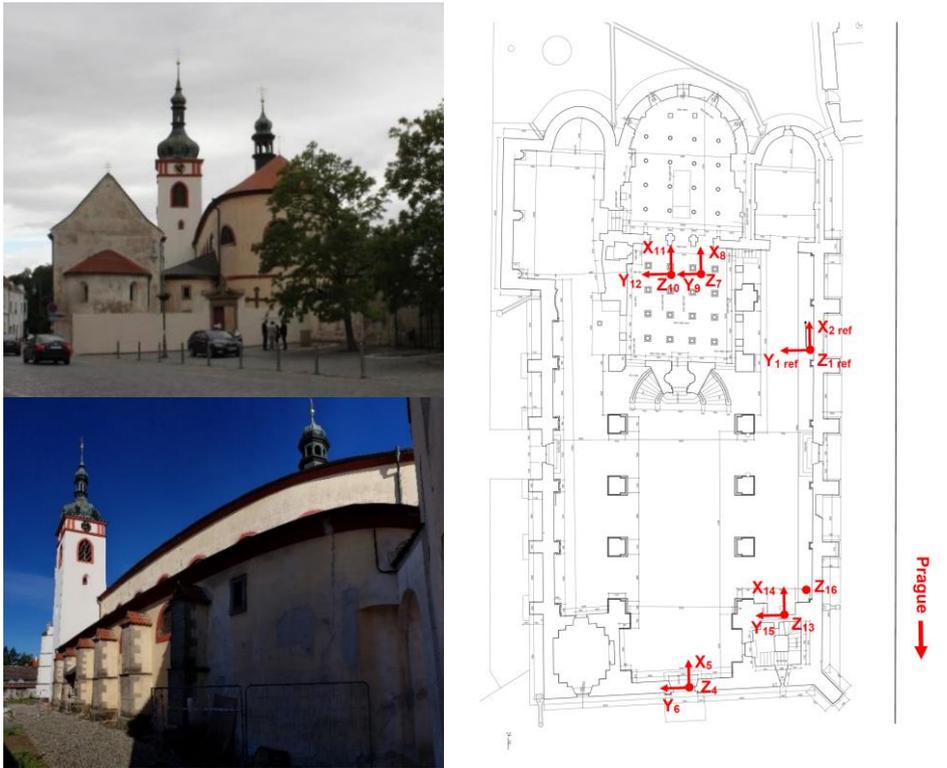
Fig. 2. Basilica st. Wenceslav in Stara Boleslav and plan of the accelerometers setup.

The Baroque reconstruction of this building was completed in 1745. This is a three-nave building with a central nave and two separated aisles (see Fig. 2). The central nave is vaulted by a barrel vault with lunettes; the clearance between the vault imposts is 9.30 m, the axial distance between the vault imposts is 5.0 m, and the height of the voussoir arches is 4.0 m. The vault thickness at the peak is 230 mm including the plaster. The clearance of the aisle is 13.63 m. The vault is disturbed along the length of the aisle by a continuous crack along the top. Some lunettes are also damaged by cracks. The aisles are also vaulted with barrel vaults with lunettes; the clearance between the vault imposts is 3.90 m for the northern aisle and 4.80 m for the southern aisle; the axial distance between the vault imposts is 5.0 m. The height of the voussoir arch is 2.30 m for the northern aisle, 2.36 m for the southern aisle, and the vault thicknesses at the peaks are 250 mm including the plaster. The clearance is 6.68 m for the northern aisle and 7.16 m for the southern aisle. There are buttresses on the outside peripheral walls in the positions of the vault imposts of both aisles. The vault ceiling does not show any apparent defects, neither do the peripheral walls of the central nave and the aisles. According to available information, the building was constructed on layers of river gravel.

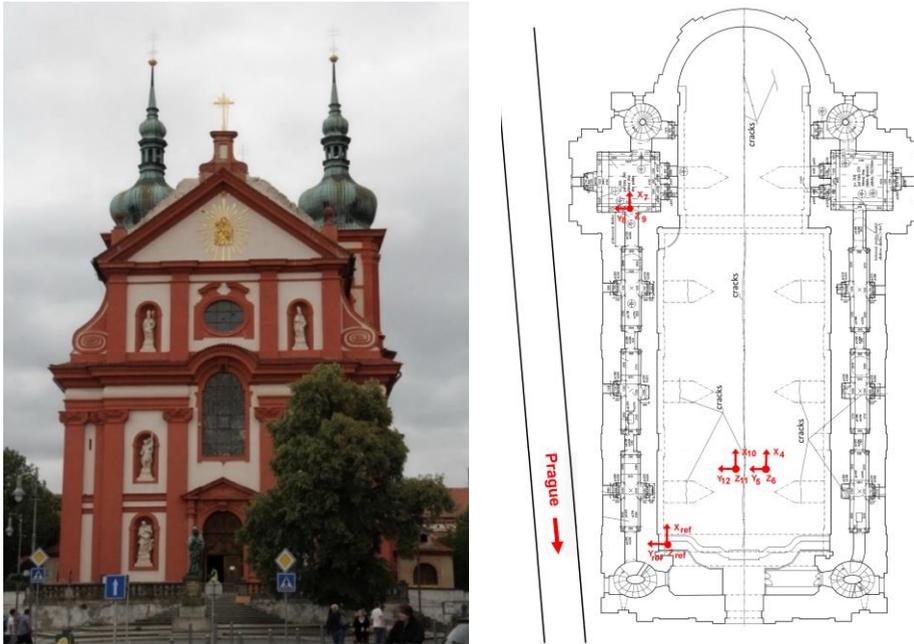
**Fig. 3.** The front view of the Basilica of the Assumption of the Virgin Mary and plan of the accelerometers setup.

The sacred buildings include the Basilica of the Assumption of the Virgin Mary with a cloister on east side (see Fig. 3). We mention this basilica as an example of our research. The church is surrounded with a terrace and access staircases. The terrace also provides access to the cloister.

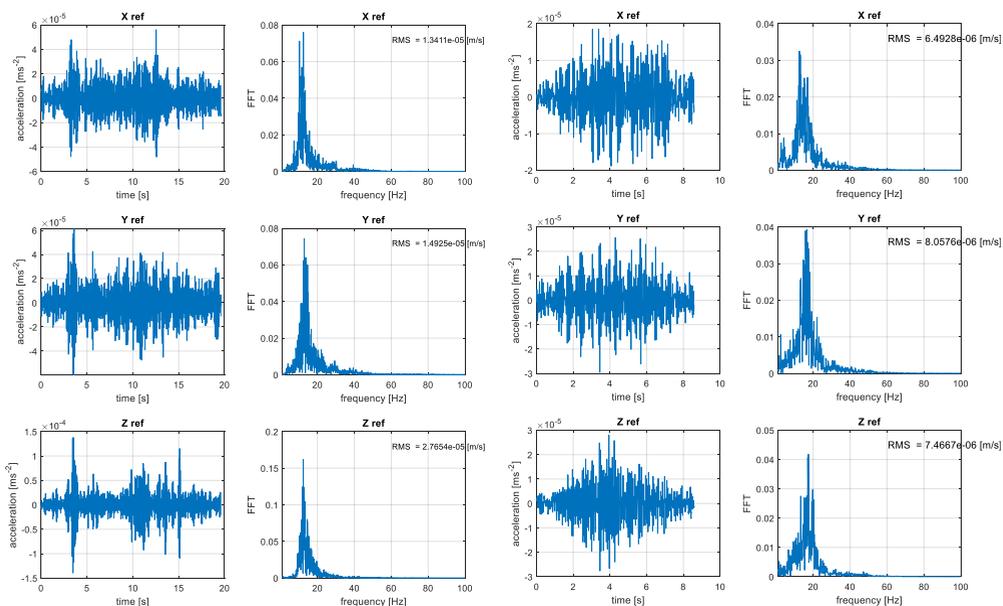
**Fig. 4.** Lorry traveling to Prague + bus traveling to Prague (the basilica of St Wenceslas).

**Fig. 5.** Bus traveling to Prague. (The Basilica of the Assumption of the Virgin Mary).

The dynamic response was measured at a reference point and other points on the X, Y, and Z axes. From the one-hour records, 10- to 30-second sections were selected and processed with a computer for evaluation of the final maximum effective vibration velocity, as it is apparent in Tables 1 and 2. Fig. 4 and 5 shows examples of the recorded accelerations in the vertical and horizontal directions and corresponding Fourier spectra (FFT) for time histories at the reference point.
