Microstructural analysis of collapsible soil before and after collapse and with loading and unloading cycle

Abstract. Aspects related to the volume variation of collapsible soils due to the change in water content are influenced by several factors, including the microstructure. The microstructure analysis of the soil is especially important in order to understand these aspects. This paper shows a comparative analysis of the microstructure of three samples of a collapsible Yellowish Red Sand from the district of Petrolina (northeast of Brazil), carried out by means of two techniques: Scanning Electron Microscope (SEM) and X-Ray Computed Tomography. Three undisturbed sample were used: the first no pressure was applied, in the second an one-dimensional compression of 160 kPa was applied and then the sample was unloaded, and in the third, between the compression and decompression, the sample was flooded with the occurrence of structural collapse. In the first sample, the soil microstructure is a matrix with a predominance of grains of sand clothed with iluvial clay with interconnected pores that confers instability. The second sample showed a reduction in macropores after loading. In

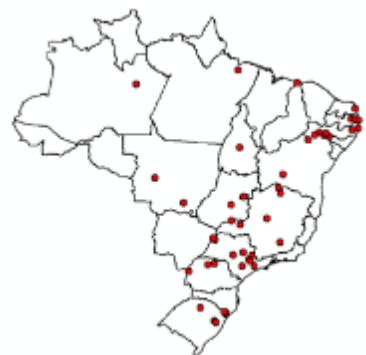
Fig. 1. Occurrence of collapsible soils in Brazil. From: Freitas (2017) [04].

There is occurrence of collapsible soil in all regions of Brazil, Fig 1 (Freitas, 2017 [04]). The tropical region influences the origin of collapsible soil (Ferreira, 1995 [05]). They are originated from pedogenic evolutions of residual or transported soils (Vargas, 1978 [06]). The occurrence of collapsible soil can be correlated with

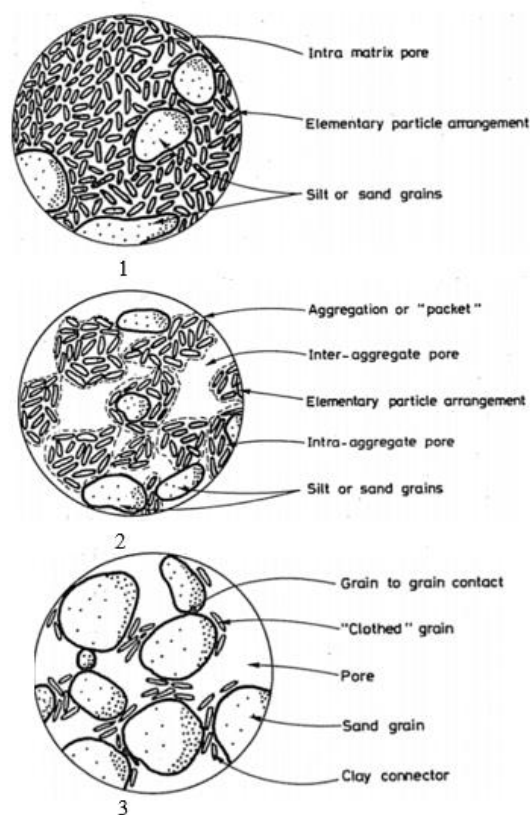
Fig. 2. Types of microfabric. McGrown and Collins (1975) [09]

Soil formation is result of its geological history. Rodrigues and Lollo (2008) [08] described four distinct processes of collapsible soil's formation: weathering of the matrix rock (residual); by the action of the winds (wind); by the action of water (alluvium and colluvium) and material compressed. McGrown and Collins (1975) [09] classified microfabric forms for expansion and collapsible soil in three types: elementary particle arrangement; 2 particle assemblage; 3 pore spaces. Figure 2 shows a schematic interpretation of this units.

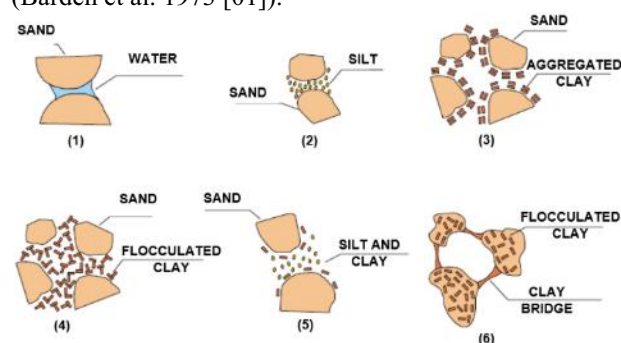
Fig. 3. Main forms of collapsible soil structure. Adapted from Clemence e Finbarr (1981) apud Ferreira (1995) [05]

Clemence and Finbarr (1981) proposed some unstable connection models showed in Figure 3. The first two models are maintained for the capillarity strength between sand-sand, silt-sand, and silt-silt. In the third and fourth, sand grain is clothed by clays. In the fifth the particles are bounded by silt and clay. In the last one, flocculated clay interacts with other through the clay bridge.

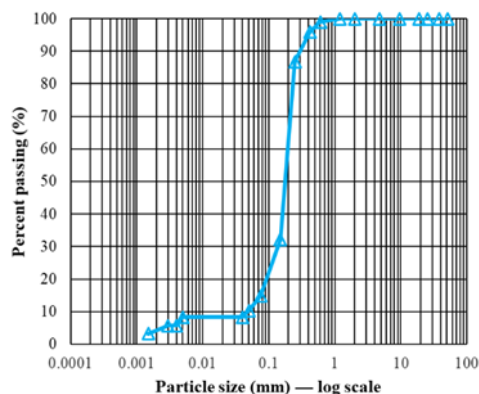
Fig. 4. Grain-size distribution. From Torres 2014 [13]

Grain-size tests were performed in the soil (Figure 4). According to the Unified Soil Classification System (USCS) this soil was classified as SM with a coefficient of uniformity 3 and a coefficient of curvature of 1.19. The optimum water content was about 7 % with a dry density of 18.3 kN/m³ (Santos 2018 [12]). The natural density of the soil ranged between 14.97 to 15.10 kN/m³ (Torres 2014 [13]).

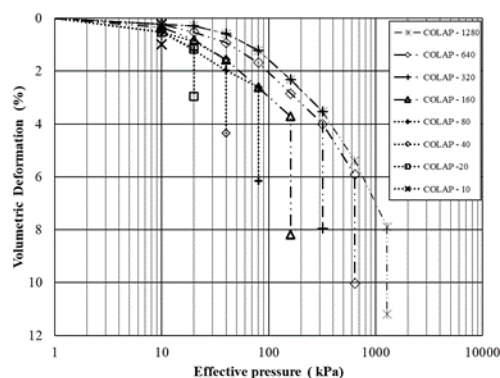
Fig. 5. Oedometer compressibility test of Petrolina’s soil. From Torres 2014 [13]

The potential of collapse (PC) (Equation 1) varies with the confinement and grow until 4.64 % at 160 kPa, and decreases until 3.59 % for the pressure of 1280 kPa. The oedometer test for undeformed samples is shown in Figure 5.

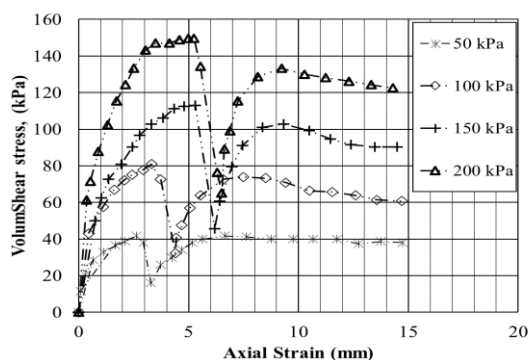
Fig. 6. Direct shear tests with collapse. From Santos (2018) [12].

The strength of Petrolina’s soil varied with suction degree, density, and confinement. The friction angle varied from 28° to 34° and the cohesion from 0 to 25 kPa (Freitas 2017 [04], Santos 2018 [12]). During the collapse there was a significant reduction in the strength, but with the strain this resistance was partially recovered (Figure 6).

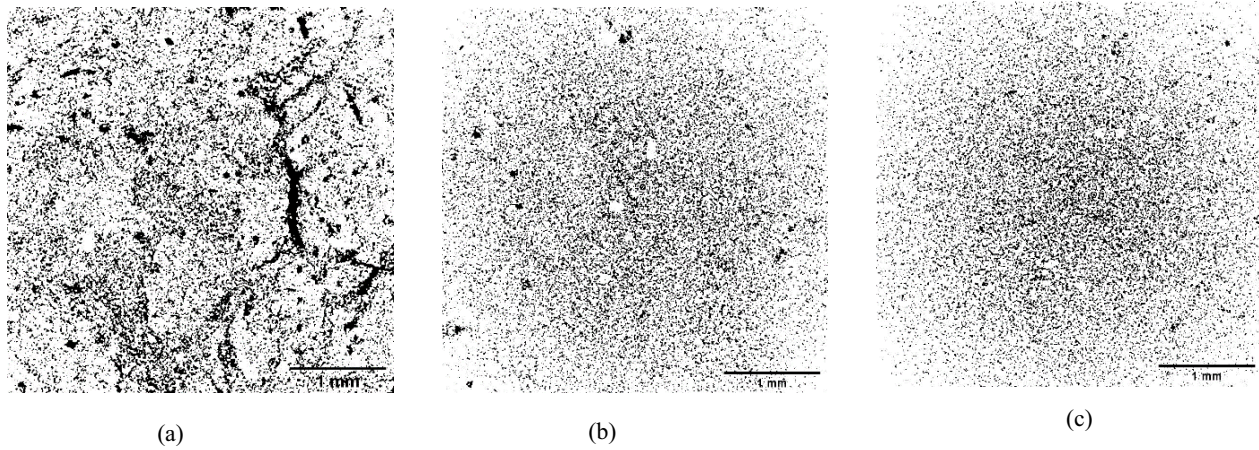
Fig. 7. Slice of (a) undisturbed sample, (b) after compression process and (c) after collapse process.

In the grayscale image (Figure 7), the black pixels represent the void in the soil. In the undisturbed sample the soil structure shows large pores (bigger than 10mm x 0.5 mm) which represent biopores (Figure 7 - a). Using a pressure above 160 kPa, the soil structure changed and the macroporosity reduced (Figure 7 - b). The imposed collapse resulted in a rearrangement among the grains due to cementation’s breakdown of clay particles and a densification of the soil (Figure 7 - c)

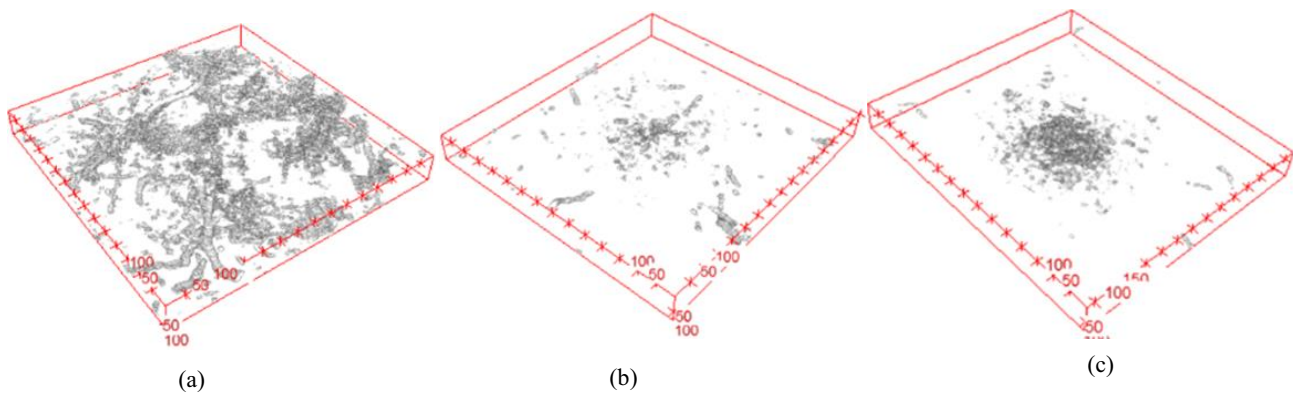
Fig. 8. Connected micropores of (a) undisturbed sample, (b) after compression process and (c) after collapse process.

Pores in 3D are represented in Figure 8 and small isolated pores were excluded to facilitate visualization. It is possible to visualize many connected macropores in Figure 8 - a, as it is an undisturbed sample, concluding that the central part of SP5 maintained its original arrangement state. The macropores in SP4 (Figure 8 - b), presented a reduction in size and connectivity after the compression applied, turning them in isolated and smaller pores. In Figure 8 - c, there are much smaller pores, however there are still some macropores, which reveals the existence of instability, and the risk of a further collapse in a smaller dimension, as reported by Alonso (2012) [15].

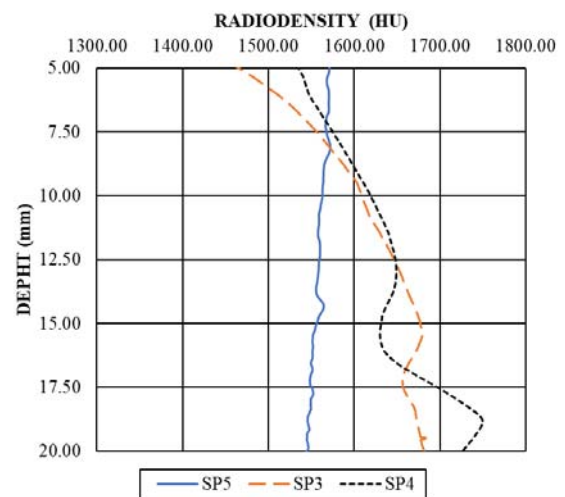
Fig. 9. Radiodensity.

The spatial variability of the soil matrix (average radiodensity in each section) can provide a qualitative assessment of the total porosity and the material type of the sample. For this analysis, a volume of 20x40x40 mm in the central part of the specimens was chosen for the spatial variability studies. For better representativeness of the sample 5 mm in the top of SP3 and SP4 were excluded, due to the volumetric deformation of the oedometer compression test. The result is shown in Figure 9. It is observed that SP5 has a less dense structure than SP3 and SP4. SP4 presented the greatest density, is the densest of all, which was expected due to compression and collapse.

The decrease of density in the top parts of SP3 and SP4 is observed, likely due to the elastic recovery of the soil in the mobile part of the oedometer cell, This behavior is not so pronounced in depth between 12.5 and 17.5 mm, where SP3 is denser than SP4. This is probably due to the presence of some pore that was not affected by the collapse in SP4 or the existence of big quartz grains in SP3, which affects the average radiodensity.

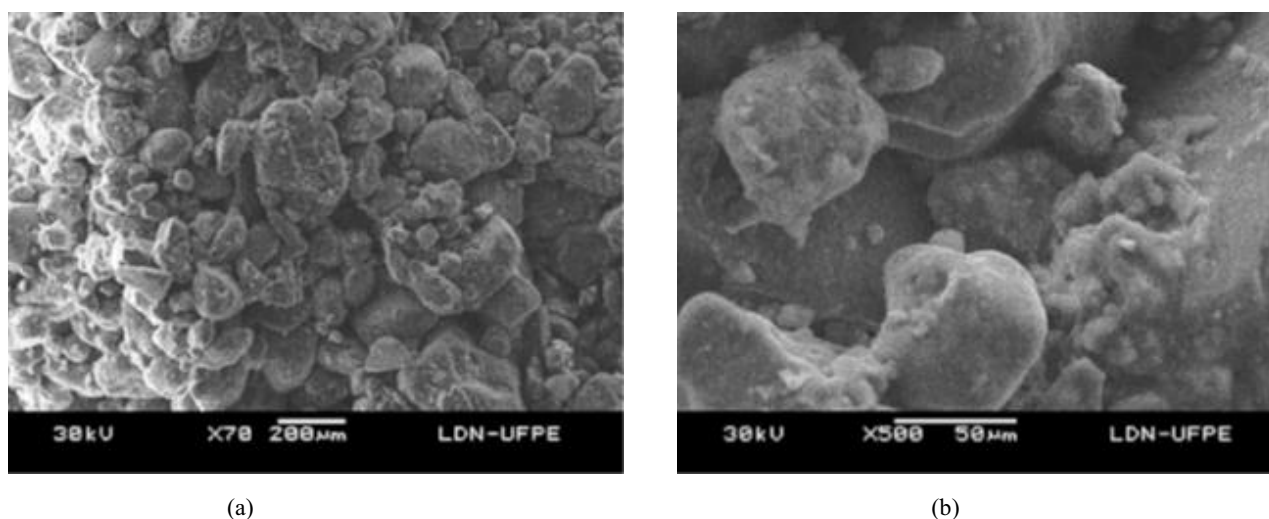
Fig. 10. Electron micrograph of undisturbed sample (a) overall fabric (b) microstructural arrangement. From Freitas (2017) [4].

The microstructural characterization of the undeformed sample is illustrated in the electron micrographs of Figure 10 (a), the overall fabric, and Figure 10 (b) the particle arrangement. The figures revealed an open fabric and a simple packaging structure of sands covered by a small amount of clay that almost always forms clay bridges at intergranular contacts by the addition of water. (Freitas (2017) [4]).

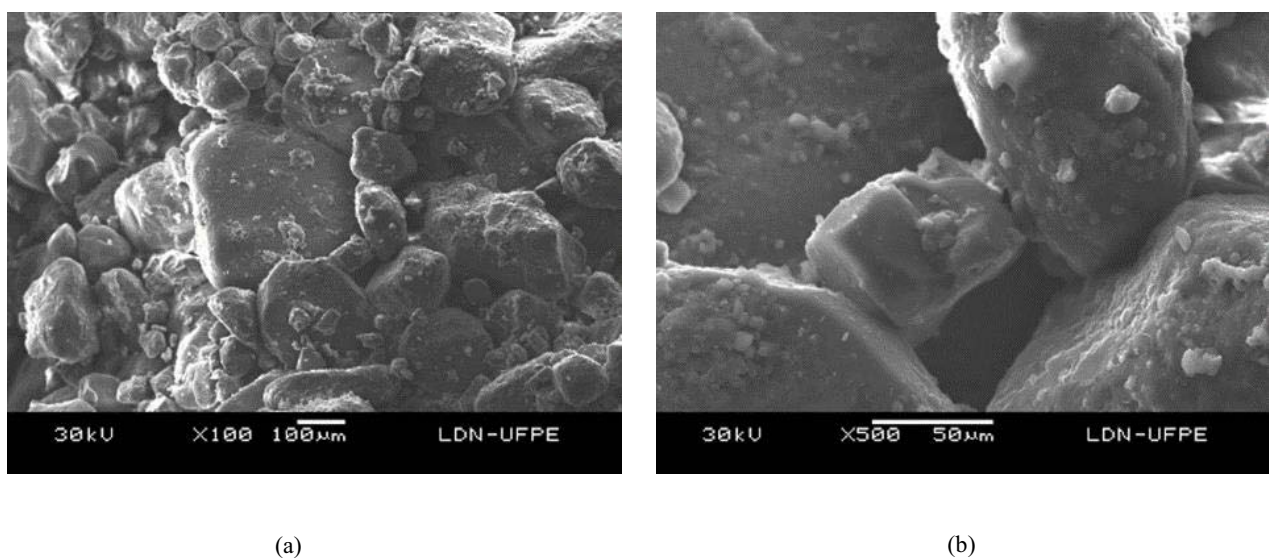
Fig. 11. Electron micrograph of soil arrangements after the compression process under the pressure of 160 kPa and unloaded to zero pressure (a) overall fabric (b) grain-grain contacts.

The electron micrographs of Figure 11 illustrate the different soil arrangements after the compression process under the pressure of 160 kPa and unloaded to zero

pressure, with a positive volume change of 0.41 %. Despite all the effects of the sample preparation process (strain relief, cutting, among others), it was observed that the soil structure after loading (Figure 11 - a) was similar to the undisturbed sample of natural soil (Figure 10 - a). The soil matrix consisted in an intense amount of sand grains and little clay (Figure 11 - b).

The grains of sand were quartz in varied sizes and sub-rounded and sub-angular shapes. The application of the pressure of 160 kPa caused deformation in the soil and reduction of the voids between grains. There was a denser packing between grains, caused by pressure application. The soil's microstructure was unstable, and the grains of sand were clothed with illuvial clay.

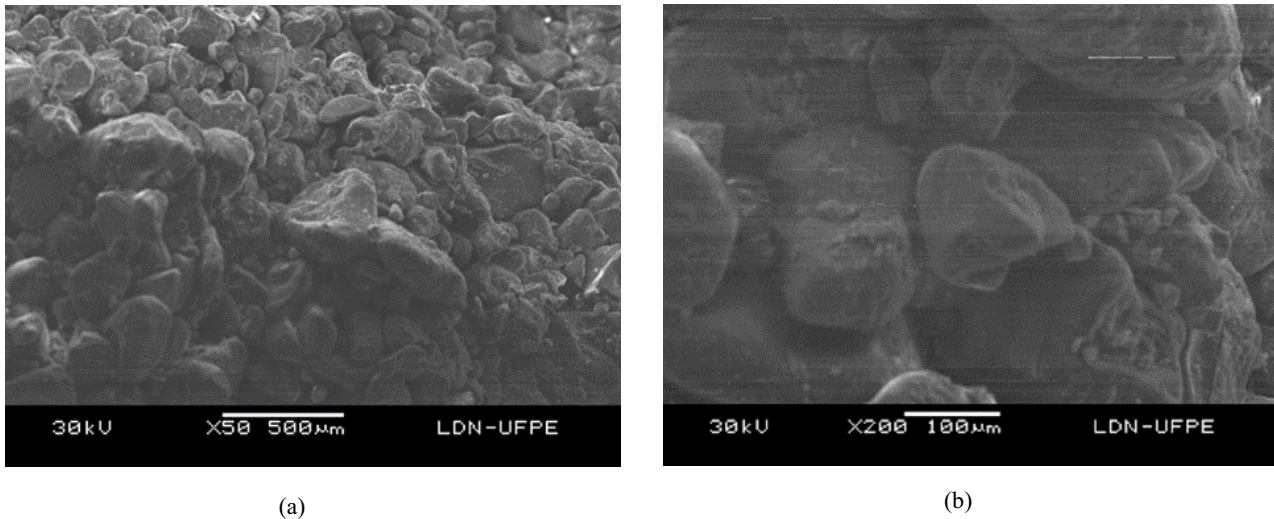
Fig. 12. Electron micrograph of soil arrangements after the compression and collapse process. (a) overall fabric (b) microstructural arrangement.

Electron micrographs shown in Figure 12 illustrate different soil arrangements after the compression and collapse process under the pressure of 160.00 kPa and unload to zero pressure with a positive volume change of 0.65 %. As previously mentioned, despite all the effects of the sample preparation process (drying, strain relief, cut among others), it was observed that the soil structure after collapse was similar to the undisturbed sample of natural soil and the sample compressed to 160 kPa. There was a greater packing between grains, caused by the application of pressure and collapse (Figure 12 - a). The microstructure of the soil (Figure 12 - b) was still unstable because the grains of sand were clothed with illuvial clay.

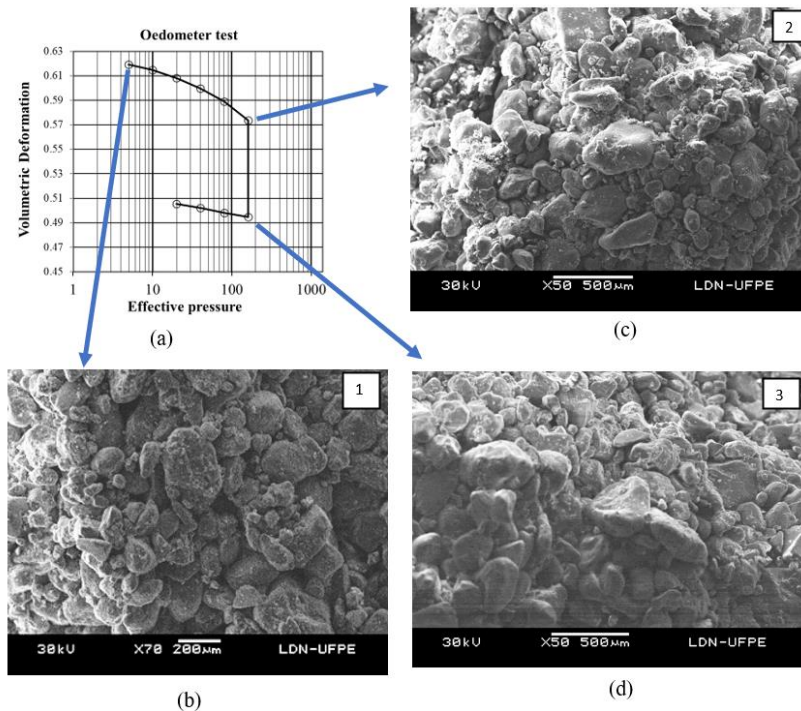
Fig. 13. Schematic view of different soil arrangements with the Electron micrograph (a) oedometric graphic (b) undisturbed sample (c) soil arrangements after the compression process under the pressure of 160 kPa and unloaded at zero pressure (d) after the compression and collapse process.

A schematic view of the different fabric and the oedometer test are shown in the Figure 13. The undisturbed sample (Figure 13 - b) has a void ratio of 0.626 and a specific density of 16.19 kN/m³. After oedometer compression, the sample has a void ratio of 0.574 and a specific density of 16.73 kN/m³ (Figure 13 - c). The collapse process made a denser soil, with a void ratio of 0.479 and a unit weight of 17.61 kN/m³ (Figure 13 - d).
