Optimising post- collision repair costs with the use of the audanet system with 3d intelligent graphics

Abstract. Transporting people and goods poses a risk of participating in road collisions which results in damage to be eliminated to bring the car back to operation. When running a business, it is essential to optimise the repair costs. Also, the insurance companies search for repair cost determination methods adequately to the damage incurred. Currently the post-collision cost calculations are supported by specialised IT tools offering various spare parts assortments to be used for repair, painting methods as well as the process of technological replacement of the elements damaged. Cars, due to their complex structure, require a new approach to the process of determining the size of damage and the resulting repair cost. The article covers the problem of optimising the post-collision repair costs while using 3D Intelligent Graphics of AudaNet. The procedures presented in the article can be used by researchers modelling technological post-collision repair processes and they are applicable.

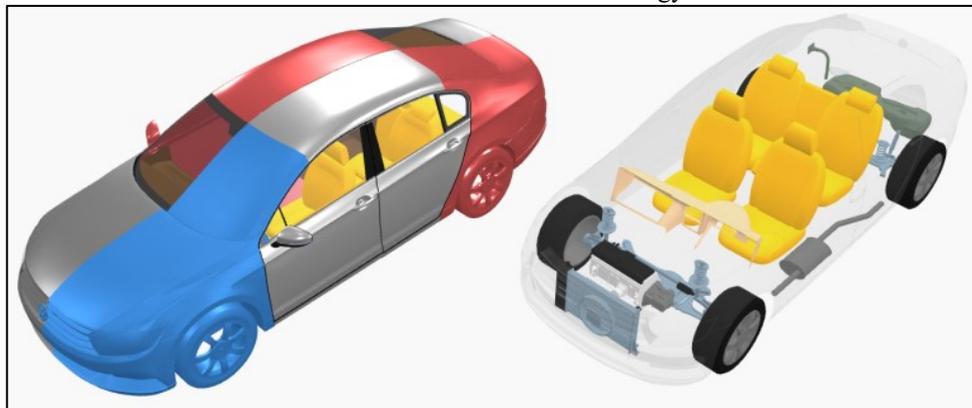
Fig. 1. AudaNet dialogue window in the damage zone selection mode.

However, for repair cost calculations, the AudaNet program with 3D Intelligent Graphics was applied. It is a state-of-the-art Internet platform facilitating communication among the damage liquidation process participants and the repair cost calculation following the specific vehicle make manufacturer's technology and eliminating the duplication of the process operations. 3D graphics facilitates a visualisation of the vehicle parts the way they look on the car, which makes identifying parts easier. The program database includes the prices of the spare parts of the chassis, equipment option, steering, exhaust system, the suspension, engine and the gearbox. The program dialog window in the damage zone selection mode is given in Fig. 1 (<https://www.audanet.pl>). The program offers also two painting methods; vehicle manufacturer's and the Allianz Centre's for Technology.

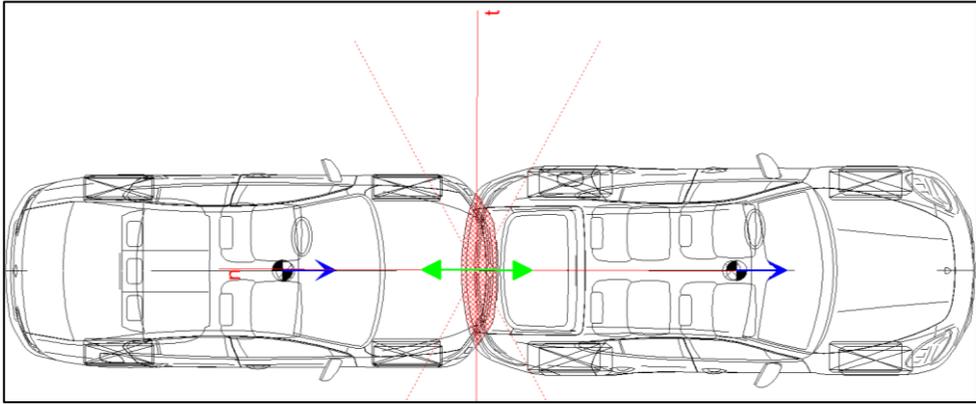
The vehicle damage circumstances involved the vehicle's front impact into a stopped preceding car. The object of the study was not observed to have activated the airbags and so, from [9], specifying the collision velocity was assumed as 20 km/h. Fig. 2 presents a collision which resulted in a damage to the front part of the body and the internal vehicle elements illustrated in the cars as the hatched area (in red).

Fig. 2. Vehicle's impact into the preceding vehicle.

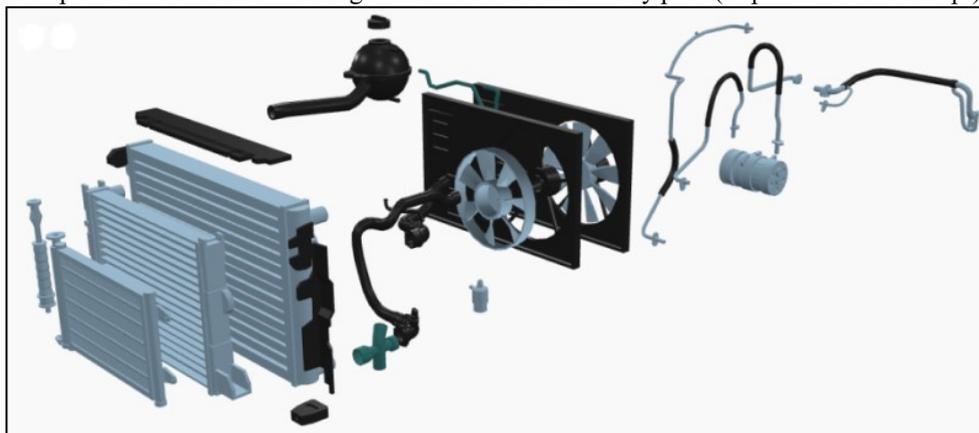
Fig. 3. Cooling and air-conditioning damage zone selection mode.

Fig. 3 presents the program dialogue window in the cooling and air-conditioning damage zone parts selection mode and Fig. 4 – the front external body part (<https://www.audanet.pl>).

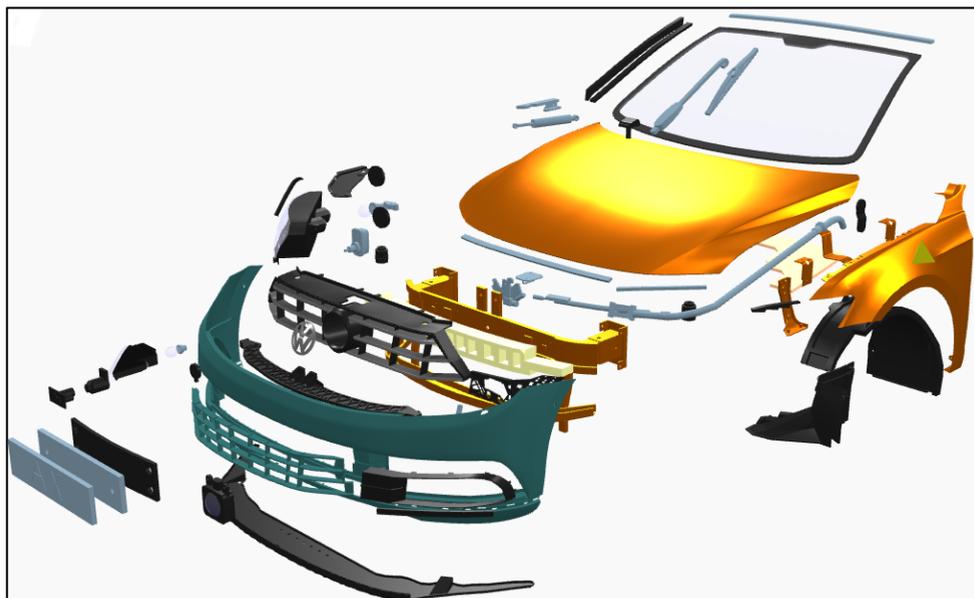
Fig. 4. Front external body part damage zone parts selection mode.

- Front bumper with an air-inlet grille and a spoiler; a replacement,
- Front bumper reinforcement; a replacement,
- Headlights with blinkers; a replacement,
- Fog lamps (halogen lights); a replacement,
- Air-inlet grille (front grille); a replacement,
- Front wings; a replacement,
- Engine compartment cover; a replacement,
- Radiator; a replacement,
- Air-conditioning condenser (radiator); a replacement,
- Front reinforcer; 1 manhour repair.

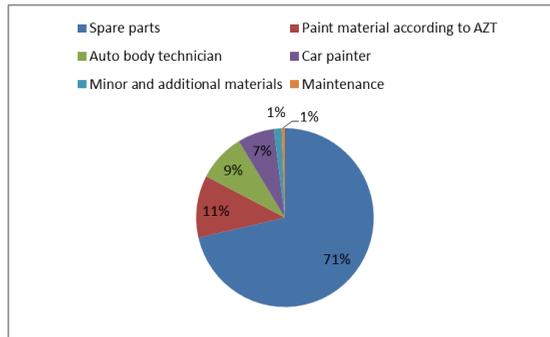
Fig. 5. Repair cost components vehicle manufacturer's original parts O.

Spare parts			14 710.30 PLN
Paint material according to AZT			2 320.02 PLN
Auto body technician	119 JC	150,00 PLN	1 785.00 PLN
Car painter	17,40J C	150,00 PLN	1 376,00 PLN
Minor and additional materials			294.21 PLN
Maintenance			120.00 PLN
	Total repair costs (net)		20 605.53 PLN
	Total repair costs (gross)		25 344,80 PLN

Figs 5-7 provide a breakdown of the repair cost for the above three variants and Fig. 8 – a comparison of the total costs across the repair cost calculation variants. The calculations show that the repair costs are dominantly affected by the evaluation of spare parts used for post-collision vehicle repair effect on repair costs. The costs of original spare parts from alternative suppliers are 23 % lower than the original spare parts with the vehicle manufacturer’s logo. The costs of spare parts of comparable quality, however, are 63 % lower than the original ones with the vehicle manufacturer’s logo.

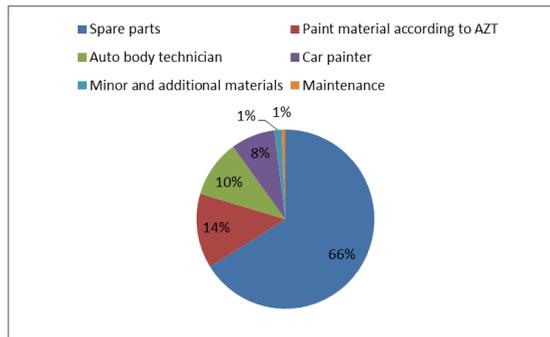
Fig. 6. Repair cost components original parts from alternative suppliers Q.

Spare parts			11 357.58 PLN
Paint material according to AZT			2 320.02 PLN
Auto body technician	119 JC	150,00 PLN	1 785.00 PLN
Car painter	17,40J C	150,00 PLN	1 376,00 PLN
Minor and additional materials			227.15 PLN
Maintenance			120.00 PLN
	Total repair cost (net)		17 185.75 PLN
	Total repair cost (gross)		21 138,47 PLN

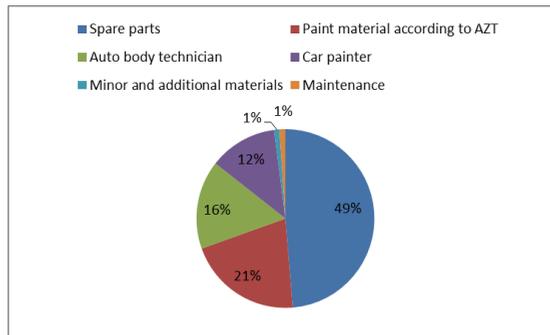
Fig. 7. Repair cost components parts of comparable quality P.

Spare parts			5 418.28 PLN
Paint material according to AZT			2 320.02 PLN
Auto body technician	119 JC	150,00 PLN	1 785.00 PLN
Car painter	17,40J C	150,00 PLN	1 376,00 PLN
Minor and additional materials			108.37 PLN
Maintenance			120.00 PLN
	Total repair costs (net)		11 127.67 PLN
	Total repair costs (gross)		13 687,03 PLN

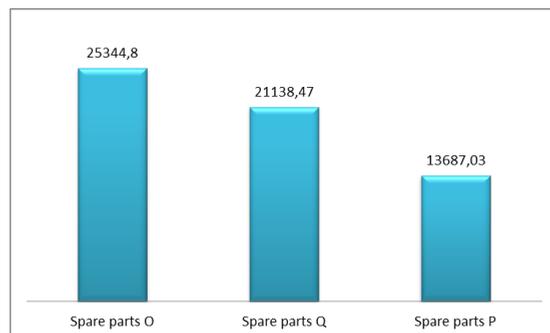
Fig. 8. Total repair cost comparison parts: O, Q and P.
