# Autogenous healing in ultra-high-performance fibre reinforced concrete: application in two reduced scale water reservoirs

**Abstract.** Self-healing is defined as the capacity of a material to repair internal damage without any external intervention. In the case of concrete, this process can be autogenous, which is the natural capacity of the material. Ultra-High-Performance Fibre Reinforced Concrete (UHPFRC) has a high self-healing potential due to its high binder content with a low w/b ratio and its crack pattern with multiple micro cracks. This paper describes two UHPFRC water reservoirs, which were designed to minimise the volume of concrete used. The design is made of ribbed thin walls where shrinkage cracks are likely to happen. The objective of this work is to study the autogenous healing capability of this concrete in these cracks. The two water reservoirs have internal dimensions of  $1.30 \times 0.75 \times 0.70 \text{ m}^3$  and with 20 mm thickness in the centre of the walls. These walls displayed cracks ( $w < 100 \mu\text{m}$ ), which were produced just after casting. Both reservoirs were filled with water, showing apparent water leakage. The cracks were monitored

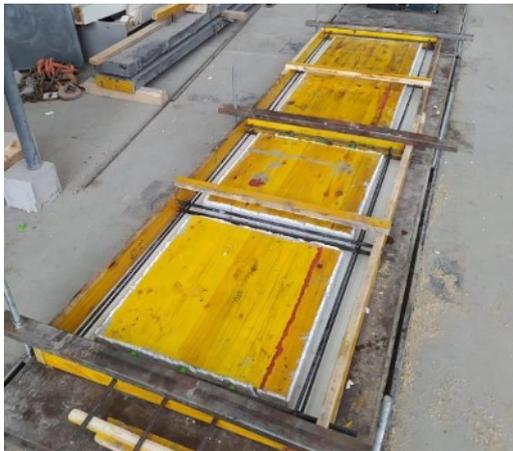
**Fig. 2.** Formwork and placed rebars for the lateral walls

The two lateral walls of reservoir no.1 were cast on 10th September 2020 (Fig 2), and on 18th September 2020, the two lateral walls of reservoir no.2 were cast. The four frontal walls (two per water reservoir) were cast on 14th September 2020 (Fig 3).

After this process, the formwork and reinforcement for the base elements were prepared. The frontal and lateral walls were placed in their final position. Frontal and lateral walls were fixed to one another by using threaded rods and nuts. Fig 2 shows these rod elements in the lateral walls' formwork and the holes prepared for the connection in the frontal walls' formwork (Fig 3). At this stage, the precast walls were around 10-14 days.

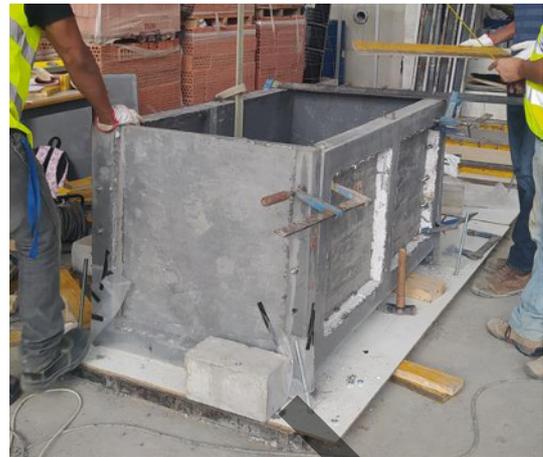
**Fig. 4.** Frontal and lateral walls placed before pouring UHPFRC for the base of a reservoir.

During the pouring process of the bases, clamps were used as an additional support for fixing the elements in their position. Additionally, plastic sheets were placed to ensure no leaks of UHPFRC were produced (see Fig 4). Fig. 5 shows the pouring process for producing the base of one of the reservoirs, which was done by pouring from the interior of the element, and thanks to its self-compacting properties, the material flowed and was distributed throughout the formwork.

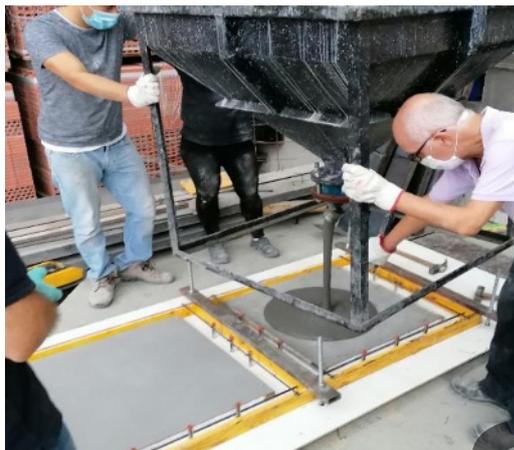
**Fig. 3.** Formwork of the lateral walls and UHPFRC being poured into the formwork of the frontal elements.

The self-compacting properties of this UHPFRC mix allowed casting all the ribs easily. Fig 3 shows the mix being poured into one of the formworks for a frontal wall.

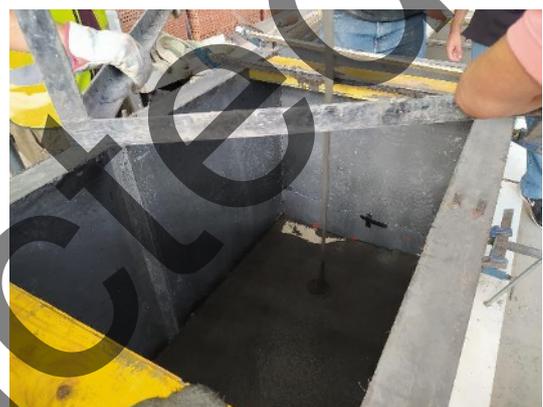
**Fig. 5.** Pouring UHPFRC inside the formwork for producing the base of the reservoirs.

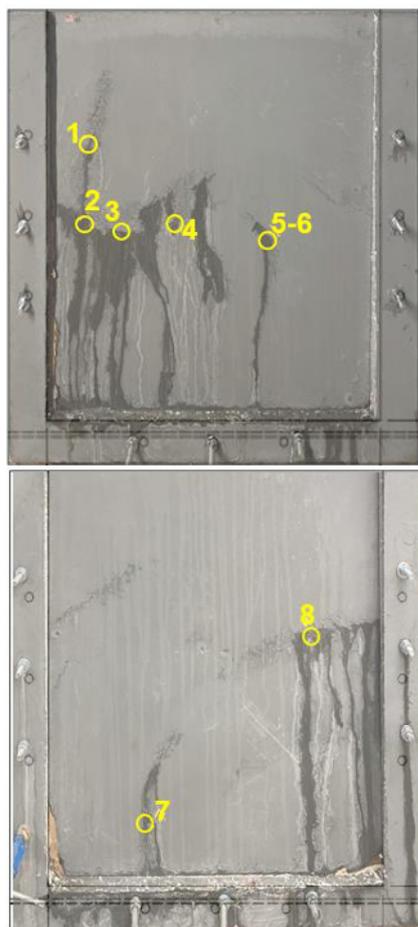
**Fig. 7** Images of the two opposite frontal walls of reservoir no.1 with water leakage marks (top and bottom).

In order to evaluate the self-healing capability, the crack sizes on the two frontal walls of the two reservoirs were measured using a YINAMA Wi-Fi microscope. Among all the crack branches, the most representative cracks were chosen from those with apparent water leakage. Eight cracks from water reservoir no.1 were monitored (marked with circles and numbered in Fig 7) for 43 days. Four cracks from water reservoir no.2 were monitored for 37 days as well.

In all the walls, vertical and horizontal cracking was observed. Vertical cracks appeared in the walls and started at the confluence of the walls with the base, reaching 1/3 of the wall height. The highest cracks appeared in the middle of the wall. The horizontal cracks appear in the frontal walls. The crack patterns that were produced in the frontal walls of water reservoir no.1 are displayed in Fig 7. The crack pattern in water reservoir no.2 walls were very similar.
