Study on the Present Situation and Cause of Formation of Rocky Desertification in Xichuan County

Abstract. As the eco-environmental security guarantors for water source, Xichuan and its hydro-ecological condition play important roles in Middle Route Water Transfers Project from South to North. Via analyzing the soil, water quality, rock and vegetation et al., we studied the current extend of rocky desertification in Xichuan. Considering the local situation, we analyzed the human factors and natural factors that contribute to the rocky desertification in Xichuan, which are helpful in reducing rocky desertification and worthy of promoting.

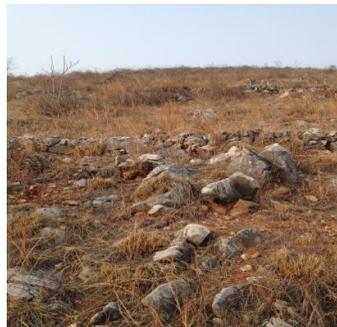
Figure 1. Rocky Desertification Status in Jinhe Town, Xichuan County

41 tons / ha [2-3]. The rocky desertification areas are distributed in the surrounding area of Danjiang reservoir, Danjiang River, Taohe River, Guanhe River, Qihe River and other river basins, including 12 towns and townships, such as: Jinhe, Shangji, Madeng, Dashiqiao, Laocheng, Jingguan, Siwan, Xihuang, Maotang, Taohe, Cangfang. The rocky desertification mountain rock in Xichuan County is most limestone and the soil is mostly tyrosinase subgroup ballast soil. Due to long eroding of rainfall, the base rock is exposed, and the gravel is aggregated, so the soil is barren and the vegetation is sparse.
