A qualitative investigation on double-skin façade fires

Abstract. Fire hazard of the green architectural feature double-skin façade is always a concern. A hazard scenario with a room fire adjacent to the façade was identified earlier after interviewing with fire professionals. Experimental studies on the consequence of the fire hazard due to trapping heat and mass in the façade cavity carried out before will be reported in this presentation. The rig was of height 15 m with a fire chamber placed next to it. Flashover was induced to direct hot flame and smoke out. Only part of the building was studied instead of a full height façade due to resource limitations. Air temperature next to the upper interior glass pane was confirmed to be higher than the air temperature next to the exterior pane with normal air cavity depth in double-skin façades. Flame will then be diverted to the interior glass pane, giving possibility to spread fire to the upper rooms.

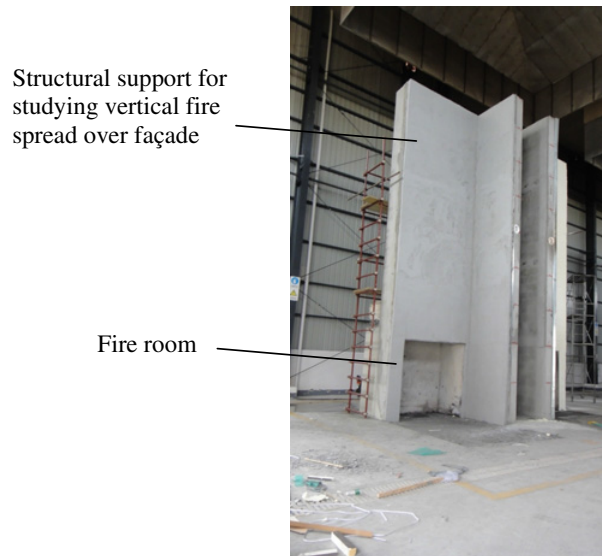
Figure 3. New tests proposed in GB (2013).

Note that a smaller room was used in some testing standards [11–15] as in Figure 3. But in this design, it is difficult to control the window jet. This is different from the arrangement designed in testing façade in this paper based on a method developed before [8–10].
