# Construction of Buildings on Peat: Case Studies and Lessons Learned

**Abstract.** Building construction on soft soils including on peat has many challenges and difficulties. The failed and deteriorated buildings have a big impact on the community. The IConCEES International Workshop 2015 which was conducted on October 2015 convened as a joint venture between Universiti Tun Hussein Onn Malaysia (UTHM) and the University College of Technology Sarawak (UCTS). The aim was to invite regional experts from academia and the industry to formally present and discuss the various construction problems encountered when working with peat. The discussions were divided into two divisions; infrastructure and building construction. This paper discusses the outcomes of the workshop and focuses on the factors and relevant challenges when constructing buildings on peat. The experts have discussed regulatory and construction issues including: drainage issues, site investigation practices, monitoring and construction guidelines. A few suggestions were outlined as a remedy to these problems and to better assist the peat practitioner at work.

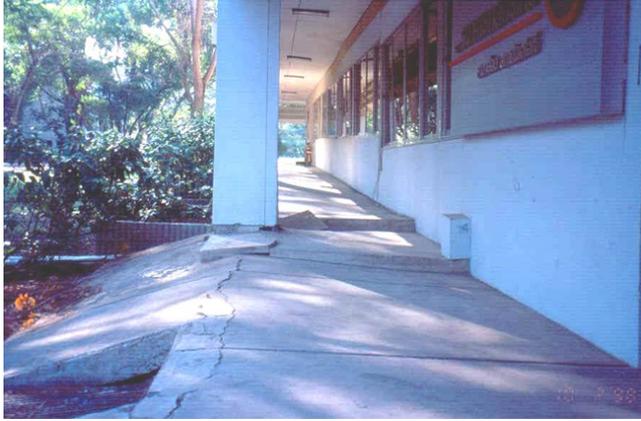
**Figure 2.** Some foundation subsidence in the Asian Institute of Technology in Thailand [2].

Phienweij [2] described the various structural and physical problems associated with construction on Peat and suggested some remedies. There are four case studies highlighted; (i) the subsidence in Ramkhanhaeng University area, Bangkok, (ii) the campus of the Asian Institute of Technology, (iii) the Nakhon Luang Aquifer, and (iv) Bangkok International Airport. Prefabricated vertical drains (PVD) were implemented as a remedy to the airport subsidence problem. It was, also, suggested that several techniques could be applied to other cases to strengthen the soil such as: vacuum consolidation and lightweight materials and soil cement columns for deep mixing methods. Figure 2 shows some foundation subsidence in the Asian Institute of Technology [2].

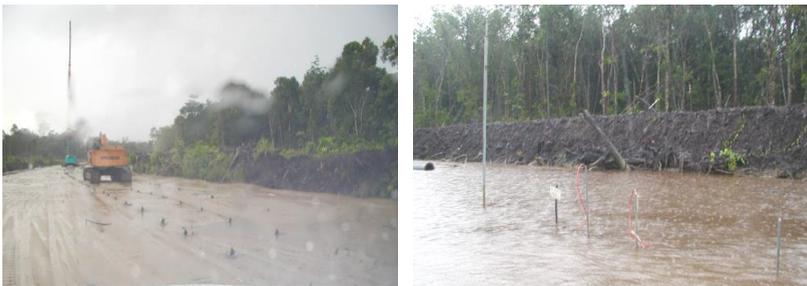
**Figure 3.** a) (left) PVD installed after sand-fill reached existing ground level and b) (right) condition of settlement plates when site was flooded [3].

Ong [3] described the construction of a 13.5 km single-carriageway linking the existing Igan Bridge to a proposed university site in Sibul, Sarawak, East Malaysia. The soft soils of maximum 30 m thick, which were found below the 5-m thick Peat layer. They were treated with pre-fabricated vertical drains to reduce post-construction settlements so that design requirements were met. After site investigation and soil characterization tests, it was successfully constructed using hydraulically placed sand-fill to replace the underlying fibrous peat. Settlement plates were installed to monitor the settlement of the sand layer-PVD system. It was shown that the rate of settlement increased markedly when PVD was installed. Field instrumentation results cross-checked with Asoaka observational method to measure settlements was successfully implemented to provide a good understanding of ground treatment of fibrous peat and soft soil. Figure 3 shows the installed PVD and the settlement plates [3].
