Prestressing Concrete with CFRP Composites for Sustainability and Corrosion-Free Applications

Abstract. Advancement in material science has enabled the engineers to enhance the strength and long-term behavior of concrete structures. The conventional approach is to use steel for prestressed bridge girders. Despite having good ductility and strength, beams prestressed with steel are susceptible to corrosion when subjected to environmental exposure. The corrosion of the prestressing steel reduces load carrying capacity of the prestressed member and result in catastrophic failures. In the last decades, more durable composite materials such as Aramid Fiber Reinforced Polymer (AFRP), Glass Fiber Reinforced Polymer (GFRP) and Carbon Fiber Reinforced Polymer (CFRP) have been implemented in concrete structures as a solution to this problem. Among these materials, CFRP stands out as a primary prestressing reinforcement, which has the potential to replace steel and provide corrosion free prestressed bridge girders. Despite its promise, prestressing CFRP has not frequently been used for bridge construction worldwide. The major contributing factor to the lack of advancement of this promising t

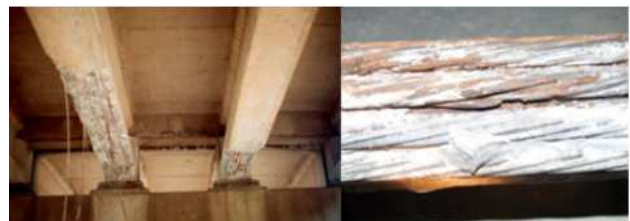
Fig. 1. Corrosion of the prestressing steel [2]

Prestressed reinforced concrete for highway bridges has been in progress since 1951 [1]. At present, around 27% of all the highway bridges in the United States consist of prestressed concrete. Nearly all the prestressed beams use prestressing steel. The problem with steel prestressing reinforcement is corrosion (Figure 1). Prestressed steel beams have prestressing steel tendons under high stress with the relatively small cross-sectional area. The possibility of brittle fracture due to stress corrosion or hydrogen embrittlement is higher in higher strength steel. This may lead to the sudden failure of a bridge without any warning [3-4]. These have initiated the use of non-metallic tendons such as Glass Fiber Reinforced Polymer (GFRP), Aramid Fiber Reinforced Polymer (AFRP) and Carbon Fiber Reinforced Polymer (CFRP) collectively referred to as Fiber Reinforced Polymers (FRPs). Among these materials, CFRP stands out as a primary prestressing reinforcement. The initial cost of CFRP is

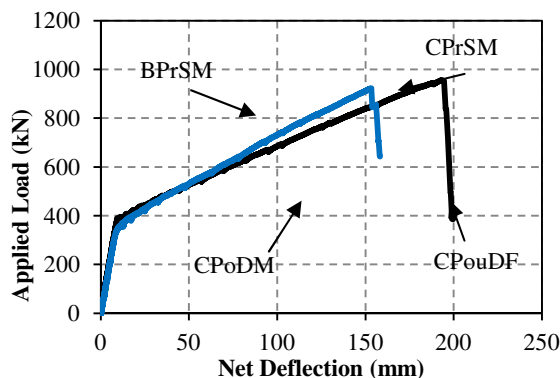
Fig. 5. Experimental load-deflection response of CFRP prestressed beams

Figure 5 shows the load-deflection curves of the four CFRP prestressed beams. The displacements presented in the figure are the average of two potentiometers at mid-span, and the applied load is measured from the load cell on the actuator. The presented load does not include the weight of the beam and the composite deck.

The overall behavior of the beams were piece-wise linear with two distinct stiffnesses up to failure. The initial stiffnesses of the beams reduced after the crack openings and remained almost constant up to ultimate load. For the pre-tensioned beams and bonded post-tensioned beam, the failure was due to rupture of the cables, and the load carrying capacity dropped to zero immediately. However, for the unbonded post-tensioned beams, the failure was due to concrete crushing and once the beams reached the ultimate load, there was a drop, but the beams had a reserved load carrying capacity. A summary of the test results is presented in Table 2.

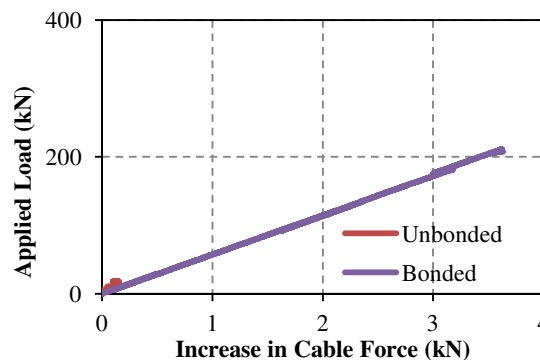
Fig. 9. Increase in cable force for the middle bottom cable for post-tensioned beams against the applied load for the bonded and unbonded case.

Figure 9 shows the change in the force of the middle bottom cable in the post-tensioned beams for two cases; unbonded in the beam CPouDF and bonded in the beam CPoDM. The results are plotted against the applied load.

At a same applied load level, the bonded case has less increase in cable force compared to the unbonded cables, however, at the same net deflection the increase in cable load is higher for the bonded case.
