Non homogeneity of surface integrity after hard milling of high tempered bearing steel

Abstract. This paper deals with surface integrity after hard milling of high tempered bearing steel 100Cr6. Surface integrity is expressed in terms of shape deviation as well as Barkhausen noise emission. Furthermore, components of cutting forces are also measured as a function of tool wear and their non homogeneity within the contact between the milling cutter and workpiece is discussed. The results of measurements indicate that shape as well as structure remarkable non homogeneity should be expected after hard milling due to missing full contact between milling cutter and workpiece. This non homogeneity can be monitored via Barkhausen noise technique. On the other hand the competitive grinding cycles produced more homogenous surface and surface state is a function of infeed speed.

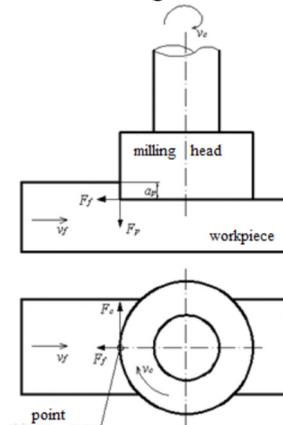
Fig. 1. Brief sketch of measurement of cutting forces during milling

BN measurement was performed by the use of RollScan 300 and software package ViewScan in the frequency range of 70 to 200 kHz (magnetizing frequency 125 Hz, magnetizing voltage 10 V). Each surface was measured in tangential direction. BN values indicated in the paper represent the effective (rms) value of BN signal. BN measurements were carried out in the dynamic mode. This means that during BN measurement components move (speed on the motion 5 mm.s⁻¹). Cutting forces were measured by the use of three component piezoelectric dynamometer KISTLER. The signal was sampled by frequency 10 kHz. Brief sketch of components of cutting force can be found in Fig. 1. Surface profile after machining was measured on MP 60 measuring device.

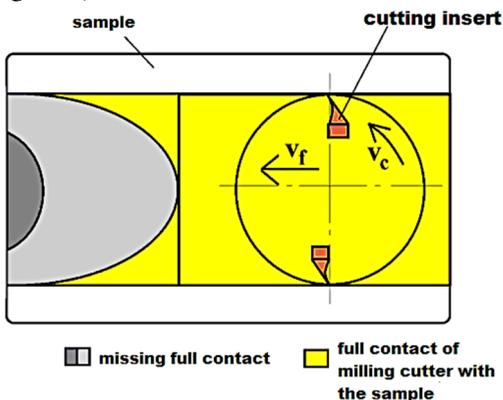
Fig. 2. Non homogenous contact between milling cutter and sample during milling

Fig. 2 and Fig. 3 illustrate the typical surface which can be obtained after hard milling. The main problem is associated with the contact between milling cutter and the sample. As Fig. 2 and Fig. 3 shows that at certain position cutting inserts start to miss the full contact with the sample and run out. This position (in Fig. 2 indicated by grey color) corresponds to the cutter diameter (in this case 50 mm). Due to limited toughness of the milling system milling head tends to be tilted against the machined surface in a certain small angle which changes the condition in the contact between milling cutter (cutting edge) and sample and results into the different appearance of machined surface in this zone. Fig. 3 also indicates that this zone can be easily found by visual inspection. Such character of machined surface can be found for all flank wears and the different sample hardness. Fig. 4 and also details illustrated in Fig. 5 and Fig. 6 show that this effect can be also found in the records of cutting forces components (only passive components indicated in this study, but all other components exhibit the similar behaviour). Fig. 4 and Fig. 5 show that during full contact F_p component oscillates in the range from 200 to 700 N (see also Fig. 6a). As soon as the full contact is missing the run out of the insert causes fall of F_p to zero (see also Fig. 6b). In the further process F_p tend to decrease due to shortening path of the contact between the cutting insert and sample (see also Fig. 6c,d).

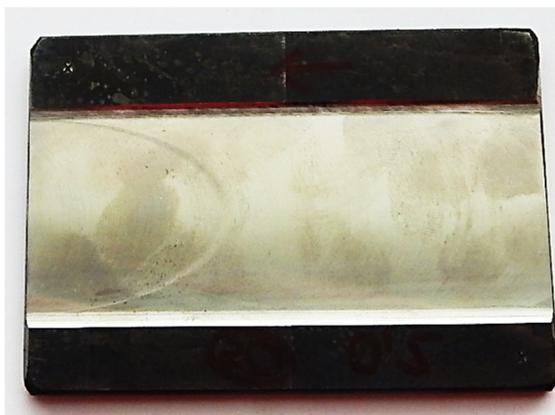
Fig. 3. Sample photo after hard milling

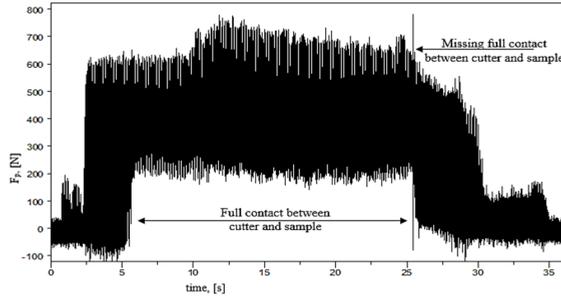
Fig. 4. Record of passive component of cutting force

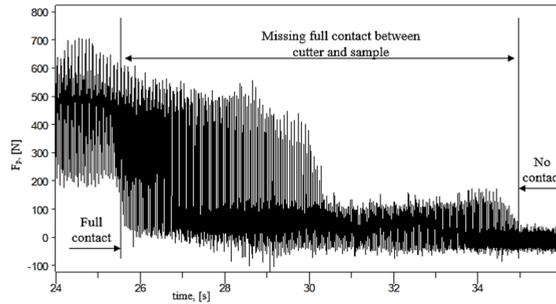
Fig. 5. Detail of passive component F_p

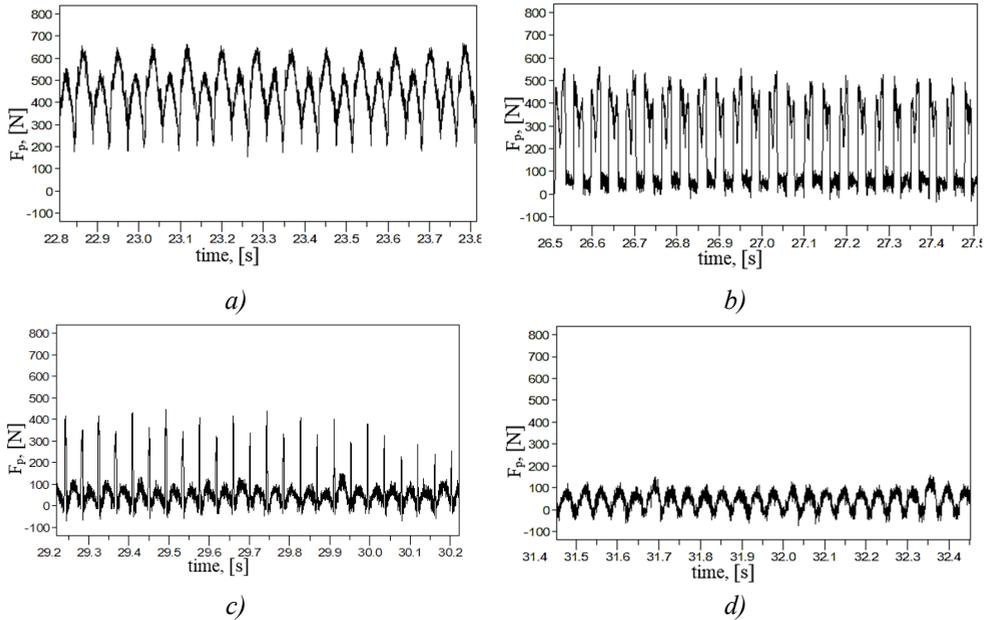
Fig. 6. Details of F_p during missing contact between milling cutter and sample – different phases

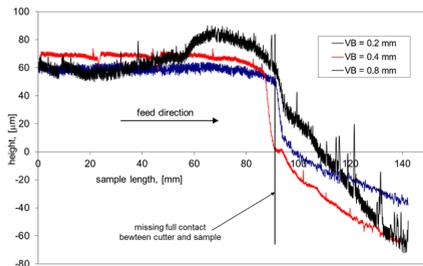
Fig. 7. Surface profile after hard milling

Further measurements of the hard milled surface produced under the variable flank wear VB indicate remarkable shape as well as structure non homogeneity of the machined surface. Fig. 7 shows record of the surface profile in which can be clearly recognized zone of full contact between the milling cutter and the sample as well as strong decrease on the surface height. This point is kept constant and corresponds to the milling cutter diameter. Quite high height of the measured profile is due to high passive forces which are typical for hard machining operation and the corresponding strong influence of passive force on precision of produced components.

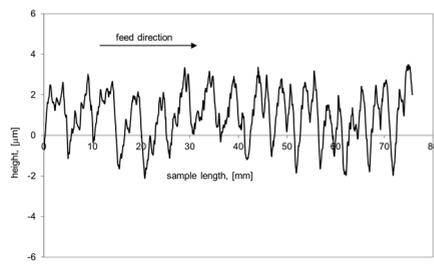
Fig. 8. Surface profile after grinding, $a_p = 0.01$ mm

Milling operations are usually employed for roughing cycles followed by consecutive final grinding. One might argue that such surface would be finished and surface non homogeneity will be removed by grinding since grinding cycles produced much better surface state from the point of view of shape deviations (see Fig. 8). However, quite high height of the profile increases allowances for the consecutive grinding cycles which in turn means longer grinding times and the corresponding costs for technological operations.

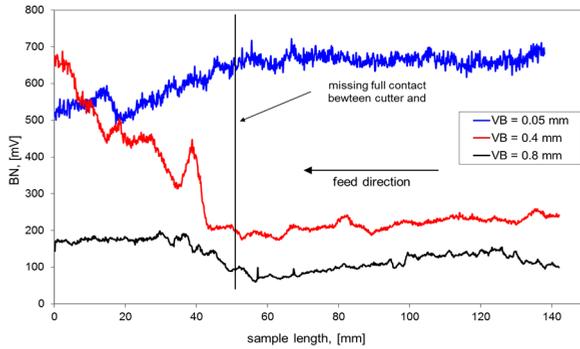
Fig. 9. Dynamic BN record after hard milling

Fig. 9 shows that non homogeneity of machined surface is not only a matter of surface height (of generally surface precision expressed in any term) but also non homogeneity of microstructure and stress state should be expected since BN emission is sensitive to the alterations of microstructure expressed in all terms as well as residual stress state. Being so, it can be found that surface integrity expressed in state of microstructure as well as stress state after hard milling also exhibits remarkable non homogeneity. lace the figure as close as possible after the point where it is first referenced in the text. If there is a large number of figures and tables it might be necessary to place some before their text citation.

Quite similar BN values (taking into consideration 1 sample) can be found for full contact between milling cutter and the sample. As soon as full contact between milling cutter and the sample is interrupted the progressive increase or decrease of BN values occurs. It is worth to mention that progressive change of BN values in the zone of missing full contact between milling cutter and the sample correspond to the progressive change of the sample height as that illustrated in Fig. 9. On the other hand, evolution of BN in the zone of missing contact is not the same for all VB. As can be seen in Fig. 9, BN decreases in the feed direction in this zone for $VB = 0.05$ mm whereas more or less visible increase can be found for more developed VB. The main reason can be found in the different thermal load versus VB. As it was reported, machined surface produced by insert of $VB = 0.05$ mm does not contain WL (considering hardness 45 HRC). As soon as VB attains 0.4 mm thin WL can be found on the machined surface. It is assumed that the differences in BN evolution in the zone of missing contact should be associated just with this aspect.

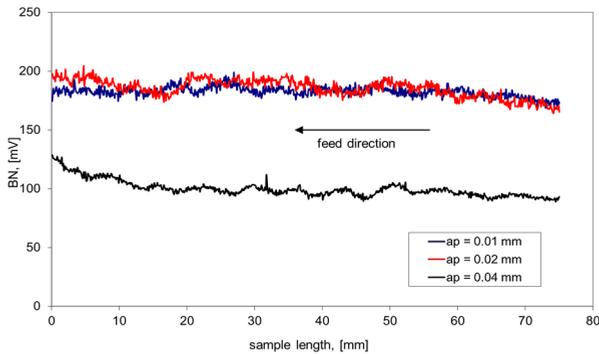
Fig. 10. Dynamic BN record after grinding

Fig. 10 illustrates the BN emission and so the corresponding surface state expressed in terms of microstructure and stress state is more homogenous for grinding cycles (when compared to hard milling cycles). BN values are kept low about 200 mV for $a_p = 0.01$ and 0.02 mm. On the other hand, increased cutting depth in grinding results into surface overheating and remarkable surface burn associated with the intensive surface oxidation

appearing as coloured surface, see Fig. 11. Surface overheating and the corresponding surface re-hardening results into initiation of WL. As it is well known WL after grinding decreases BN emission and contributes to the lower BN [3] for high infeed rates as that depicted in Fig. 10. Higher infeed rates during grinding contribute to visible waviness of BN signal due to grinding process instability.

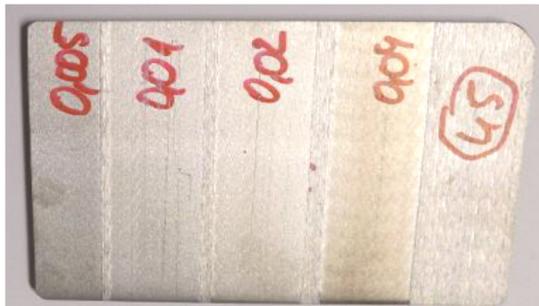
Fig. 11. Sample photo after grinding
