Conservation of irregular stone masonry in Tanais in Russia

Abstract. The article presents and describes the conservation of masonry structures at archaeological site in Tanais near Rostov-on-Don in Russia. The authors' experiences presented in the article result from many years of cooperation between the Faculty of Civil Engineering at the Warsaw University of Technology and the Centre for Research on the Antiquity of Southeastern Europe at the University of Warsaw. Works on masonry structures located in the area of archaeological excavations are characterized by a unique specificity covering both formal issues, resulting from international standards and agreements regulating the conservation of historic buildings, as well as technical and environmental issues. The basic technical issues include ensuring the safety of further excavation works, protection of masonry structures against the destructive effects of atmospheric condition and preparing the structure for possible presentation in archaeological parks organized on the site of trenches. Environmental issues relate to local, social and economic conditions. The article presents the procedures that should be used in the mainte

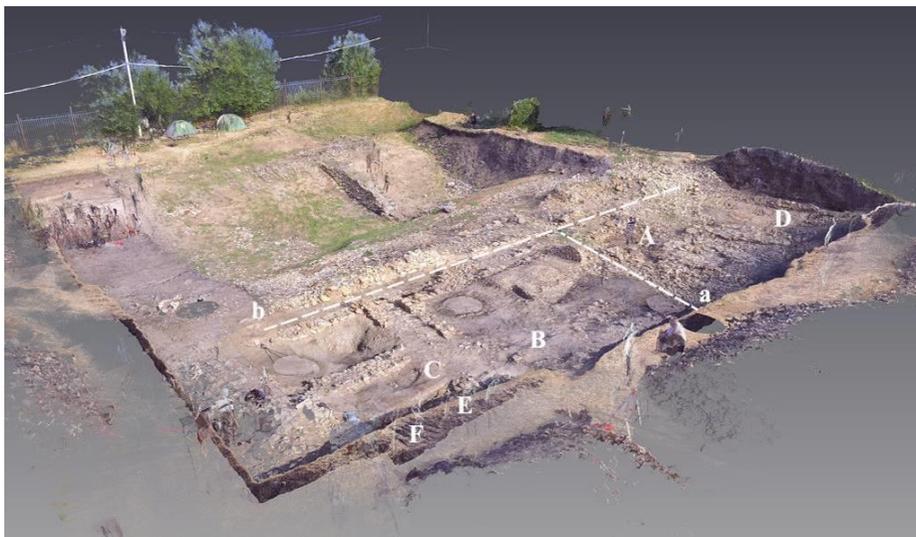
The street 'a' (Fig. 1) ran eastward from the gate to the so-called citadel of Tanais. The street 'b' had a strategic importance and ran parallel to the curtains of defensive walls. To the north of street 'a' an architectural complex of rooms 'A' and 'D' was located. To the south of this street another complex of several rooms ('B', 'C', 'E' and 'F') was situated.

Fig. 1. Three-dimensional model of trench XXV in Tanais, Russia (explanation of symbols in text).

Heretofore, conservation works at Tanais site carried by authors consist of two seasons in years 2016 – 2017. The research was carried out as part of conservation missions by the Division of Fundamental of Building and Sustainable Development of the Civil Engineering Faculty of the Warsaw University of Technology in cooperation with the Institute of Archaeology of the University of Warsaw and the Antiquity in South-eastern Europe Research Centre. The first season was oriented on detailed documentation with a 3-d scanner [23]. One of the outcomes of that documentation is three-dimensional model of the trench XXV, which allows to perform precise measurements of structures located inside (Fig. 1).

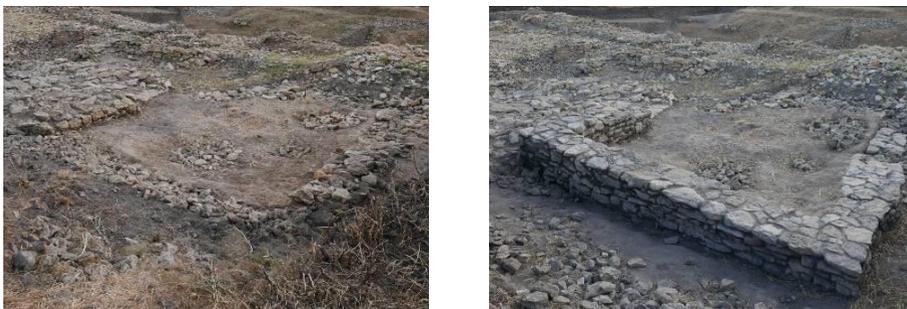
Fig. 2. Walls of the room 'D' located in the north-eastern part of trench XXV before (on the left) and after (on the right) conservation works in 2017.

Conservation work carried out in 2017 season was focused on the room 'D' located in the north-east corner of the trench (Fig. 1). A partial reconstruction was performed with semi-anastylosis method using clay mortar stabilised with lime and cement. Due to the trial stage of conservation work, the pointing with clay mortar, which is a stage of the conservation procedure described in the previous parts, was not applied. Results of the conservation work is presented in the Fig. 2. For the following season it is planned to verify

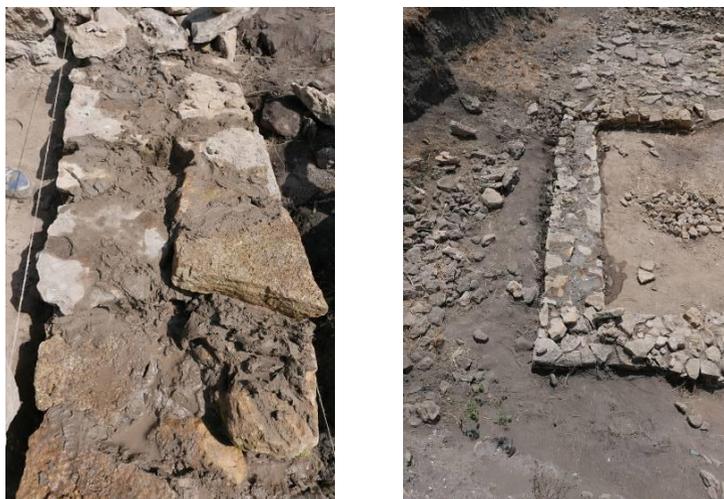
Fig. 3. Irregular masonry during conservation works: reprofiling and internal consolidation (on the left) and curing during conservation work (on the right).

- Preparation of the appropriate mortar for conservation and renovations.
- The reprofiling of existing masonry parts with the anastylosis or semianastylosis method, using prepared mortar; internal bonding of the wall, internal consolidation (Fig. 3). During reprofiling, all plants destroying the masonry structure should be effectively removed. The masonry reprofiling was realized in stages - rebuilding, bonding, consolidation with appropriate mortar, pointing – placing a pointing mortar to a fresh grout, joints complementation with pointing mortar after grout hardened and mechanical cleaning.
