Comparative study on shotcrete repair solutions of buried steel pipelines

Abstract. The research aims to optimize the rehabilitation works of steel buried pipes after their lifespan is reached. It is based on objective real situations met in the Romanian agricultural irrigation system. The study proposes an analytical approach to predict the behavior of the rehabilitated pipelines initially subjected to various corrosion rates, from low to high aggressivity of the environment. Besides traditional lining with reinforced concrete, a new trend given by the relative modern structural repair mortars is considered. The time behavior of the shotcrete lining is estimated based on information given by the appropriate European norm. The results question the design philosophy, still not clarified in the field, and emphasize the superior performance of modern cementitious materials, both in terms of technical performance and economical efficiency. Future research perspectives are also underlined with regard to the new materials meeting sprayed concrete technology requirements, and design philosophy.

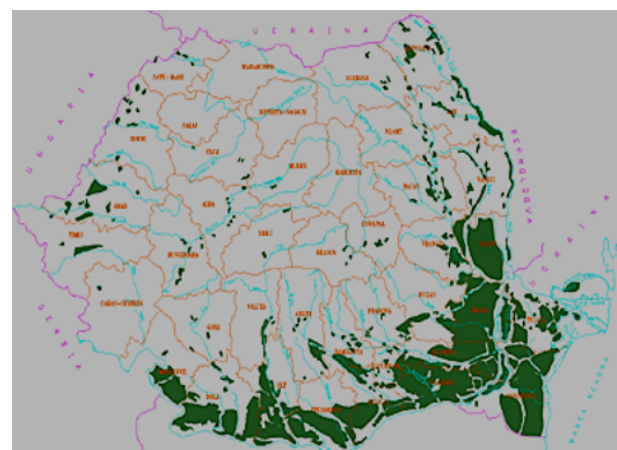
Fig. 1. Areas operated by the Romanian irrigation system.

The water supply for Romanian agriculture is ensured by an irrigation system built mainly between 1971 and 1989 (Figure 1), which covers an area of about 29,920 km². The River Danube provides 85 % of the water transported through 26,700 km of buried pipelines and 10,670 km of channels.

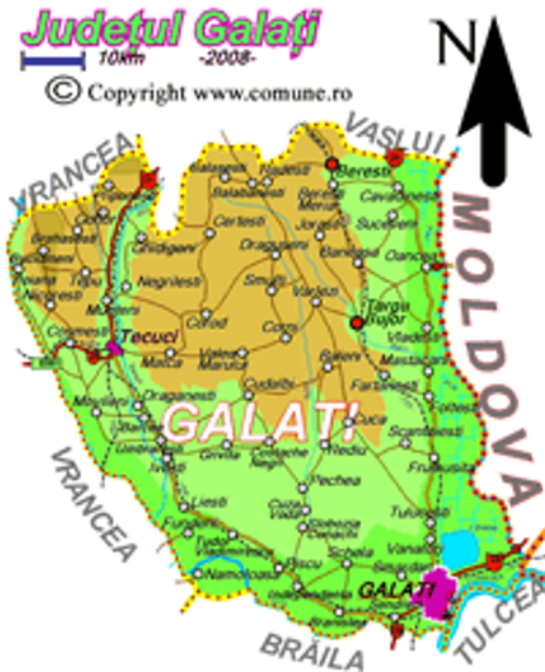
Fig. 2. Irrigation system emplacement.

The study aimed to optimize the interventions made at the steel buried pipes from the Covurlui plain (Galați county, as shown in Figure 2). These were in service since 1985-1989 and are under a comprehensive rehabilitation program.

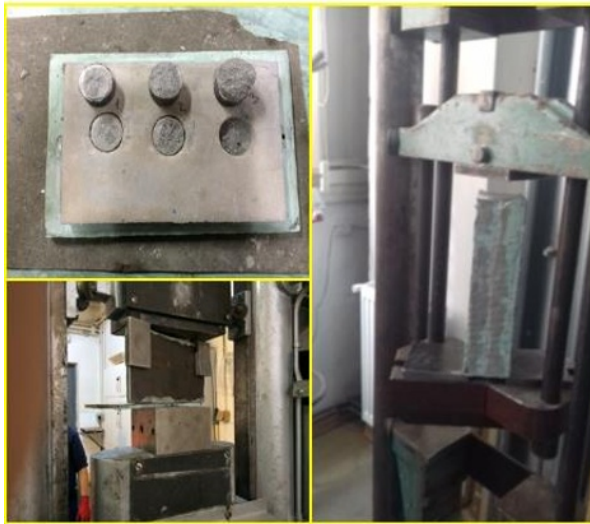
Fig. 3. Specimens and tests.

The results of the mechanical tests (Figure 3) made on the concrete C 30/37 and repair mortar R4 mixes at the age of 28 days are summarized in Table 4.

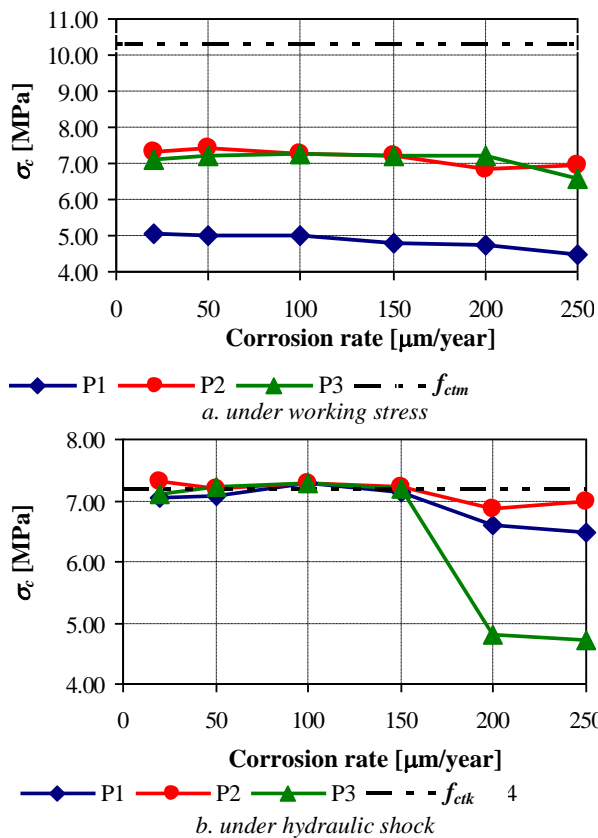
Fig. 7. Shotcrete radial tensile stress with corrosion rate.

Figures 7 and 8 emphasize the tensile stresses related to the shotcrete lining depths shown in Table 8. With two exceptions, the depths resulted from the longitudinal resistance criterion, the other being related to the same criterion on the radial direction.
