Comparative study regarding the causes of land instability phenomena in the area of the Getic Subcarpathians

Abstract. In Romania, as in many other countries of the world, there are areas, more or less extensive, which are naturally prone to landslides. Such an area, with great extension, is represented by the Getic Subcarpathians. In general, this predisposition of the mentioned area to landslides is favored by its geology and hydrogeology, its lithological structure, its morphology, the rainfall regime and to a lesser extent the tectonics of the region. Based on these considerations, in this paper, we have conducted a comparative study aimed at highlighting in a more concrete manner the causes that led to the onset of land instability phenomena recorded in the past 17 years in this area, also taking into account the human activities. For this purpose, we delimited three study areas, corresponding to the counties of Gorj (an area with shutdown mining activities), Vâlcea (area with lignite open-pits in operation) and Argeş (where human actions that can trigger landslides are related to infrastructure constructions, especially by excavation, other constructions, but also deforestat

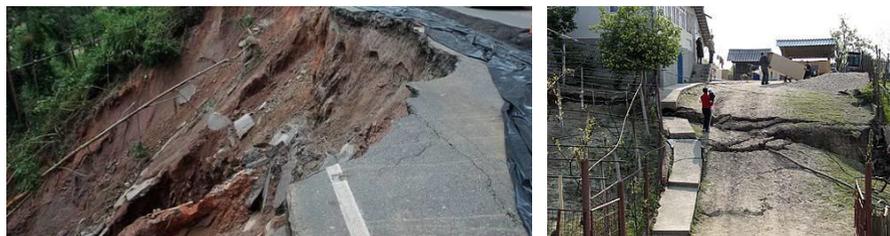
Fig. 1. Landslides and their effects in Poiana Seciuri - Bustuchin area (Gorj County).

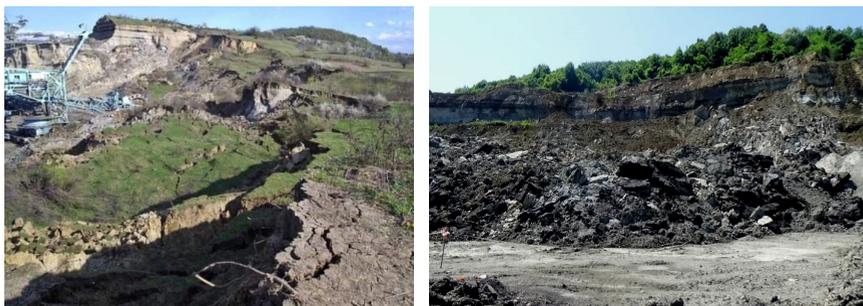
Fig. 2. Massive landslides affecting mining operations in Panga and Alunu open pits (Vâlcea County).

Most landslides occurred, during the studied period, in the Berbești - Alunu mining perimeter, in Panga and Alunu open pits and in the adjacent areas, including some nearby villages. It is mentioned that most of the landslides occurred at the working slopes of the open pits, respectively at the slopes of the inner and outer dumps (belonging to the two mentioned open pits) [8, 9].

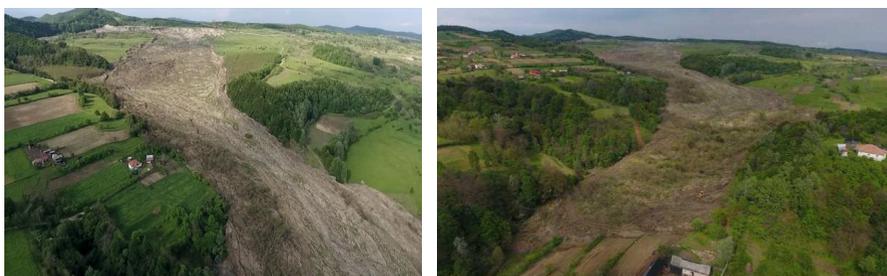
Fig. 3. Massive slide of Alunu exterior waste dump (left – in 2017; right – in 2019 partially stabilized and revegetated).

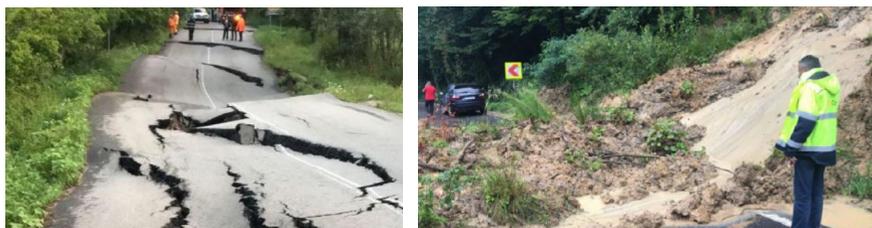
Fig. 4. Landslides in Argeş County and their effects on infrastructures.

If we refer to the analyzed surface, it is observed that in Argeș County we distinguish small landslide phenomena, located and generally stabilized, unlike the areas where open pit mining operations have operated or are operating.
